P. PAPLIŃSKI*, J. WAŃKOWICZ*, P. RANACHOWSKI**#, Z. RANACHOWSKI**

INVESTIGATION OF MICROSTRUCTURE OF ZnO VARISTORS TAKEN FROM SURGE ARRESTER COUNTERS

The paper presents investigations of microstructure of varistors of damaged surge arrester counters. A similar ZnO varistor, not subjected before to operation, was a point of reference in this research. The results of investigations of the ZnO varistors show an untypical phase composition of their material, which was characterized by unsatisfying homogeneity and cohesion. The degradation processes of varistor material in the subsequent stages were recognized and described. A harmful impact of humidity inside the untight surge arrester counter on its operation and its ZnO varistors was proved. Some conclusions being the result of the operation checking of surge arrester counters were presented too.

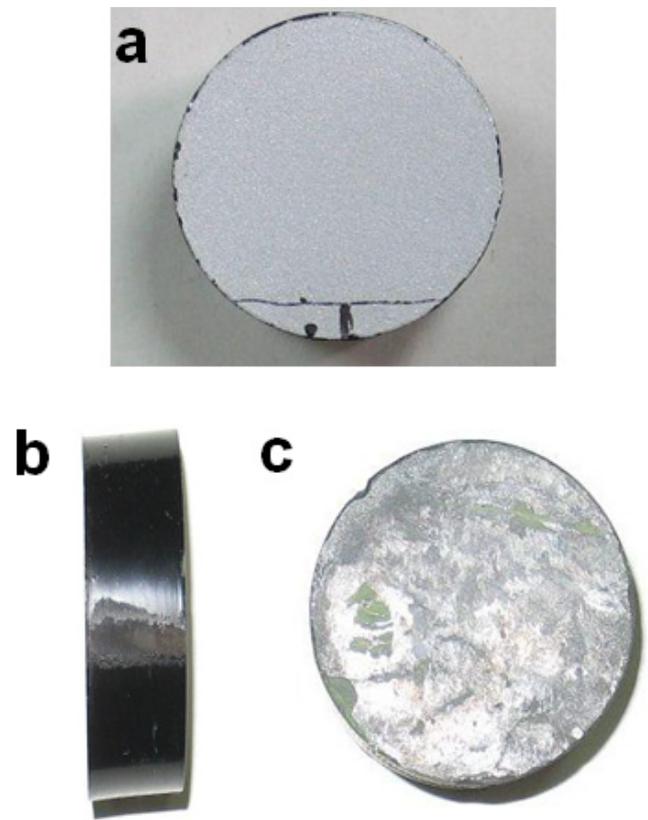
Four ZnO varistors of a leading manufacturer, coming from surge counters, were tested. A reference varistor came from a surge counter that was designed for installation in HV – 110 kV electrical network – Figure 1a. The next two varistors – marked 1 and 2 – operated in adjacent phases of the HV power grid and featured only limited traces of damage in the form of a burnt-out path on the side surface – Figure 1b. The last varistor, marked 3 – Figure 1c, was heavily smoked in the aftermath of fire. It came from a surge counter that had been installed in the 110 kV power grid phase in which, after nearly 10 years of operation, the surge arrester was destroyed.

Fig. 1. (a) – Reference varistor – coming from a surge counter that was out of operation. The area from which a block to be tested was cut off is marked on the bottom of the front surface; (b) – varistor 1 – a burnt-out path in the casing material is visible on the side surface; (c) – varistor 3 coming from a destroyed surge counter. The buildups on the front surface is noteworthy

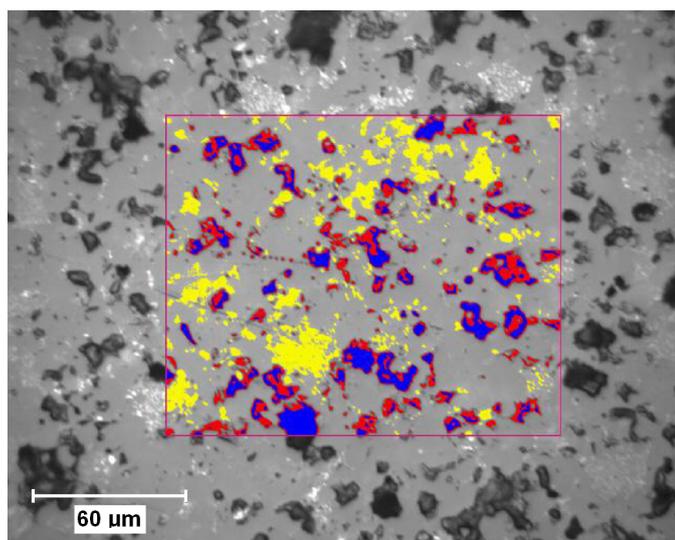
Fig. 2. Typical view of the reference varistor microstructure. A binary mask for colour was applied on the central part of the image, showing the aggregates of the light doping Bi_2O_3 phase – yellow and the spinel phase – red. The areas of chipped elements of the microstructure and scarce pores – in dark blue – cover approximately 6% of the surface. The grey background is the ZnO matrix

The observed microstructure revealed insufficient cohesion. Quite numerous spots of chipping were visible, which are the black areas with a size usually from a few to a dozen or so micrometers. It was associated with the presence of spinel phase. Individual spinel grains had an angular and polyhedral shape and a size of typically a few micrometres, which is slightly less than the ZnO matrix grains. The chipping generally covered grain groups and, together with very scarce and tiny pores, constituted on average 5.8% (from 2 to 8%) of the surface. The spinel phase was present in unexpectedly large quantities. Its non-chipped content, which remained in the microstructure, covered 12.3% (from 11 to 14%) of the surface on average. The initial spinel content in the body can be estimated at 17-18%, of which almost 1/3 was chipped during the preparation of microsections, although, a special – gentle polishing procedure was applied to samples previously flooded in epoxy resin.

The basic doping phase in varistor oxide materials is Bi_2O_3 . In the tested samples, the precipitates of bismuth oxide were distributed very heterogeneously. They were also very diverse in shape and size. The average content of Bi_2O_3 was 10.8% (from 8 to 16%). It should be emphasized that the content of Bi_2O_3 in typical varistor materials is approximately 1 to 3% [7,10]. Figure 3a shows the percentage shares of the tested phases in 10 observation fields of the reference varistor sample.

The microstructure of the material, both in the micro- and semi-macro scales, may be evaluated unfavourably, since it is insufficiently compact and homogeneous. Heterogeneity may indicate unsatisfactory mixing of powder components of varistor composite before its pressure forming and subsequent sintering. The brittleness of the spinel phase and its large clusters also suggest a non-optimal selection of sintering conditions, e.g., temperature, time, atmosphere, and their derivatives. However the reference varistor material showed the microhardness on the medium level – of $\text{HV1} = 141.6 \pm 3.6$.

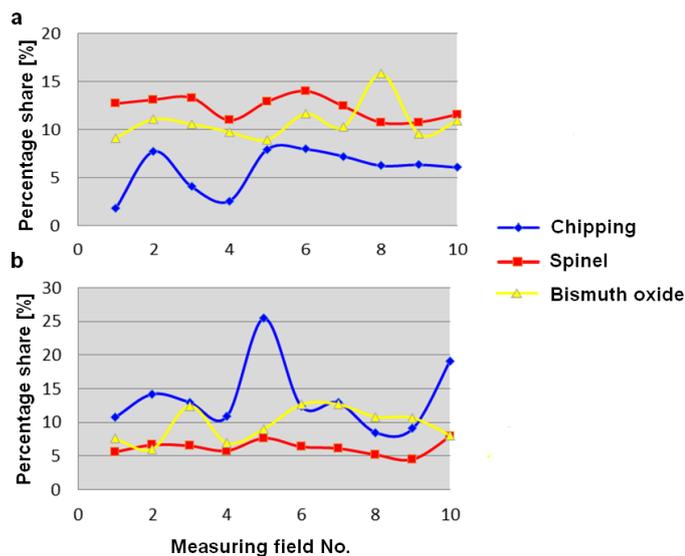
The samples from varistors 1 and 2 contained a material from the areas of direct over burning in the form of a path visible on their side surface, as well as from a slightly distant zone. Generally, the degree of the degradation of the material in both samples was similar, i.e. subcritical. However, at the same time, the microstructure parameters were significantly diversified, depending on the field of observation. This resulted from both – the insufficient homogeneity of the tested material and the degradation effects. The content of individual phases in different measuring fields changed quite widely – Figure 3b.

Only the part of the spinel phase that remained in the microstructure (non-chipped) was quite homogeneously distributed, which is similar to the reference material – Figure 3a. However, its content halved with the number of chipped microstructure elements increasing more than twice. On the other hand, the average Bi_2O_3 content, despite a significant spread, remained at the same level as in the reference sample – approximately

Fig. 3. Percentage share of individual phases in the material samples in 10 observation fields. (a) – The average values for the reference sample are as follows: crushed out elements and pores – 5.8%; non-chipped spinel – 12.3%. The initial structure contained 17-18% of the spinel phase. Bismuth oxide occupied, on average, 10.8% of the surface. (b) – The average values for varistors 1 and 2 are as follows: crushed out elements and pores – 13.6%, non-chipped spinel – 6.3%, and bismuth oxide – 10.8% of the surface

increased to a wide range of 8 to 25%-13.6% on average, as shown in Figure 3b. Under the influence of a fault current flow and thermo-mechanical stresses, the next part of the spinel phase was separated from the microstructure. Approximately 1/3 – 6.3% on average, remained out of its original quantity at the level of 17 – 18%. Moreover, the ZnO grains had a small share in the chipped elements of the microstructure – up to 2%. In some areas, peripheral microcracks around the groups of (or even individual) ZnO grains were poorly visible, but they were not chipped from the matrix. Microhardness of the material in the samples of both varistors decreased significantly, while the dispersion of this important parameter increased considerably $HV1 = 99.3 \pm 8.1$.

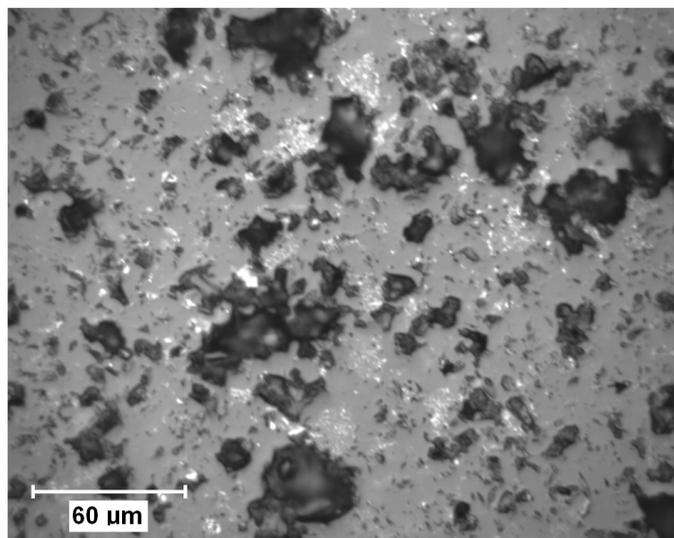
11%, on average. Therefore, it was present in relatively high quantities, but with heterogeneous distributions. Figure 4 shows a typical microstructure of Sample 1 in a zone 1 cm distant from a burnt-out path.

Fig. 4. Image of the microstructure of varistor 1 approximately 1 cm from a burnt-out path. The chipping of microstructure elements accounts for 11% of the surface

In the material of Samples 1 and 2, especially in the vicinity of the path burnt out on the cylindrical surface, the material microstructure significantly loosened, where the microstructure was not compact, cohesive, and homogeneous. The number of chippings – crushed out fragments observed in microsections,

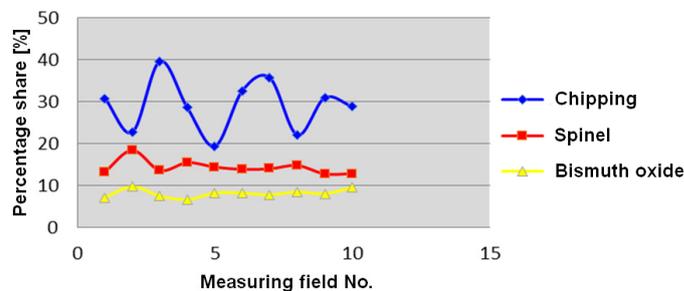
As predicted, the degree of the material degradation in the sample could be described as highly advanced subcritical, and close to critical. There appeared strong loosening and mechanical weakening of the material, the initial compactness, and cohesiveness of which were already low. At the same time, the microstructure parameters were diversified, depending on the field of observation. In particular, the fields of the areas of the crushed out elements of the material varied widely – Figure 5. This was a consequence of both – strong thermo-mechanical stresses as well as the insufficient homogeneity of the tested material.

Fig. 5. Percentage share of individual phases in the material of varistor 3 in 10 observation fields. The average values are as follows: chipping and pores – 29.1%, non-chipped spinel – 14.4%, and bismuth oxide – 8.2% of the surface

Only the part of the spinel phase that remained in the microstructure was quite homogeneously distributed, which is similar to in the material of the remaining samples – Figures 3a and 3b. However, contrary to the expectations, not only its content was not subsequently reduced, but it was even higher than in the reference material (approximately 12%). In Sample 3, the spinel phase accounted from less than 12% to approximately 19%, on average 14.4%. Therefore, only approximately 3% of the original spinel content (17-18%) was chipped. A possible explanation for this quite surprising phenomenon is a significant improvement in the binding of the spinel grains with each other and with the ZnO matrix grains as a result of melting and recrystallization effects. This could have happened in the aftermath of a sharp

Bismuth oxide, which accounted for almost 11% in both the reference material and the structures of Sample 1 and 2, was still present in significant quantities – approximately 8%.

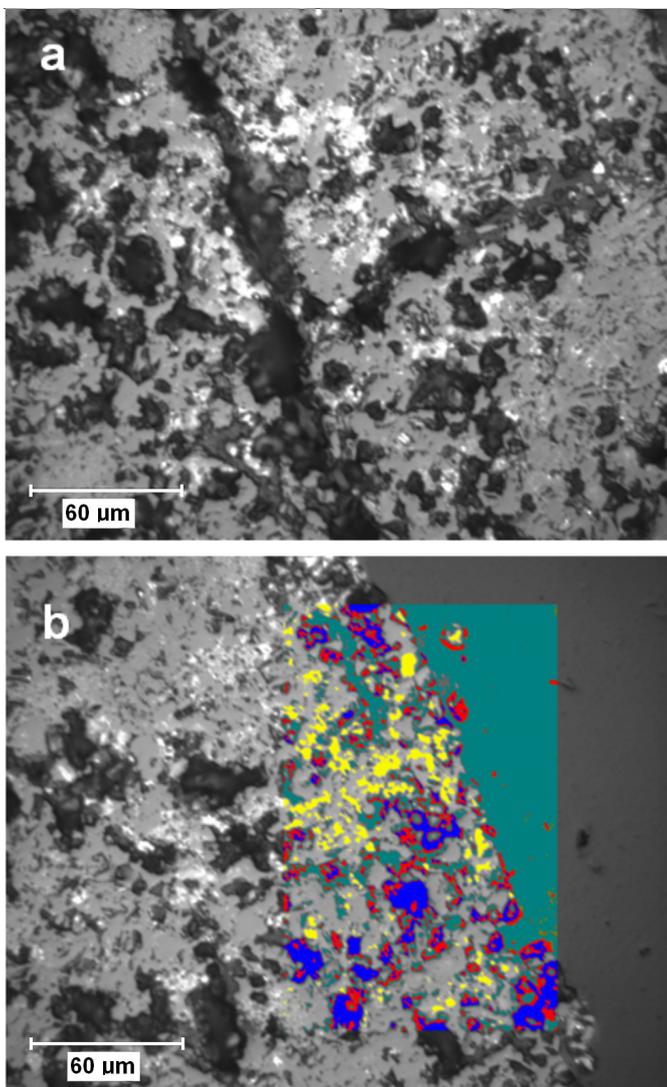
High weakening of the compactness and loosening of the material microstructure is clearly visible in Figures 6a and 6b. The number of crushed out elements observed in the microsections increased to a wide range of 19 to 40% of the surface, 29.1% on average. Thus, almost 1/3 of the material, under the influence of strong thermo-mechanical stresses, was separated from the microstructure and was chipped when polishing the microsections. However, the loss in the doping phases, Bi_2O_3 and spinel – was small – approximately 2.5% and 3%, respectively. In particular, the ZnO matrix was severely degraded. The chipped ZnO grains

Cracks were another effect of far-reaching degradation that was already critical – Figure 6a. Observation of their directions proves that they were formed and disseminated in places with large precipitates of the doping phases – Bi_2O_3 and spinel.

High temperature caused the melting of metallization (contact layer) on the front face of varistor 3. The microstructure in the boundary layer was weakened and loosened to such an extent that deep gaps were formed, through which the resin penetrated deep into the sample. The depth of the heavily cracked layer at the front surface of the varistor reached $80 \mu\text{m}$ – Figure 6b.

Fig. 6. Images of the boundary area of varistor 3. (a) – long crack initiated and propagating in the place of higher concentration of the doping phases – light Bi_2O_3 and darker spinel. (b) – the front face. The layer of metallization was melted. Grey epoxy resin in which the sample was mounted is visible on the right side. A binary mask presents the doping phases – light Bi_2O_3 aggregates – yellow, spinel – red and crushed out fragments – navy blue. The ZnO matrix is grey. Marked turquoise resin penetrates deep into the sample

These observations indicate the need for diagnostic tests of the surge counters at least in the time cycles provided for the surge arresters. The tests should include a visual inspection of the counter viewer and a check whether the continuity of the current flowing through the counter is maintained.
