GPR AS A SUPPORT TOOL IN DETERMINING THE CAUSES OF FAILURE OF OBJECTS BUILT IN THE “WHITE BOX” TECHNOLOGY

A. LEJZEROWICZ¹, M. WUTKE²

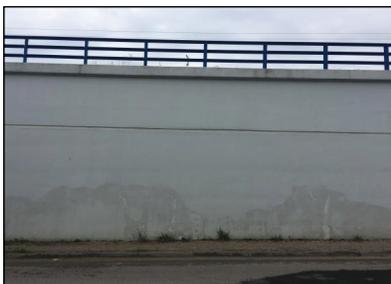
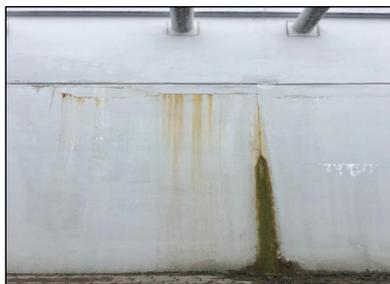
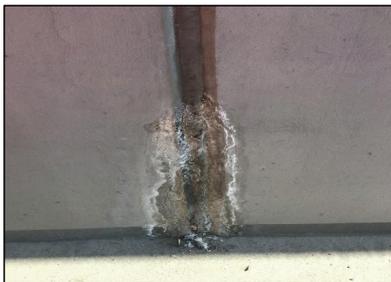
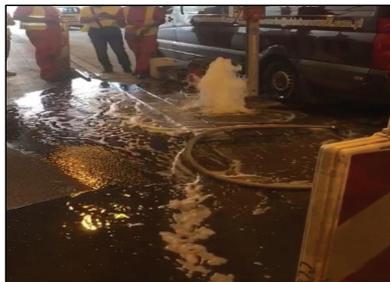
Because of design and implementation errors as well as unsuitable materials used for construction, structural damage may occur, which in the presence of water will lead to leaks (Fig.1) [3]. Leaks in the next phase lead to the break of construction continuity, which can affect the loss of load-bearing capacity and safety of use of the object (Fig. 2).

Figure 1. Leaks in tunnel built in the 'white box' technology: (a) Leakage on the whole wall of the tunnel; (b) Leak at the dilation and in the vicinity of the working gap; (c) Efflorescence and leakage in the area of wall dilatation; (d) Outflow of water under pressure after drilling the control well.

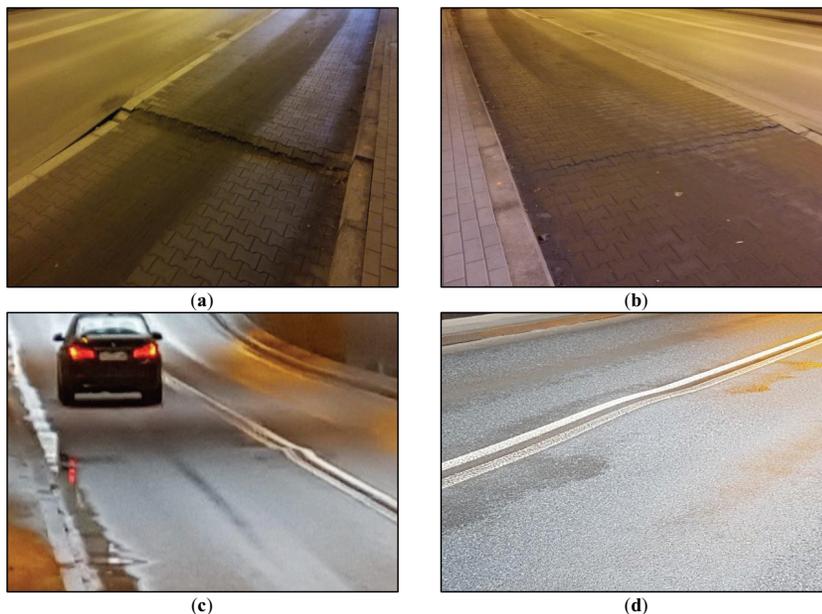
Figure 2. Structural damage resulting from leaks in tunnels: (a) and (b) cracking and elevation of the pedestrian walkway in the tunnel; (c) and (d) deformation in the form of elevation of asphalt layers of the tunnel.

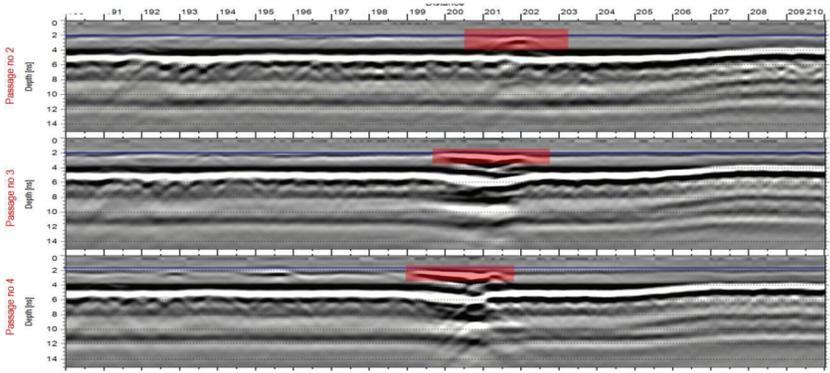
Fig. 6 presents radargrams from measurements of the section covering the observed deformation of the surface. The blue, continuous line indicates the border between the asphalt layers and the bottom slab (at a depth of 11.5 cm). The results of measurements from passage no. 2, 3 and 4 indicate the presence of water between the asphalt layers and the bottom slab: places with a high value of the wave reflection amplitude due to the presence of water are marked with a red rectangle. High amplitude values in the area of the observed surface bulge confirm the presence of moisture (in Fig. 7 it is marked with a red rectangle). Similar anomalies are not observed for the rest of the object's bottom slab. In Fig. 7 it is shown that moisture between the asphalt layers and the bottom slab of the tunnel causes an increase of high frequencies in the spectrum of the wave propagating through the structure (here in the range of 2000 – 5000 MHz) after Short Time Fourier Transform in the time window corresponding to the border between the asphalt layers and the concrete part of the object. Changes in the EM wave spectrum propagating in a medium containing water are determined by two mechanisms: absorption and reflection. The water in the medium absorbs the high-frequency wave components more strongly, which results from the nature of the imaginary dependence of the dielectric constant on frequency; the central frequency is therefore shifted towards smaller values. On the other hand, the same relationship

between the real and imaginary dielectric constant components causes the opposite effect when the EM pulse is reflected from the water surface (e.g. a water lens or a highly hydrated area). The reflection coefficient increases with the wave frequency when the real component is fairly constant and the imaginary component increases. Therefore, stronger reflexes in the higher frequency range lead to a shift of the central frequency in the received wave spectrum towards higher values.

Figure 6. Test results of the bottom to

m slab - high amplitude values under the asphalt indicate the presence of water in this place (after [19], modified). Hyperbolas: reinforcement of the first layer of the tunnel bottom slab (bars perpendicular to the scan direction).

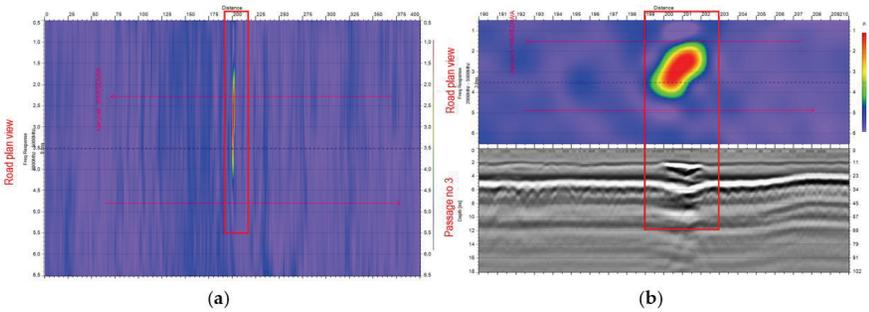
Figure 7. Investigations results of the bottom slab of the tunnel - maps of frequency spectrum of the wave propagated through the structure in the time window 2 – 3 ns corresponding to the depth between the asphalt layers and the bottom slab of the tunnel: (a) shows that similarly high amplitudes are not observed in the rest of the tunnel; (b) the map was compared to the same radargram. High amplitude values on the maps are marked with a red rectangle (after [19], modified).

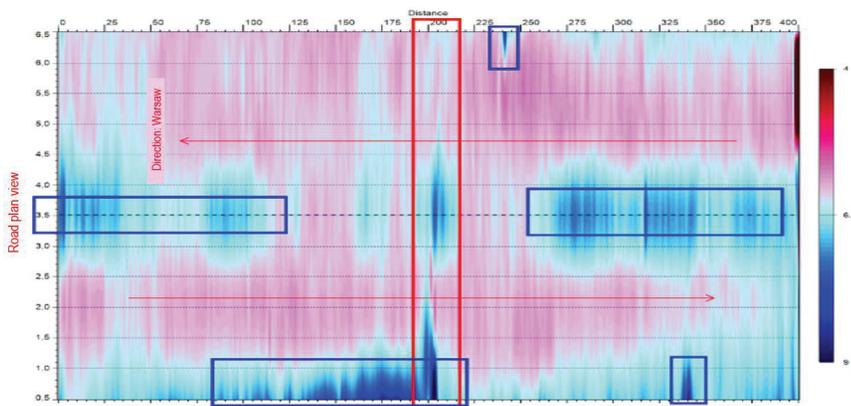
In Figure 8, a blue rectangle indicates increased values of dielectric constants: in the middle of the road resulting from the presence of road salt (chlorides); at the lower edge of the road (at the bottom of the drawing) resulting from incorrect water drainage through drainage wells to the drainage system; at the higher edge of the road resulting from migration of water from dilatation to the tunnel surface. The deformation area of the asphalt surface is marked with a red rectangle - higher values of dielectric constants indicate that the residual water is pushed to the surface, most likely as a result of vehicle traffic. The area of deformation is characterized by higher values of dielectric constants (blue rectangle in Fig. 8) from the values characteristic for the surface of the mineral-asphalt mix (MAM) in the dry state - this means that MAM free spaces are filled with water. Such a result may indicate a damage to the insulation between MAM and the concrete slab and the outflow of water remaining under the insulation through the asphalt layers.

Figure 8. Maps of dielectric constants on the pavement surface (after [19], modified).

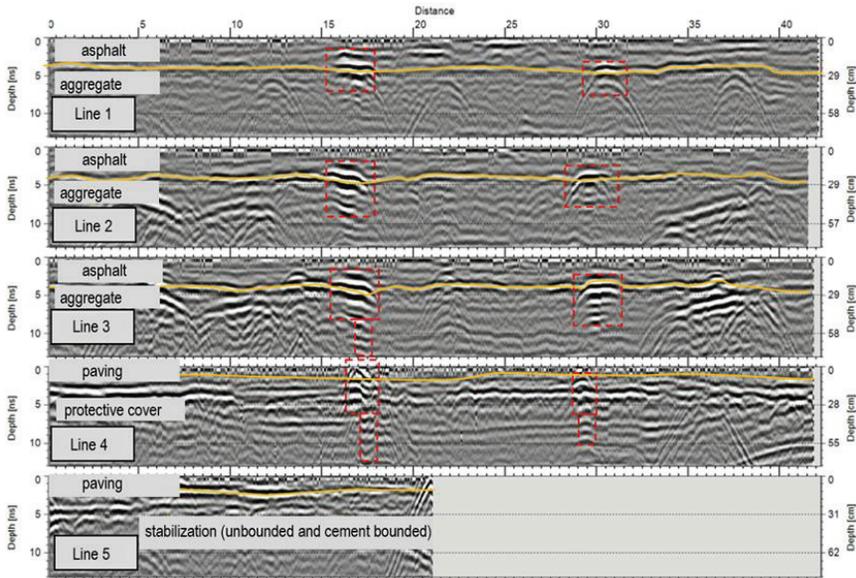
Figure 9 presents radargrams performed using 1.0 GHz air-coupled antenna. Profiles 1-3 are made on the roadway, where the layer system is a 24 cm bundle of asphalt layers on the aggregate (total thickness: about 64 cm). Under the road surface there is a reinforced concrete coat (at least 20 cm) on the bottom slab, separated from the bottom slab by waterproofing. The yellow, continuous line

indicates the boundaries between the asphalt layers and the aggregate. The red, dotted line indicates probable voids created as a result of elevating the asphalt layers and detaching them in this way from the aggregate in the area of dilatation between neighboring segments of the structure. The boundary between the aggregate and the protective cover of the bottom slab is beyond the reach of used antenna. Profile 4 was made in the bus bay. Layer system there is a pavement cube on the cement-sand bedding (13 cm in total) laid on a reinforced concrete protective cover with a minimum thickness of 67 cm. The red, dashed line indicates an offset of pavement cubes (between segments) and a vertical shift of the protective cover with respect to adjacent segments.

The bottom of the protective cover is beyond the reach of the 1.0 GHz antenna. Profile 5 was made on the platform of the bus stop. Layer system is there about 100-cm thick road surface of which the top layer is a concrete cube on the cement-sand bedding. The yellow, continuous line indicates the border between the concrete cube and the foundation of the cement stabilized aggregate. The boundary between the aggregate and the protective cover of the bottom slab is beyond the reach of used antenna.

Figure 9. Investigation results of the bottom slab of the tunnel with deformation in the form of cracking and elevation of the pedestrian walkway - GPR profiles recorded with a 1.0 GHz antenna. Hyperbolas appear in the aggregate layer, those are probably drain pipes.

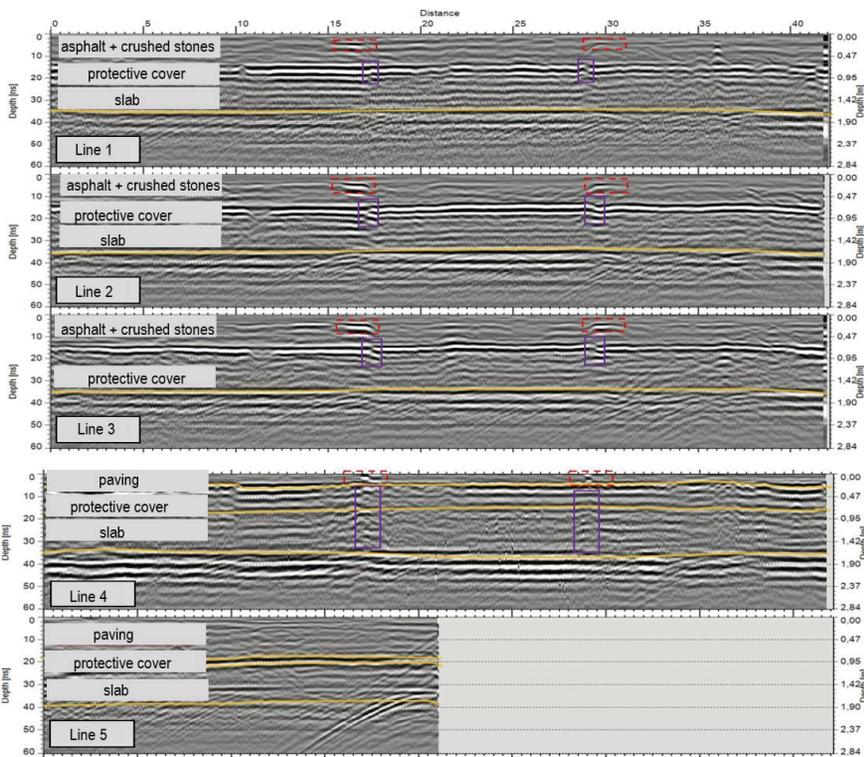
Figure 10 presents radargrams from investigations using 400 MHz antenna - the range of this antenna for the studied medium is about 300 cm, therefore following analysis concerns a depth of up to 300 cm. Profiles 1-3 were made on the roadway, where the layer system is a 24-cm bundle of asphalt layers on the aggregate (a total of about 64 cm). Under the road surface is a reinforced concrete coat (at least 20 cm) on an 80-cm bottom slab, separated from it by waterproofing. The red, dotted line indicates probable voids created as a result of elevating the asphalt layers detaching them in this way from the crushed stones layer. A purple, continuous line is marking a fault location between neighboring structure segments at the depth of the protective cover. The underside of the bottom slab is marked with a yellow, continuous line. It is noted that strengthening and weakening of the amplitude of the horizontal reflex corresponding to the underside of the bottom slab are noticeable, although it cannot be unequivocally determined whether those are changes resulting from damage of the bottom slab.

Figure 10. Investigations results of the bottom slab of the tunnel with deformation in the form of a pedestrian walkway cracking - GPR profiles (line 1-5) recorded with a 400 MHz antenna.

Profile 4 was made in the bus bay. Layer system there is a pavement cube on the cement-sand bedding (13 cm in total) laid on a reinforced concrete protective cover with a minimum thickness of 67 cm. A line of pavement cubes is marked with a red, dotted line. The purple, continuous line shows anomalies in the area of dilatation between the construction segments at the depth of the protective cover and the bottom slab. While in the case of a protective coat, the vertical shift of the protective coat is observed in relation to the neighboring segments coats and elevating it up, in the case of the bottom slab the interpretation of the anomaly is not unambiguous.

Profile 5 was made on the platform of the bus stop. Layer system in this place is as follows: about 100-cm road surface, underneath there is a 15-cm layer of protective coat and 80-cm thick bottom slab, separated by waterproofing. The yellow, continuous line indicates the boundaries between the road surface and the protective coat, protective coat and bottom slab, and the underside of the bottom slab. On profile 5, no significant anomalies are observed in the area of the protective coat and the bottom slab.

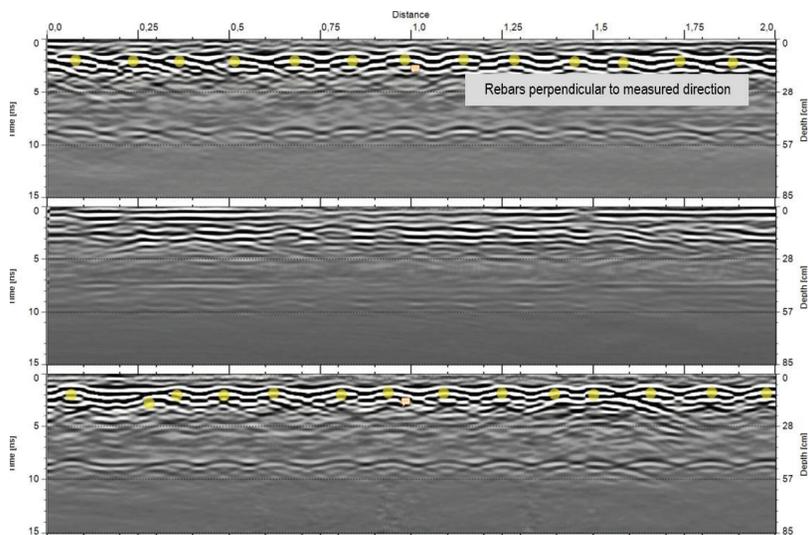
Figure 11 shows radargrams from measurements in the area of the dilatation from the deformation area observed on the surface. On radargrams made on both sides of the dilatation, diffraction hyperbola corresponding to steel bars (reinforcement) in the structure are visible. Reinforcement (due to the fact that it reflects electromagnetic waves) makes it impossible to determine the moisture status of the wall in this place. Anomalies on a radargram from passing directly above the gap may indicate moisture. However, it should be remembered that the presence of reinforcement in the close distance to the gap affects the GPR measurement result and the interpretation of measurements of reinforced elements directed to determine the humidity status is often ambiguous.

Figure 11. The results of GPR investigations of tunnel walls.
