Research paper

The landslide in the slope and side of the Warta River valley in the village of Wronki – process analysis, exploratory research, preventive measures, monitoring

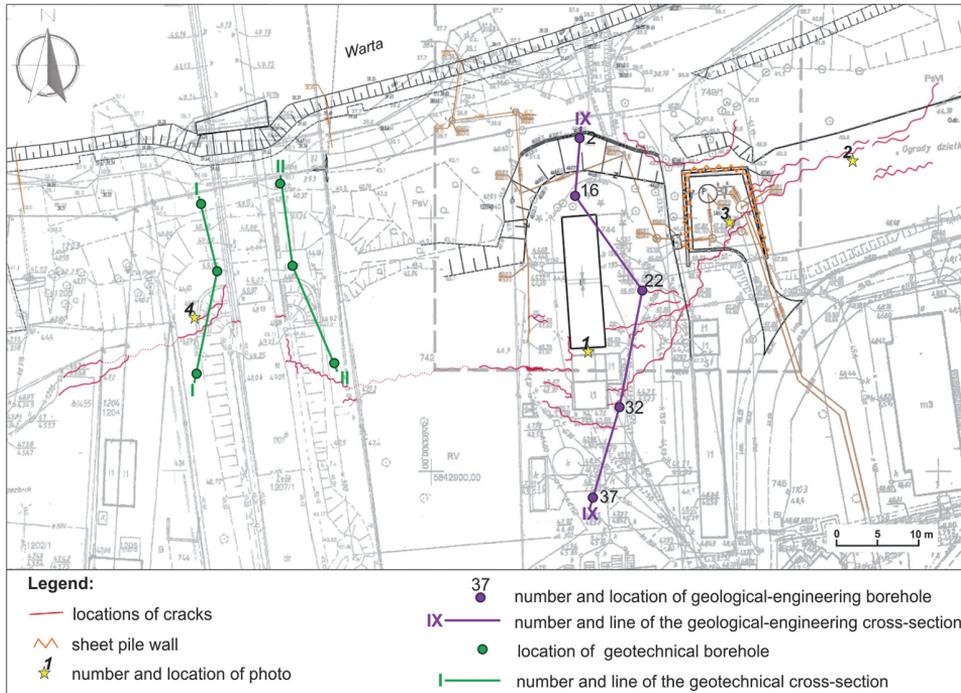
Fig. 2. Map of the distribution of deformations in the subsoil of the Warta side in Wronki [12]

During the site inspection, in the autumn of 2018, an inventarization of deformations in the subsoil was made. They arose after mass movements in the slope and side in the area of the road bridge in Wronki. Fig. 2 shows the research area with the, marked in pink, cracks in the surface caused by landslides. As can be seen on the map, the greatest amount of ground deformation developed in the area to the east of the bridge, i.e. in the area of the closed wastewater treatment station of the Correctional Facility, the sewage pumping station of the Municipal Enterprise in Wronki and allotment gardens.

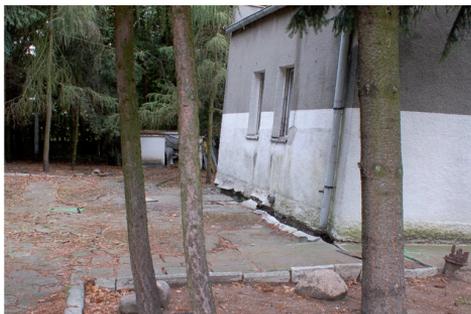
Visible inclination of the building by about 25 cm towards the river in the closed wastewater treatment station of the Correctional Facility in Wronki

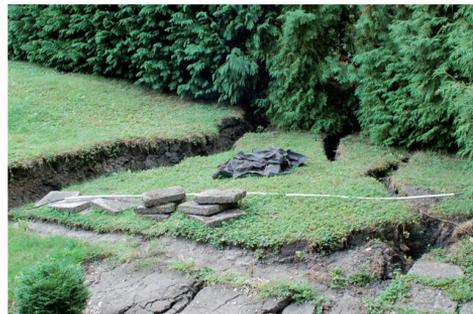
Cracks in the ground, approx. 50 cm wide, in the allotment gardens in Wronki

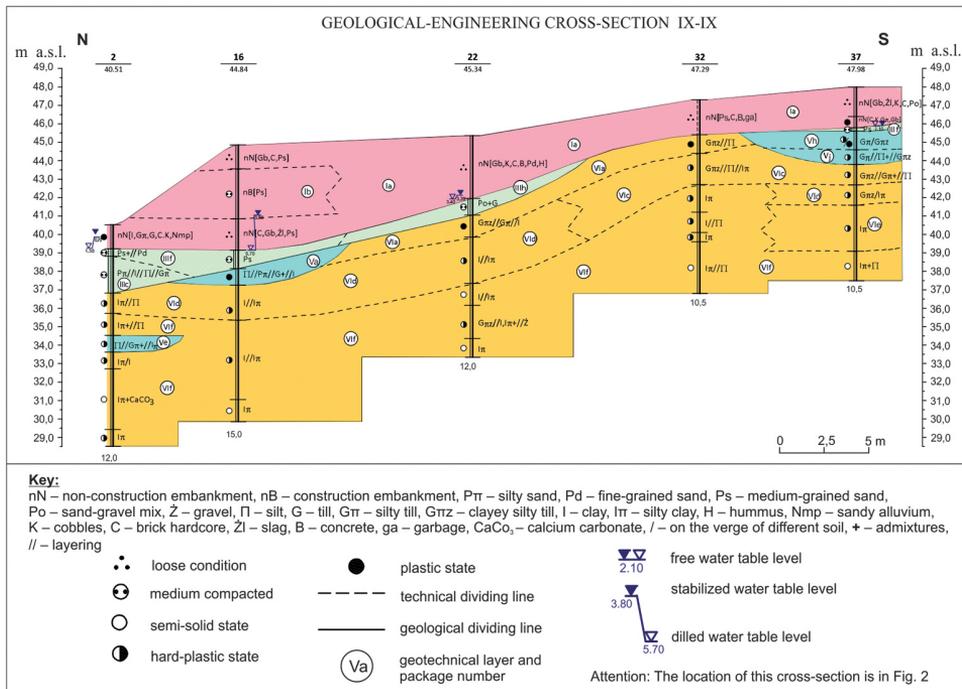
Fig. 6. The fragment of the geological engineering cross section IX–IX (modified) [16]

2018 (Fig. 6). The yellow color in the cross-section shows a package of Neogene sediments created mainly in the form of clays, silty clays and clayey silty tills with variable value of liquidity index. This package is locally layered with silts, silty tills and silty sands marked in blue. In the zone of the steepest slope of the roof of the Neogene formations, there is a small thickness layer of fluvial- and fluviglacial accumulation sediments of the North Polish glaciation, formed as silty sand, fine-grained sand, medium-grained sand and sand/gravel mix, in moderate dense state (marked in green) and partially watered. The watered sediment layer is discontinuous with a unconfined and confined nature of the groundwater table (Fig. 6). Fluctuations in the groundwater table in the annual cycle may range from +1.0 m to -1.0 m depending on the intensity of precipitation and fluctuations in the level of the Warta River in this area.

The geological-engineering cross-section illustrates the characteristic geological structure within the range of the analyzed landslide and shows a significant transformation of the slope's subsurface zone, what is confirmed by all the testing boreholes made, in which non-construction and construction embankments with variable thickness of up to 5.7 m were drilled in the subsurface zone. Below these embankments, cohesive soils are generally deposited (Fig. 6).

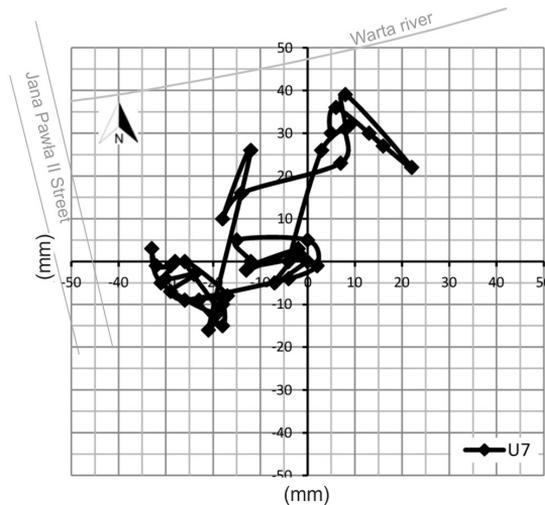
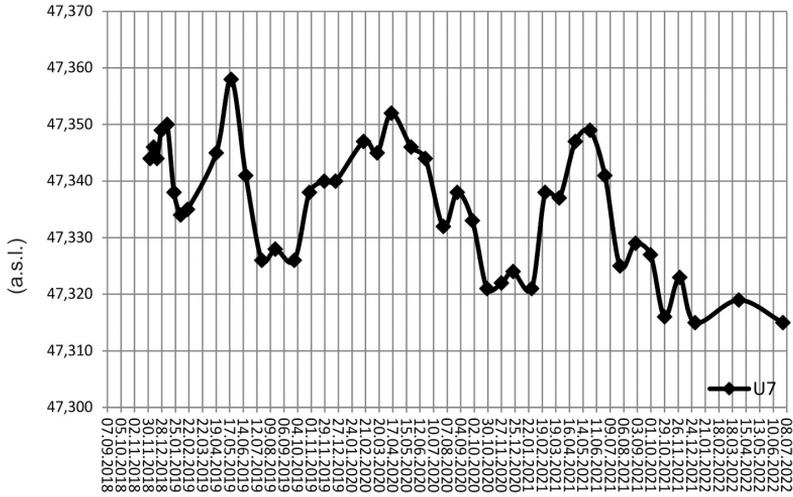
Fig. 8. Diagrams of horizontal (a) – measurements made in the period from December 2018 to February 2019, every 1–2 weeks; from March 2019 to December 2021, every 1 month; from January 2022 to June 2022, every 3 months and vertical displacements (b) for the control point U7

The graphs show the chaotic movement of control points. All points in the landslide zone have a very similar nature of displacements, i.e. they are ambiguous, unequal displacements, and therefore very difficult to interpret. Harmonic displacements of control points once to

the left, once to the right, once up and once down can be explained by the fact that the mass movement takes place in very specific geological-engineering conditions, i.e. within the slope and on the side, on the surface of intensely irrigated and plasticized expansive soils with considerable potential for changes in volume with changes in humidity. The high

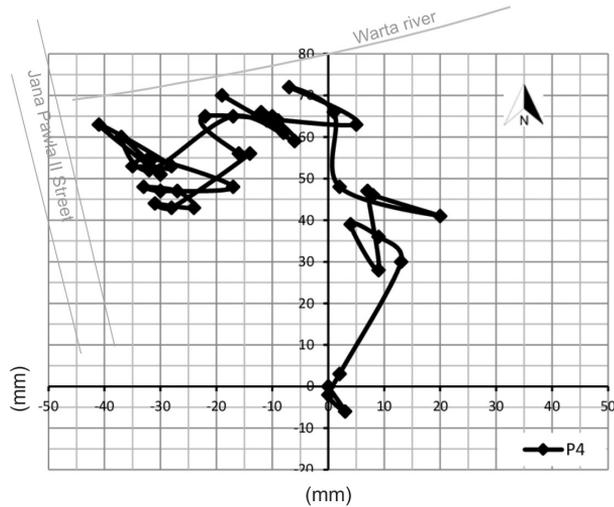
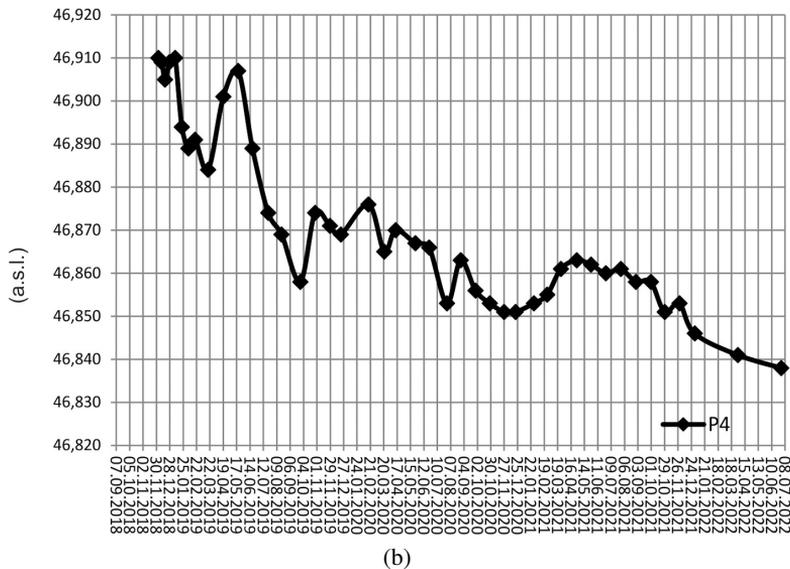
Fig. 9. Plots of horizontal (a) – measurements made in the period from December 2018 to February 2019, every 1–2 weeks; from March 2019 to December 2021, every 1 month; from January 2022 to June 2022, every 3 months and vertical displacements (b) for the control point P4

degree of expansiveness of Pliocene clays is related to the presence of a large amount of smectite minerals in their mineralogical composition. The average content of each group of clay minerals in the entire series of Pliocene clays is as follows: smectite – 46%, illite – 28% and kaolinite – 26% [8]. Smectite minerals absorbing water can increase their volume at least 4 times. This is undoubtedly one of the most important, cause of vertical movements of the studied benchmarks [11, 13–15].
