Research paper

Reinforcement solution of damaged load-bearing frame structure in a coal power plant for additional loads

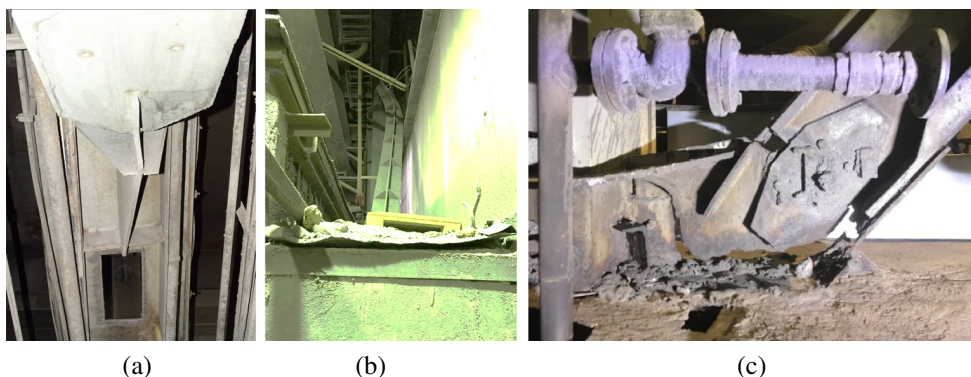
The structural analysis was performed not only due to planned works described in Section 1 but also due to numerous existing structural damages. The damage was particularly evident in the cross-braces of the vertical tie systems. The analysis of existing damages allowed to group them into three categories: (i) local loss of stability of members, (ii) global loss of stability of members and (iii) local damages for example rupture of tension members. Examples of damages are presented in Fig. 4.

Fig. 4. Damages of the steel structure: a) buckling of gusset plate, b) buckling of a bracing member, c) ruptured of bracing at the node

- ruptured bracing connection should be strengthened;
- struts that exhibited buckling should be reinforced or replaced;
- struts that is likely to buckle and whose location means that there is no substitute system capable of supporting the horizontal load must be reinforced. If there are several bracings in the same axis at the same level, the limit state of the bracing system determines the qualification for strengthening. Some members are allowed to buckle if the global stability of the structure is maintained;
- in the bracing of horizontal planes, connections and some members must be reinforced so that the global stability of the structure is maintained;
- overloaded columns should be strengthened by increasing the cross section.

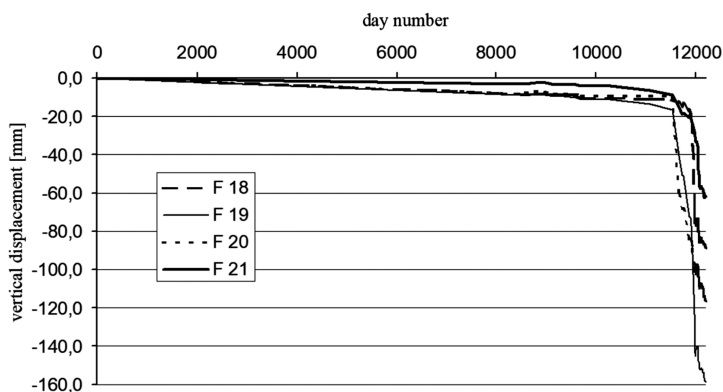
The ground settlement propagation is measured in number of days in reference to the initial state, which is described as day zero. Fig. 5 shows the development of the column settlement in selected row F of block 6 over a period of more than 33 years of operation of the facility. It can be clearly seen that after about 32.5 years of operation, there was an unexpected sharp increase in the displacement of the supports. In the period of two months from day 11907 to 11976, the settlement in some places (e.g. column F19) reached 7 cm [24, 25]. The degree of settlement of the subsoil can be described as sudden. It became the cause of numerous damages to the steel supporting structure and building's equipment.

Fig. 5. Vertical displacement of the F row columns in block 6 from day 0 to 12193

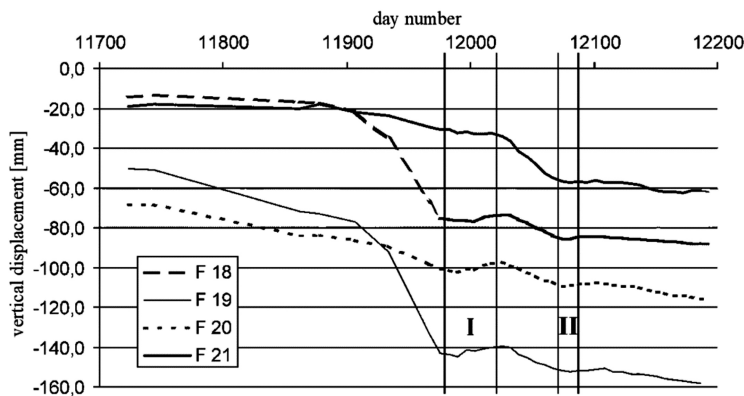
The immediate repair works included stabilizing of the ground and temporary shutdown of the block. The results of these actions are presented in Fig. 6. For the same F row columns, the most intensive settlement is shown compared to two periods when the block was out of operation. Apart from the damage to the building, the boiler system, especially technological pipelines, got significantly deformed. The decision to shut down the boiler was necessary for safety reasons and to repair the deformed system. Additionally, coal mills were also shut down. The coal mills are a major source of vibration generated in the ground near the boiler room. The presence of these vibrations can be attributed to the poorly executed stabilization, which was conducted as soon as signs of settlement were discovered. Only the second shutdown of the boiler led to a significant slowdown of the settlement process. The data collected to date indicate that the uneven settlement continues, but with significantly lower rate.

Fig. 6. Vertical displacement of the F row column in block 6 from day 11739 to 12193 with visible effect of the operation stoppage at period I (days 11982–12019) and period II (days 12072–12086)

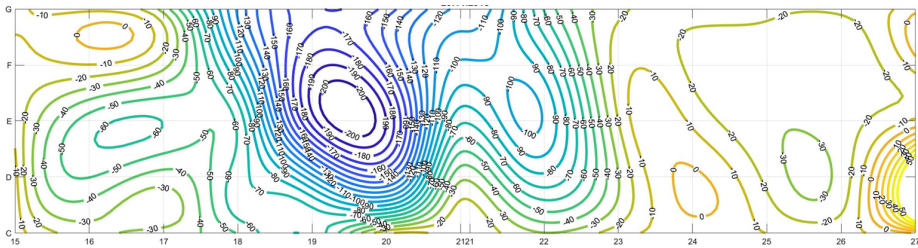
Fig. 7. Contour map of subsoil settlement

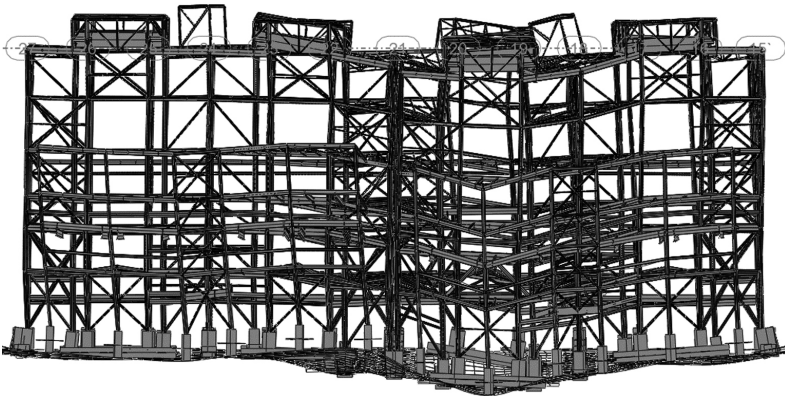
Fig. 8. Deformation of the structure caused by the settlement

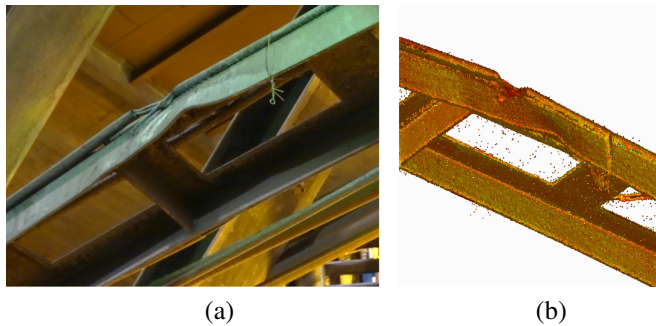
Fig. 9. Comparison of a real-life photo of damaged member with a model from point cloud data: a) photo of a local buckling, b) laser scanning model

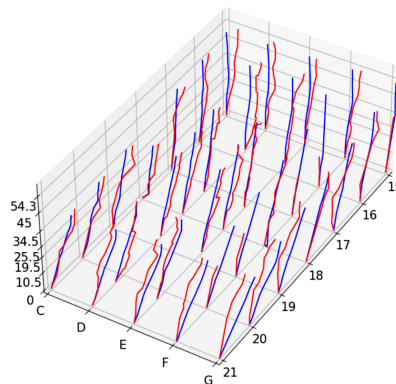
Except of detailed geometric data, laser scanning was used to determine the global deformation state of the structure. Based on the analysis of point cloud data, the shape of the column axes was determined showing the displacement of the structure from loads and settlements acting during the operation of the power plant. The obtained data from laser scanning were compared with the results of numerical analyses (see Fig. 10).

Fig. 10. Comparison of global state of deformation of columns in the area of blocks 5 and 6 obtained by laser scanning with deformations obtained in numerical way (blue – numerical analysis, red – laser scanning)

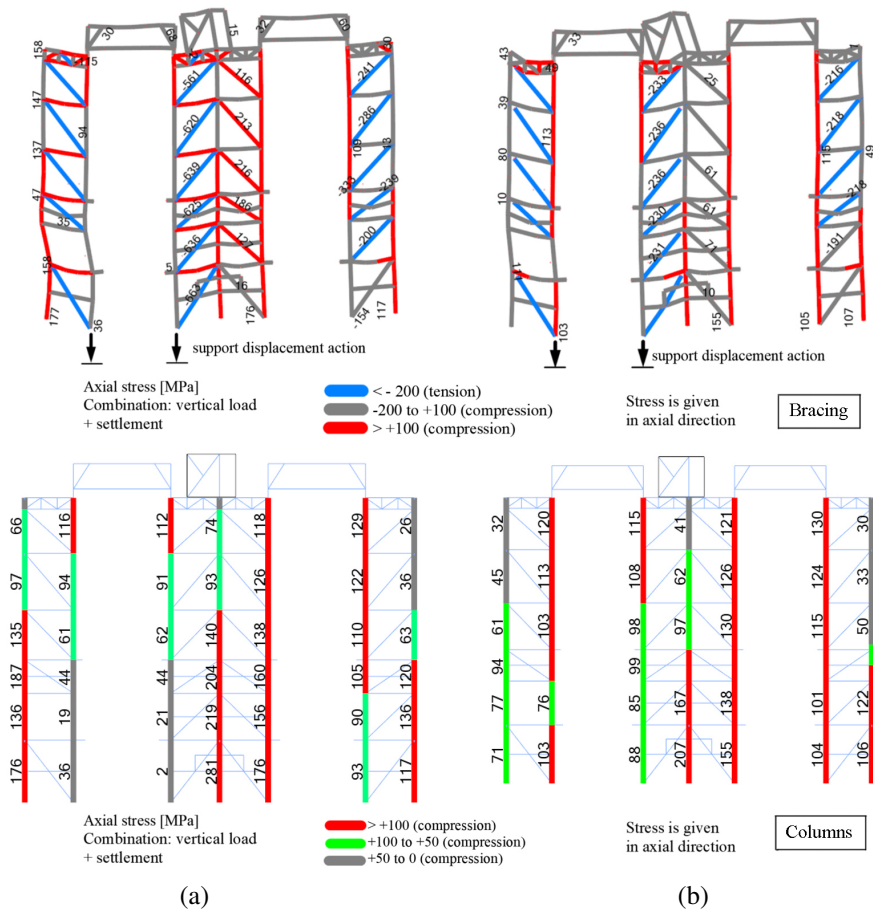
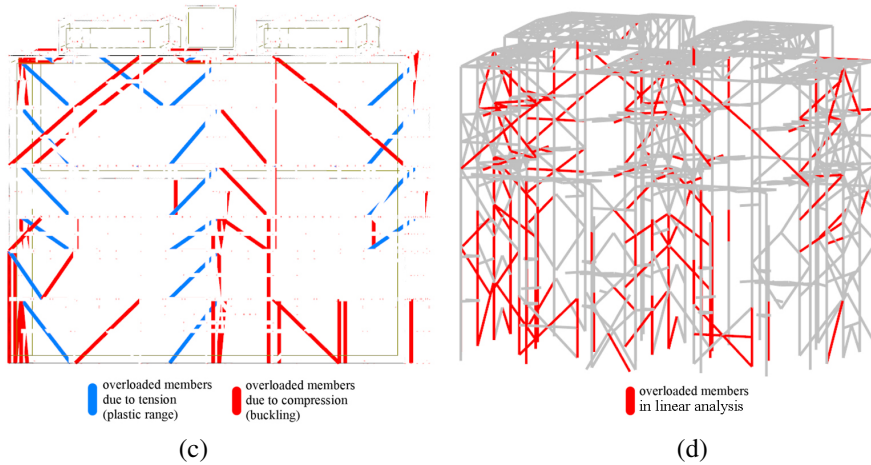
Fig. 11. Comparison of the linear and non-linear analysis: a) linear analysis, b) non-linear analysis, c) linear analysis – overloaded members, d) Members with exceeded load-bearing capacity

elements which show significant exceedances of the load-bearing capacity conditions in the case of linear analysis are presented. The significant exceedances of load-bearing capacity shown in the linear analysis did not reflect the current state of the structure, which proved that the results should be disregarded for the analysis.

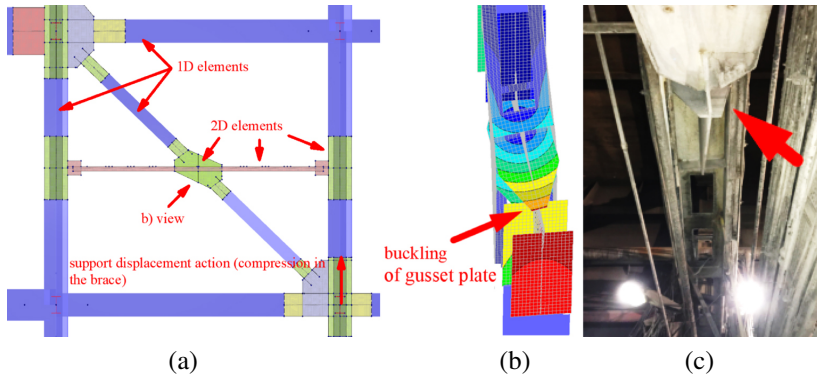
Fig. 14. Part of vertical bracing calculation model – type 1: a) calculation model, b) buckling in num. model, c) buckled member in reality

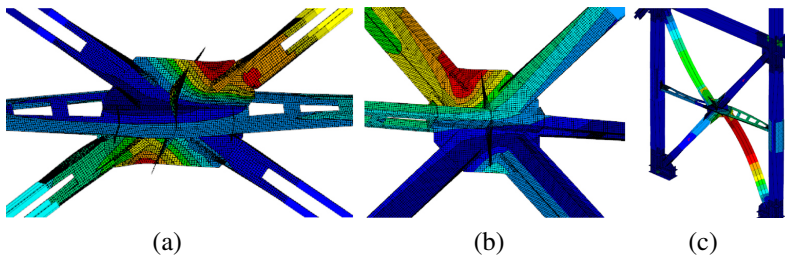
Fig. 15. Buckling of different bracing types: a) type 1, b) type 2, c) type 3

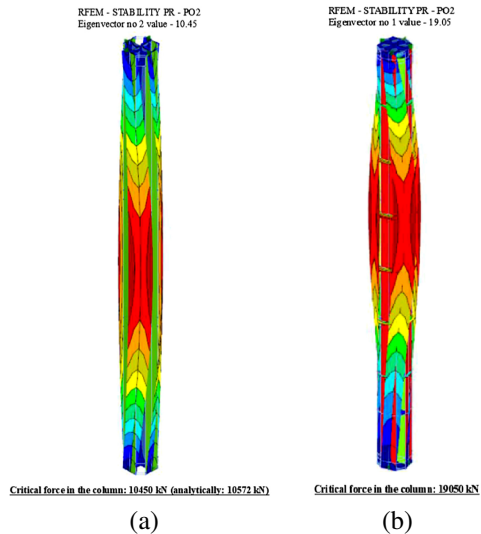
Fig. 16. Buckling analysis of columns with a flanged cross cross-section: a) without horizontal stiffeners, b) with horizontal stiffeners
