## DYNAMIC ANALYSIS OF DAMAGED MASONRY BUILDING REPAIRED WITH THE FLEXIBLE JOINT METHOD

A. KWIECIEN<sup>1</sup>, P. KUBOŃ<sup>1</sup>

The paper presents a dynamic analysis of the damaged masonry building repaired with the *Flexible Joint Method*. Numerical analysis helped to determine the effect of the applied repairing method on natural frequencies as well as values of stresses and accelerations in the analyzed variants of numerical model. They confirmed efficiency of the proposed repair method.

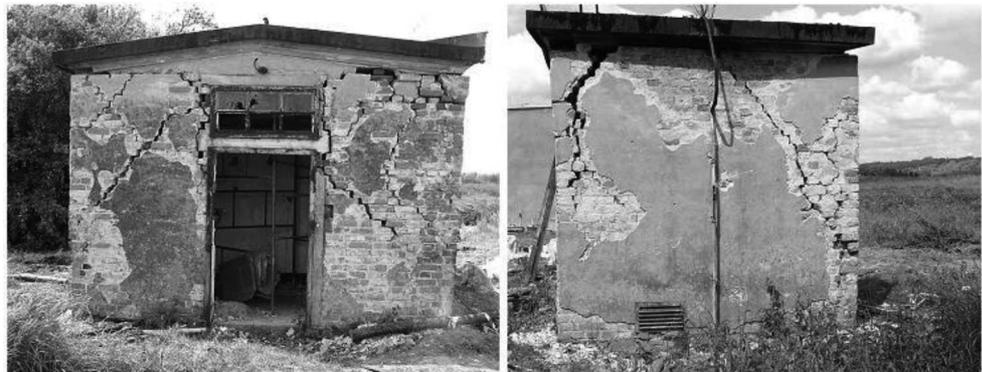
Next, the building was damaged by hitting excavator bucket in the rear upper corner at ceiling level, which generated a torsion vibration mode and caused formation of cracks in the plane of the walls (Fig. 2). A map of created damages was more or less characteristic for masonry buildings located in seismically active areas, obtained after an earthquake. The analyzed building was weakened to such extent that any small dynamic excitation could lead to its collapse, which was a positive factor from the research point of view.

Fig. 2. View of the analyzed building – damaged stage.

Subsequently, the building was repaired by cleaning and priming cracks and then filling in the largest ones with pieces of brick. Surfaces of the cracks were covered outside with a layer of gypsum and then cracks were filled in with polymer (pm/45)

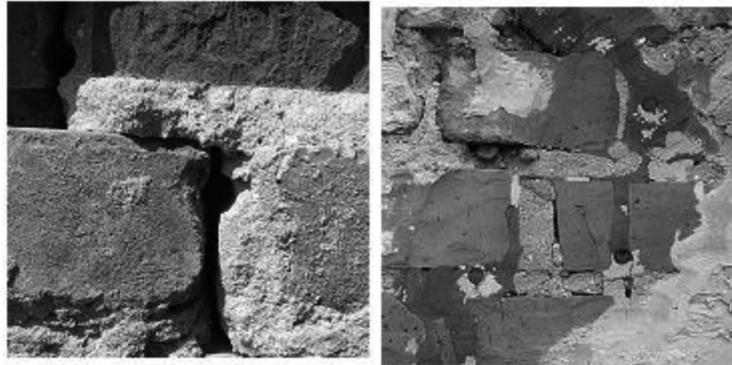
Fig. 3. Exemplary wall gaps and the final stage of its repair.

dispensed under low pressure. Revision openings, made in the repaired cracks for the control, showed that the used polymer has well-filled empty spaces in the wall (Fig. 3).

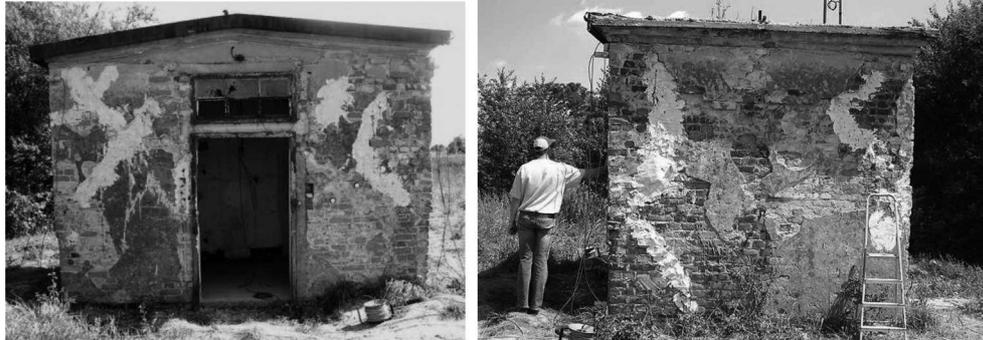
After the repair, the building was subjected to strong dynamic excitation at soil surface [2, 3] with its resonance frequencies, what is dangerous for the structure [4]. There were no new cracks, what indicates that flexible polymer joint restore coherence of the cracked walls (Fig. 4).

Fig. 4. View of the repaired building during the strong dynamic excitation.

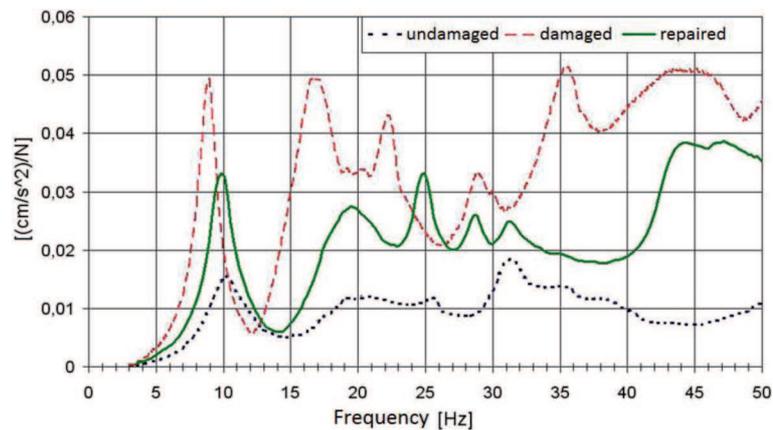
Fig. 8. Changes of the inertia module  $|I(f)|$  of the analyzed building, recorded on the sensor 8y.  
Rys. 8. Zmiany modułu inercyjności  $|I(f)|$  badanego budynku, zarejestrowane na czujniku 8y

Shown in the amplitude-frequency characteristics of the inertance (Fig. 8), estimated for the "8y" measuring point of the building being in three stages, illustrate the influence of damage and repair for the dynamic response of the building. The inertance amplitudes increase significantly after cracking in relation to the undamaged building and after cracks repairing with polymer they are reduced again. Analysis of the inertance functions allowed determining changes in resonant frequency at different stages of analyzed building, which are presented in Table 1.

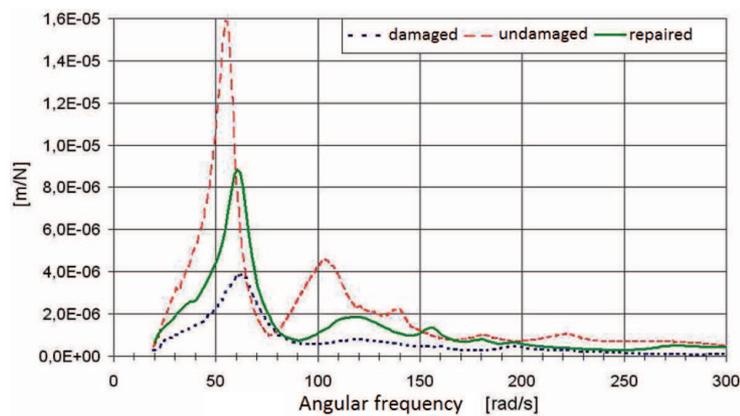
The compliance module  $|A(\omega)|$  [m/N] is related [5] to the inertance module  $|I(\omega)|$  [(m/s<sup>2</sup>)/N] in frequency field  $\omega$  by the relation (3.2). As in the inertance case (Fig. 8.), the compliance estimated for "8y" measuring point confirms influence of damage and repair for the dynamic response of the building (Fig. 9).

Fig. 9. Changes of compliance module  $|A(\omega)|$  of the analyzed building, recorded on the sensor 8y.

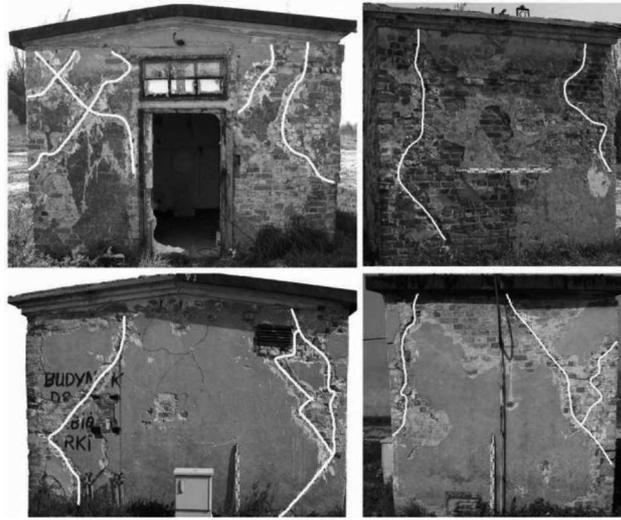
The FEM model of the repaired building was constructed on the basis of the laser gravimetric maps, which allowed determining the grids of points. These grids defined walls of the building model in the *MSC MARC* system, considering the actual scheme of cracks filled with polymer – marked with white lines in Fig. 11.

Fig. 11. Location of the repaired cracks in the building by the laser gravimetric determination.  
Rys. 11. Lokalizacja sklejonych pęknięć w budynku przy użyciu grawimetrii laserowej

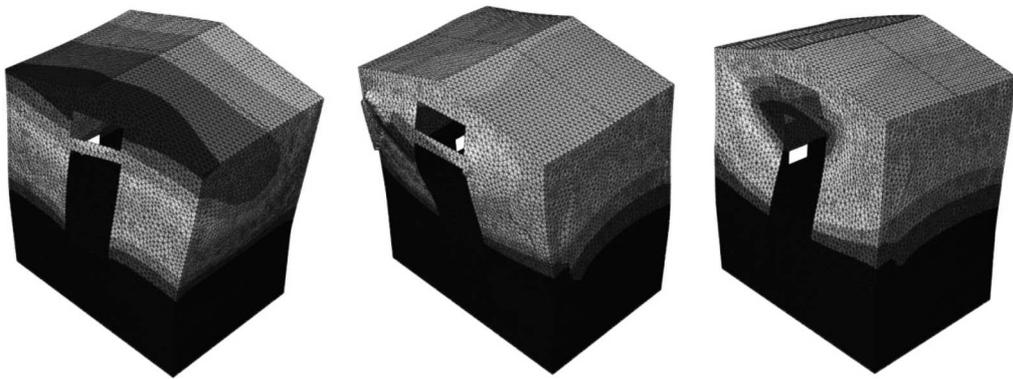
First five natural frequencies obtained for different variants of the simplified model are presented in Table 4. Comparison of the results obtained for the models of the undamaged and cracked building showed decrease of the calculated natural frequencies in the range of 31÷37%. In the case of the repaired building model the frequencies increased in the range of 26÷34% in comparison to the damaged one.

Fig. 15. Second free vibrations forms: a) undamaged building  $f_2 = 20.35 [Hz]$ , b) damaged building  $f_2 = 13.5 [Hz]$ , c) repaired building  $f_2 = 17.1 [Hz]$ .

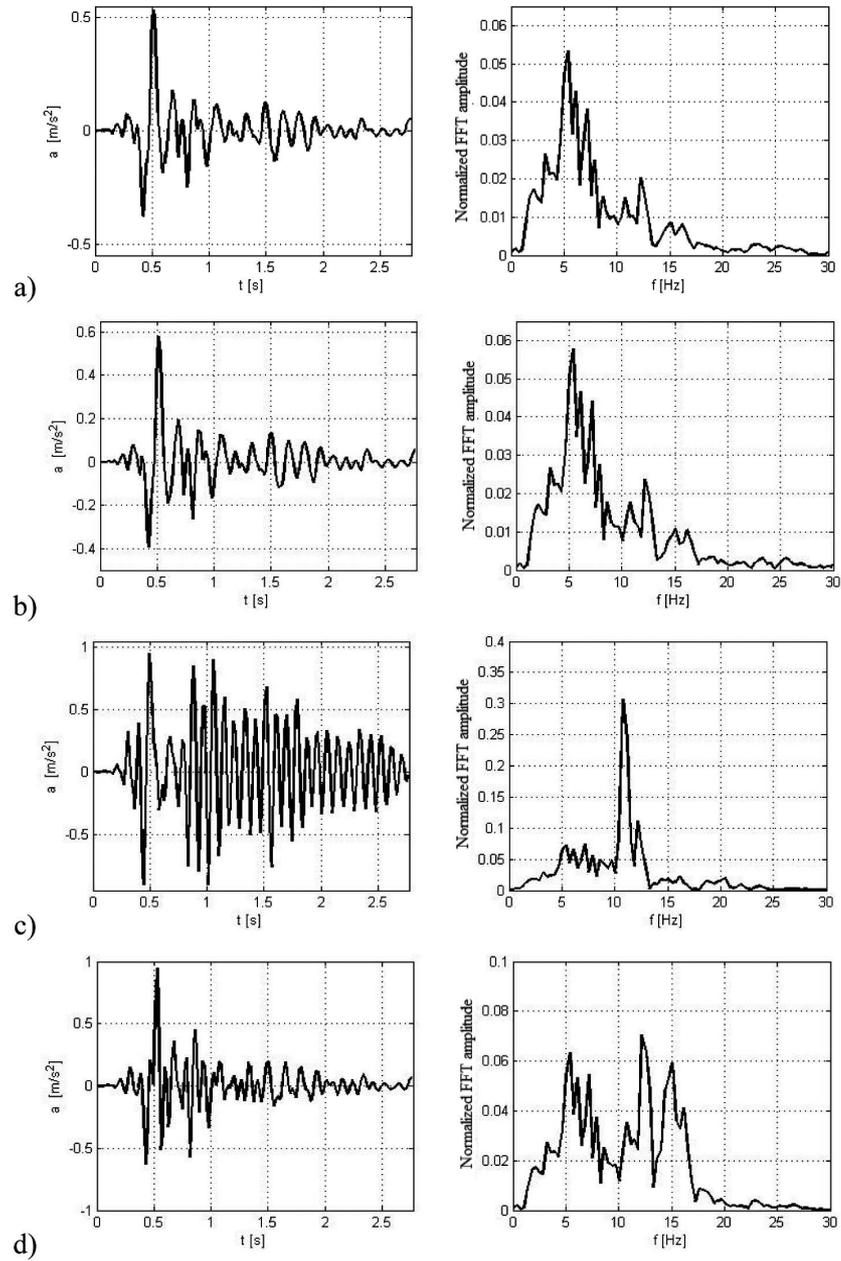
Horizontal accelerations  $a_x$  [ $m/s^2$ ] with corresponding FFT transforms of the excitation and the building responses in three different stages (determined in the E595 point) are shown in Fig. 16. It is observed that undamaged building responses with the excitation characteristic as the stiff body and after the damage process the dynamic response increases considerably (many times) with particular resonant frequencies. This is the reason why cracked masonry buildings are vulnerable to after-shock excitations in seismic areas. Repair of the cracks with polymer flexible joints decreases this response, shifting them to the higher frequency band.

Fig. 16. Horizontal accelerations  $a_x$  [m/s<sup>2</sup>] with corresponding FFT: a) excitation at the support, b) point E595 – undamaged, c) point E595 – damaged, d) point E595 – repaired.
