DANIEL WAŁACH*, PIOTR DYBEL*, MAREK CAŁA*, JUSTYNA JASKOWSKA-LEMAŃSKA***EVALUATION OF LOAD CAPACITY OF SHAFT COLLAR SUBJECT TO UNINTENDED
EXCEPTIONAL LOADS****OCENA NOŚNOŚCI GŁOWICY SZYBOWEJ PODDANEJ NIEZAMIERZONYM
OBCIĄŻENIOM WYJĄTKOWYM**

The article presents an evaluation of the technical conditions of the shaft collar as well as its load capacity in which the consequences of uncontrolled displacement of part of the ventilation drift could have caused additional stress to occur. On the basis of comprehensive diagnostic examination undertaken by the authors, a comprehensive analysis of the static resistance of the shaft collar, which takes into consideration the exceptional unintended load. Examinations as well as calculations carried out have allowed for the evaluation of the practical degree of danger for shaft objects (constructions) as well as their infrastructure.

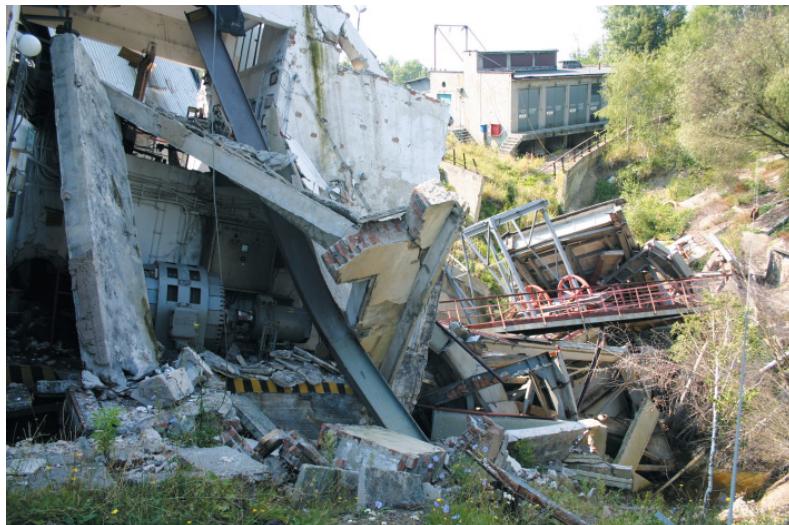
Fig. 1. Construction failure on a shaft object caused by the lack of corrective action

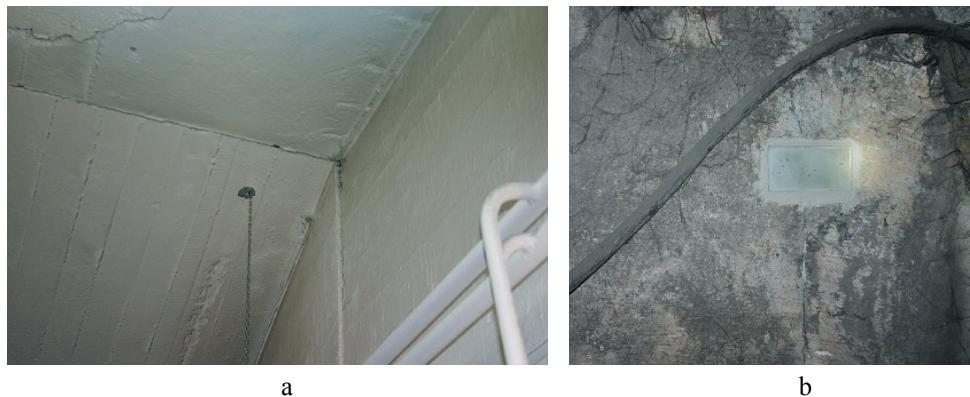
- slight displacement of the rotating part of the L-2 ventilation drift noticeable on expansion joints – Fig. 3a,
- vertical cracks on the expansion joints and of individual parts of the ventilation drift,
- lack of progress on the delamination of expansion joints on the basis of installed seals – Fig. 3b,
- displacement of the vertical part of the L-1 ventilation drift relative to the shaft collar – Fig. 4,
- no damage to the shaft collar in the breakout location under the ventilation telescope,
- loosening of wall elements in shaft top undermining the new ground beam,
- damage to the shaft top corner of the wall of the building.

Fig. 3. Recorded damage a) displacement of ventilation head, b) view of the installed seal

On the basis of observation carried out it was found that the resulting damage could have been caused by uncontrolled displacement and rotation of the individual parts of the ventilation drift. The placed seals allowed for constant monitoring of the possible increase in the rate of delamination of the registered cracks and damage. On the basis of the analysis of damage it was assumed that factors triggering the displacement of individual elements of the ventilation duct stabilized, which was confirmed by the lack of damage to the seals. Additional confirmation of the stabilization of possible effects causing displacement of the ventilation duct were the results of periodic surveying of shaft deflection guides and hoist tower. Table 1 lists the results of measurements of a given year, which clearly shows the lack of effects causing further displacement of the rock mass in this area or that this phenomena is of a relatively small range. The obtained results of the guide shaft deflection and hoist tower are within the limits of the margin of error.

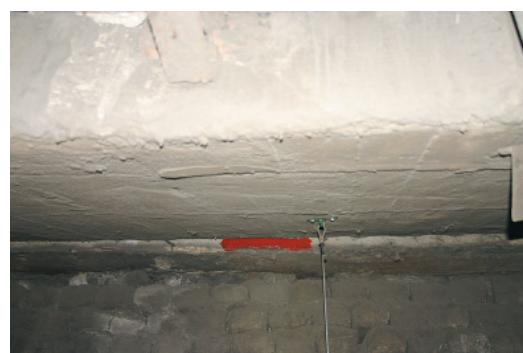
Fig. 4. Registered displacement of ventilation drift relative to the shaft support structure

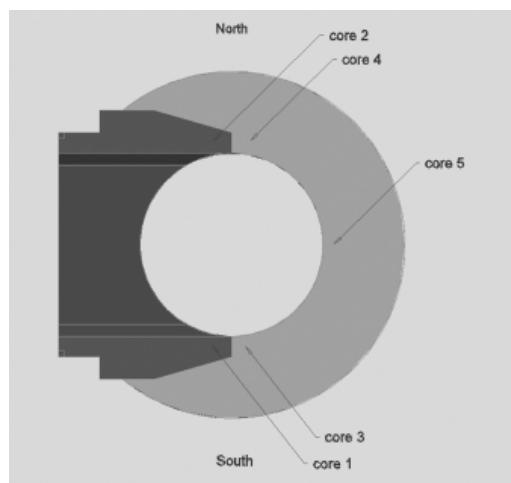
Fig. 5. Location of core drilling taken

Five core samples were taken from the shaft collar support structure and ventilation drift, the location of which is marked in Fig. 5. A total of eleven samples were cut from the cores and subsequently tested for durability in a hydraulic press. The results obtained are shown in Table 2.

Based on the results of laboratory tests, it was stated that the material parameters of the ventilation duct are substantially worse than the resistance properties of the material of the shaft support structure. Average compression and tension resistance of the ventilation duct material amounted to 12.07 MPa and 2.23 MPa, respectively. In contrast, the average compression and tension strength of the shaft support structure material amounted to 25.42 MPa and 2.28 MPa.

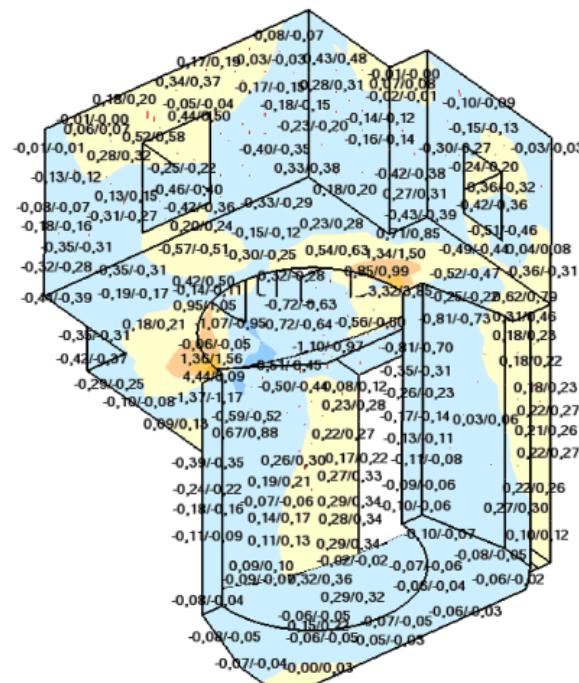
On the basis of calculations, it was ascertained that the maximum value of the reduced compressive stress in the shaft collar does not exceed 1.35 MPa and that the reduced value of the maximum tensile stress is 3.21 MPa. The tensile stress of this value occurs only locally at the place of support of the ventilation channel on the shaft collar.

Fig. 7. Map of the reduced normal stress [MPa] occurring in the collar
– a view from the side of the shaft

3. The maximum value of compressive stress in the reduced shaft collar has been determined on the basis of numerical calculations and did not exceed 1.35 MPa and occur locally at

the base of the shaft collar of the shaft support structure. The maximum value of reduced tensile stress in the analyzed element is 3.21 MPa and occurs only locally at the site of the ventilation channel on the back of the shaft collar. It should be noted that the shaft collar was made as a reinforced concrete structure and the location where tensile stress was applied and steel inserts have been used – in the form of a reinforced concrete bar.

5. On the basis of the analysis carried out it can be concluded that both the collar and shaft support structure are able to transfer the additional load coming from the ventilation duct. It is necessary to carry out continuous monitoring of the displacement of individual elements of the ventilation duct installed by observing seals and the analysis of the results of surveys of the guide shaft deflection and hoist tower. It is also recommended to carry out constant monitoring of ground deformation by using special measures, which are described, amongst others, in the work of Gustkiewicz et al. (2004).

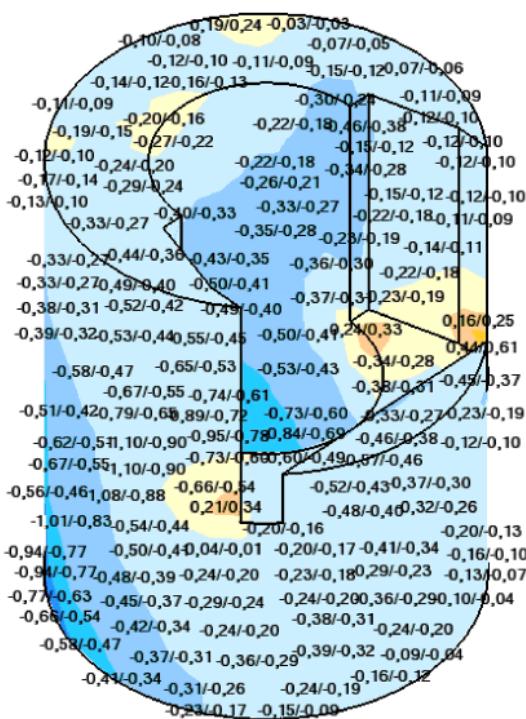
In the case of the shaft support structure the maximum value of the reduced compressive stress is 1.1 MPa. In turn, the reduced tensile stress values do not exceed 0.61 MPa. It should be emphasized that the values obtained for both the reduced compressive stress and the tensile stress do not exceed the strength of the material from which the shaft support structure is made.

Fig. 8. Map of the reduced normal stress [MPa] occurring in the shaft support structure – view from the canal shaft

4. Based on the results of numerical calculations it can be concluded that the critical stress in the shaft support structure is compressive stresses with a maximum value of 1.1 MPa. In turn, the reduced tensile stress value of the shaft in the support structure does not exceed 0.61 MPa. The obtained values of reduced stress, both compressive and tensile loads do not exceed the strength of the material from which the shaft support structure is made.
