Nidal H. Abu-Hamdeh¹

Experimental and theoretical study of a vane pass frequency for a centrifugal pump

¹King Abdulaziz University, Jeddah, Saudi Arabia.

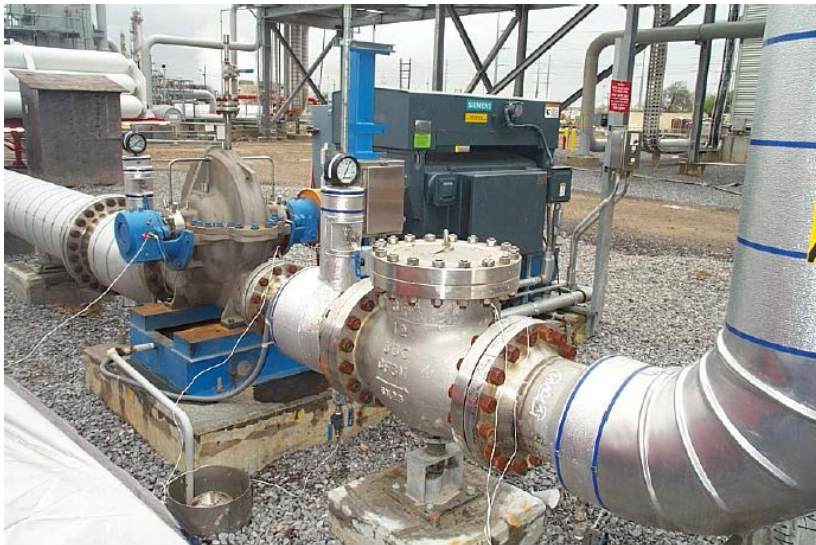
The structure of each pump in the pump station is shown in Fig. 1. The diameter of the intake line, which is shown on the left of the figure, is 0.46 m, with a 0.46×0.30 m reducer located exactly before the 0.30 m pump intake flange. On the 0.20 m pump discharge, which is to the right of the figure, there is a 0.20 × 0.30 m reducer, tracked via a tiny spool portion fixed to a 0.30 m check valve. Precisely preceding the valve is a perpendicular elbow inside the 0.30 m line of discharge.

Fig. 1. Pump configuration

All length measurements were with ± 0.005 m uncertainty. It is the first elbow in a group of elbows comprised of 4 elbows which outline the upright loop which links the discharge of the pump to a joint header. The further 2 pumps in the station are designed and constructed in the same way.

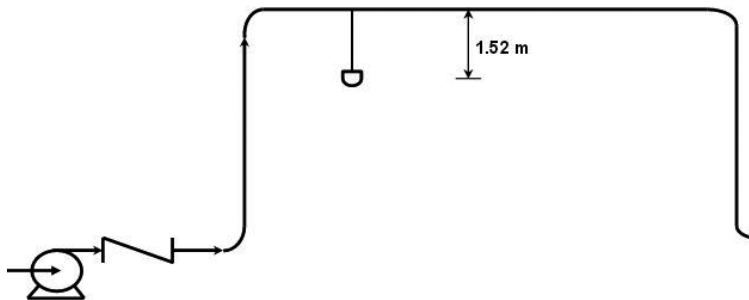
One of the probable sources for failure was the configuration of the thermowell which brings about the turbulence induced by the flow. The flow preceding the thermowell results in vortices which appear at a distinctive frequency of vortex shedding. In the case when the frequency of vortex shedding equals the thermowell's natural mechanical frequency, a resonance takes place. The resonance causes extensive vibration which might possibly bring about fatigue failures. Nevertheless, two diverse geometries of thermowell were constructed and it was found it didn't make any vibration difference. The frequencies of vortex shedding were computed for the geometries of thermowell at suction and discharge settings together. Those were matched to the projected thermowells' natural mechanical frequencies (the mode of 1st cantilever). Natural mechanical frequencies were well-separated from the frequencies of vortex shedding matching American Society of Mechanical Engineers (ASME PTC 19.3). Accordingly, there was no obvious relationship between the problem of vibration and flow-induced turbulence. At that time, numerous diverse operating settings and piping configuration variations were considered. Specially, the impact of adding a damper of one quarter wave-length [16] on the shaking force was investigated. It is anticipated that a substantial (\sim by an order of magnitude) drop in the shaking forces possibly will be accomplished through setting adjusted dampers in the lines of discharge. This will considerably decrease the vibrations brought by pulsation. Depending on this modeling work, a one quarter wave-length stub dampers were installed in the line of discharge of the horizontal section. The length of the dampers was about 1.52 m and was set up as demonstrated in Fig. 2. The consequences that follow after the dampers were set up were to some extent amazing. In the general piping system, the levels of pulsation were decreased from the wide range of $13 \div 34 \pm 0.5$ kPa to a one little greater than 6 ± 0.5 kPa. In the

Fig. 2. Damper configuration

pipng system, the vibration appeared to be remarkably decreased. Nevertheless, the level of vibrations detected on the pumps was almost persistent. Although the piping system was not still considered as a matter, the vibration levels of the pump remained extremely high. Consequently, pump testing was undertaken with the key intention to seek after the pulsation-induced matters.

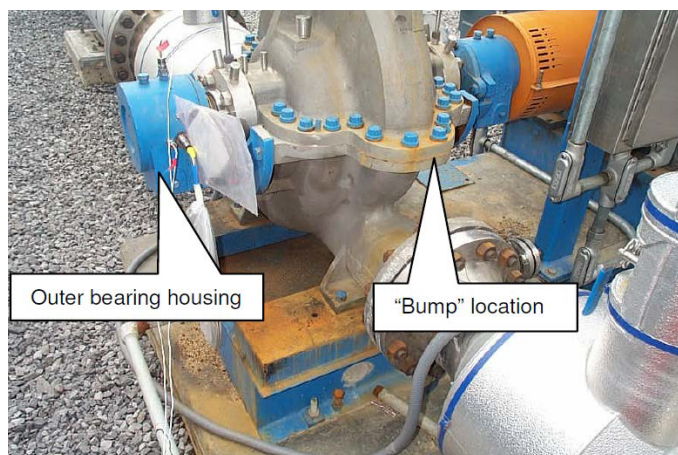
With the intention to additionally explore the source of the vibrations and the impact solution, a sequence of pulsation and vibration assessments was carried out. These assessments were made for the vibration accompanying the running of the pump at around 10 positions, although the pump was running at a minimal volume of $150 \pm 1 \text{ m}^3/\text{h}$. In the major part of these positions, assessments were carried out together in the horizontal direction, that is in line with the axis of the pump discharge track, and in the vertical direction. The assessments, on the exterior bearing housing, were carried out on the housing at a right angle with the pump shaft centerline. Accordingly, the horizontal assessments were undertaken on the lateral of the housing and the vertical assessments were documented on the uppermost of the housing, as showed in Fig. 3. On the termination of the housing, only axial (in line with the pump shaft) assessments were documented.

Fig. 3. Locations where the second round of measurements were taken

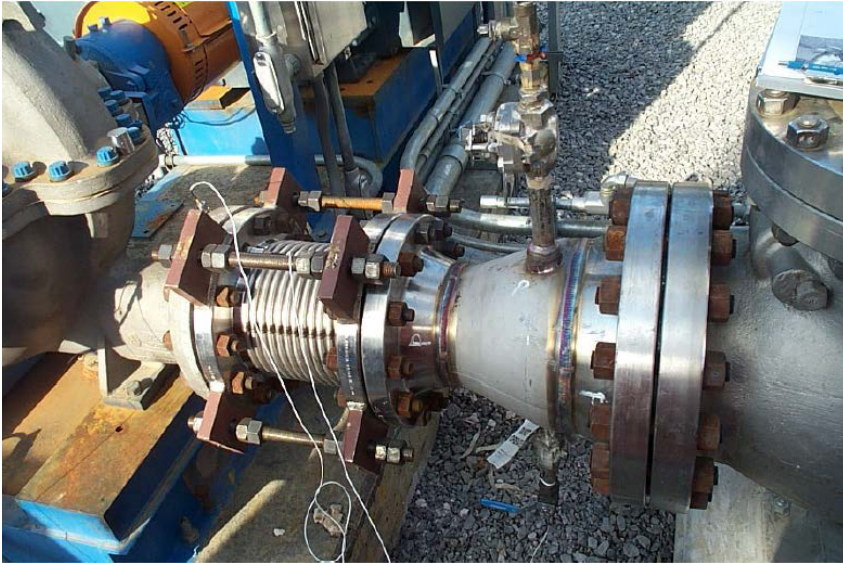
Fig. 7. Flexible coupling

In order to place the dynamic absorber at a convenient place for maximum energy dissipation, the structure mode shapes were investigated. Then, the system vibration was alleviated through application of an element to control the system vibration; specifically the spool piece was removed and substituted by a flexible coupling of bellows type, as shown in Fig. 7. Even though the coupling was still rigid, it was remarkably of less rigidity in bending than the spool piece it substituted. Forced harmonic response analysis of the pump system with an absorber installed revealed that the levels of vibration were reduced by a factor of 2. According to field testing, after placing the coupling in the pump system, there was a reduction in the structure's vibration by more than 2-fold at the VDF, as shown in Fig. 8. Thus, the modification of the rigidity of the system significantly led to the removal of the mechanical resonance away from the VPF leading to the generation of reasonable and acceptable levels of vibration.

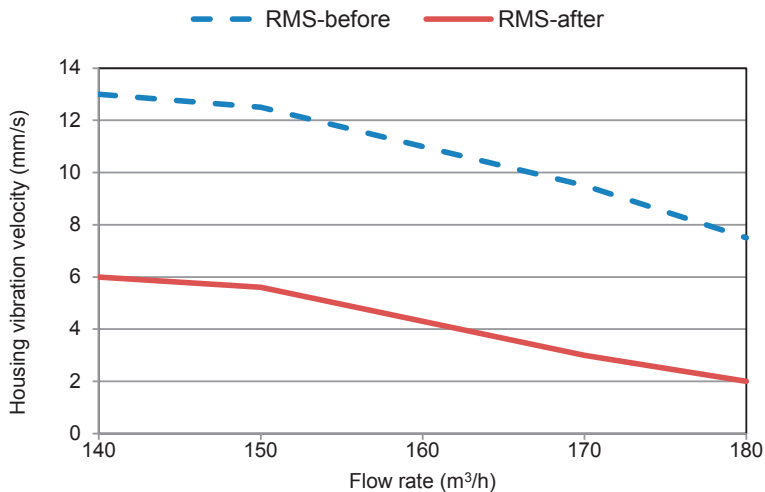
Fig. 8. Vibration before and after installing the flexible coupling

The vibration problem, in the centrifugal pump system addressed in this study, required resolution. It was proposed initially that system detuning might possibly solve the problem. Unluckily, system detuning only influenced the vibration of piping rather than the dangerous and critical pump vibration. Pulsations of piping were decreased by a factor of roughly 2. Piping vibration was almost removed through the setting up of dampers' one quarter wavelength. Pump vibrations were almost unaffected. Pump system was modeled by the application of a finite element analysis. In this situation, the pump system mechanical resonance was found to be very close to the pump's vane pass frequency. The existence of the resonance allows for a comparatively small levels of pulsation, which are predictable in this sort of pump, to stimulate the system. Piping mechanical disconnection from the pump and base was necessary to deal with the extreme pump vibration. Design modifications to adjust resonances were expensive and it was challenging to undertake sufficient modifications to change resonances outside the variable operational range speed of the pump system. To foresee probable advantages of vibration-handling element and to reach an ideal design that might possibly cover the whole extent of predictable operating conditions, the finite element analysis was used. The element was added successfully to the pump system, and vibration levels were cut down to a value acceptable for secure durable operation.
