# INFLUENCE OF METEOROLOGICAL CONDITIONS IN AUTUMN/WINTER 2021–2022 ON THE DEVELOPMENT OF STORM SURGES AND THE DUNE EROSION ON THE POLISH BALTIC COAST AS A RESULT OF CLIMATE CHANGES

Tomasz Arkadiusz Łabuz

*Institute of Marine and Environmental Sciences, University of Szczecin, Mickiewicza St. 16, 70-383 Szczecin, Poland;  
e-mail: tomasz.labuz@usz.edu.pl*

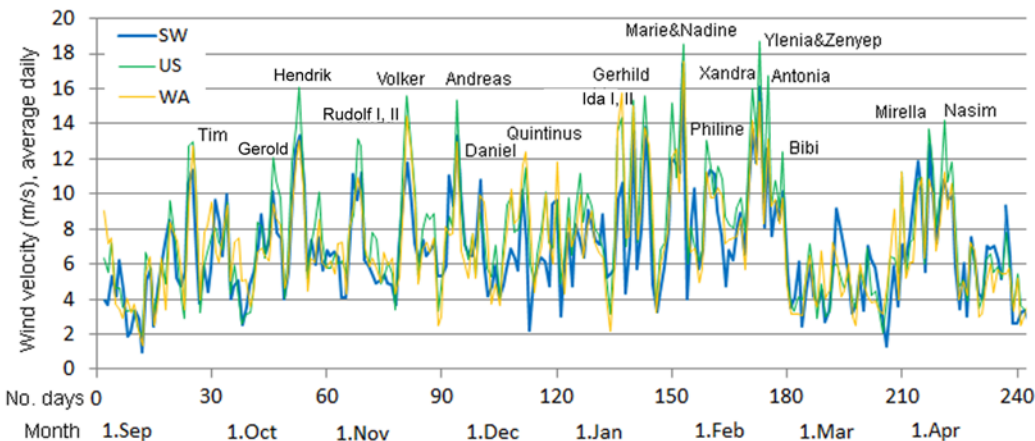
Fig. 3. Average daily wind velocity for the period 09.2021 to 04.2022 with names of main low-pressure systems. Wind station: SW – Świnoujście, US – Ustka, WA – Władysławowo. Data source of own graph: IMGW.

the Polish Baltic coast were defined as winds with a speed exceeding 10 m/s (Trzeciak, 2001; Sztobryn *et al.*, 2005). During the study period, a wind with  $V > 10$  m/s occurred more frequently from the SW than from the NW direction. High wind speeds were observed in Świnoujście (SW), Ustka (US) and Władysławowo (WA) from the end of August 2021 until the end of February 2022, and then in the first half of April (Fig. 3). It was frequently higher by approx. 2 m/s at

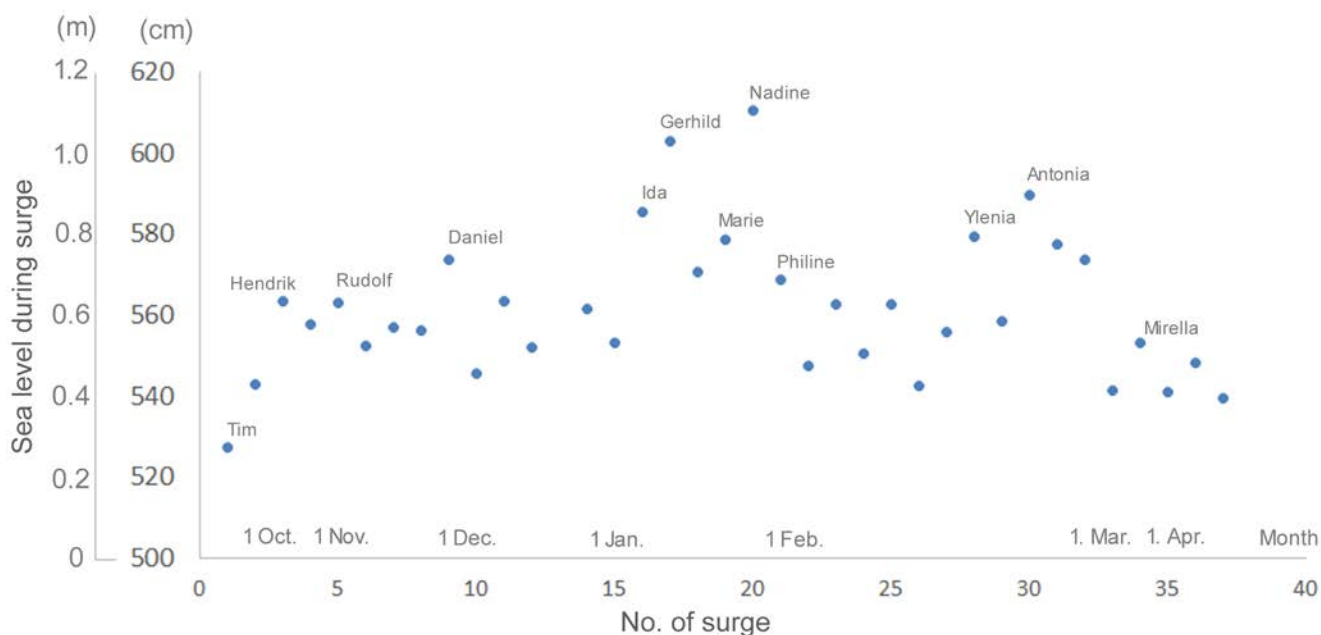
Fig. 7. Average max. sea level during storm surges in season 2021–2022 (average from 7 gauge stations, fig. 1). Main surges with names, data source: Maritime Office, IMGW, Wetterzentrale.

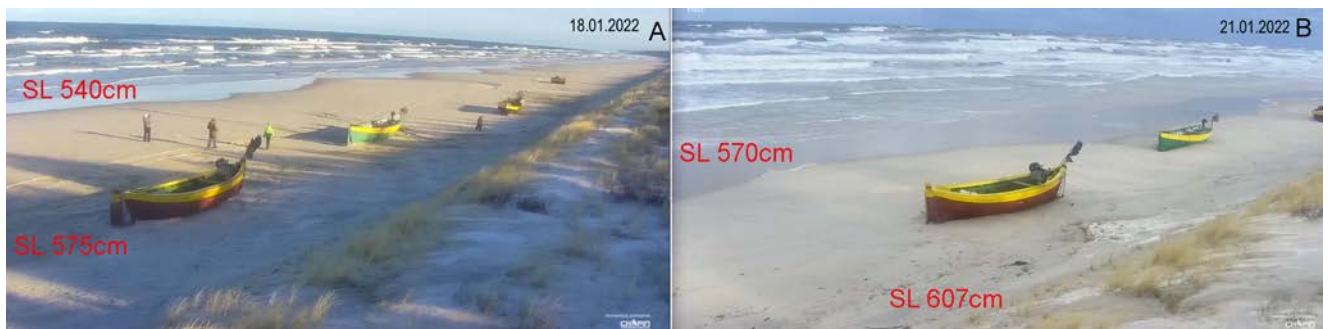
**Fig. 11.** Short-term sea level change vs run-up range on the beach (photos from the camera: <https://nadmorski24.pl/kamery/>). A – situation after surge Gerhild with max. SL = 575 cm. B – a situation during surge Ida II, after Ida I with max. SL = 607 cm.

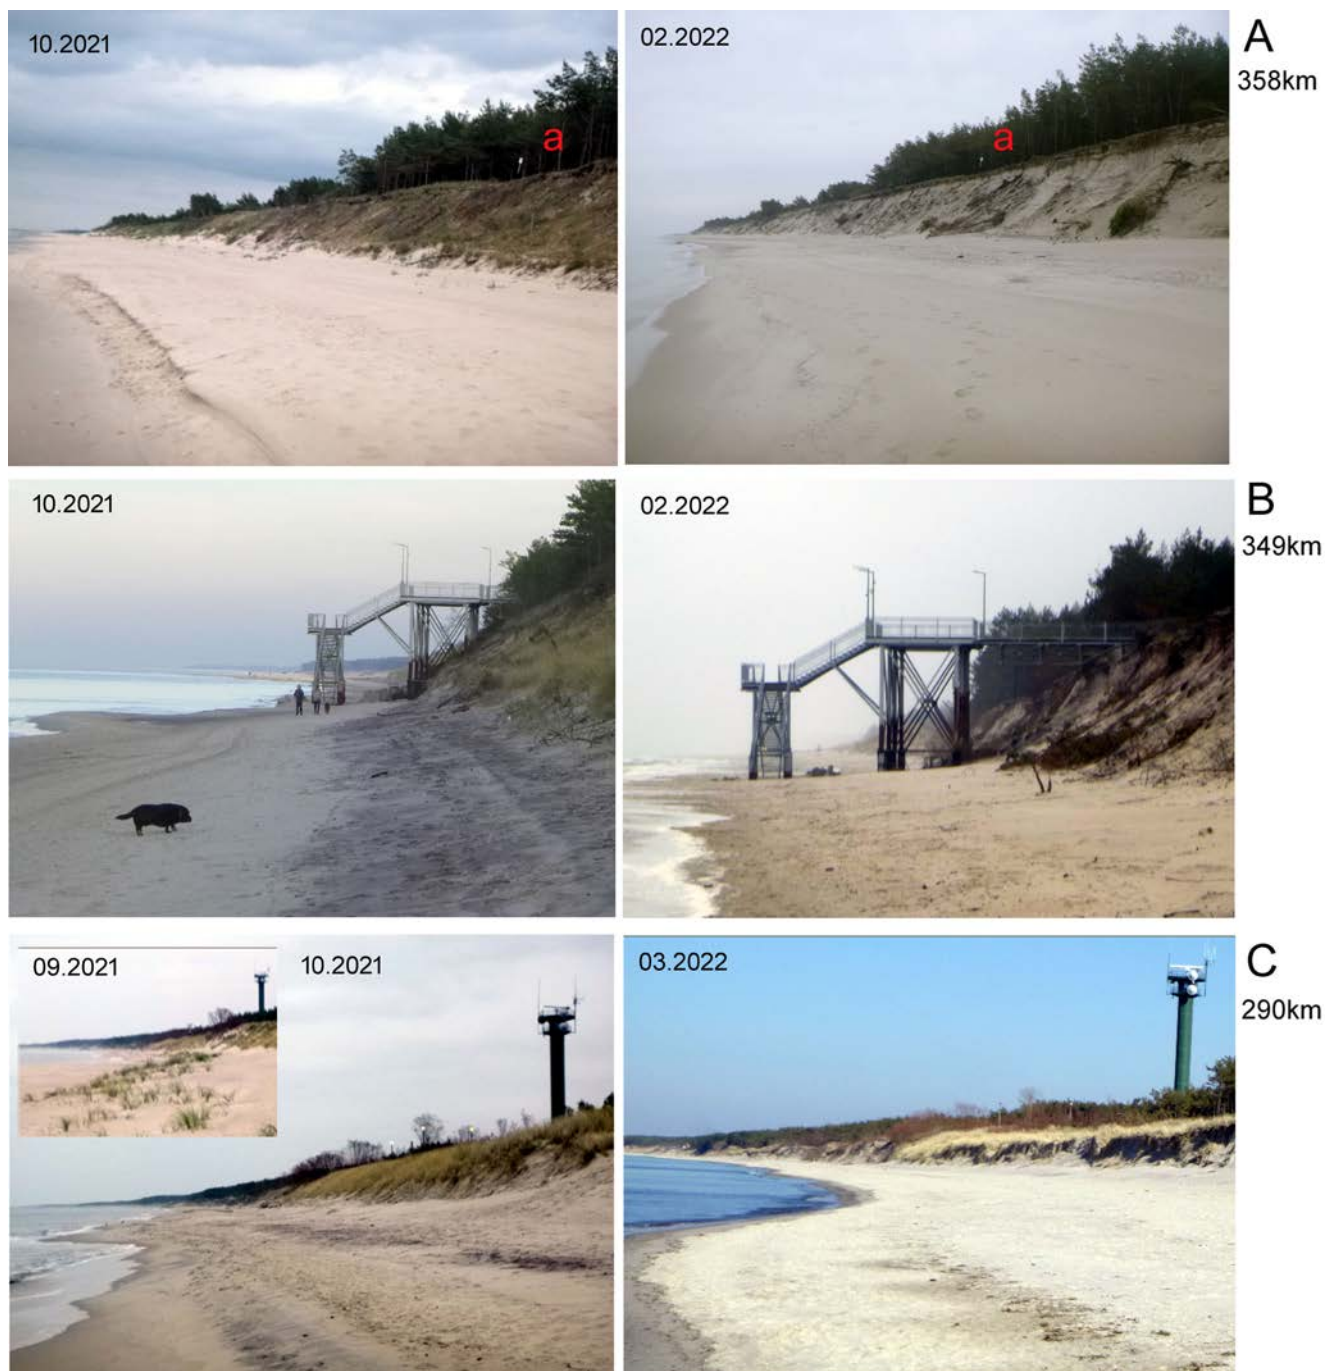
**Fig. 13.** Comparison of coast retreat after smaller surges in Autumn 2021 and big Nadine in January 2022 on the West coast. Photos from 10.2021 show the coast after Hendrik & Rudolf surges in October 2021. A – lowered beach and then retreat of 3–5 m of a dune toe on the Rega River Sandbar, km 358, a – kilometrage sign. B – lowered beach with heavy minerals and then dune retreat of 6–8 m on the promontory on the Resko Lake Sandbar, km 349. C – embryo dune erosion after October surges, then dune retreat 2–3 m after Nadine surge, Jamno Lake Sandbar, km 290.

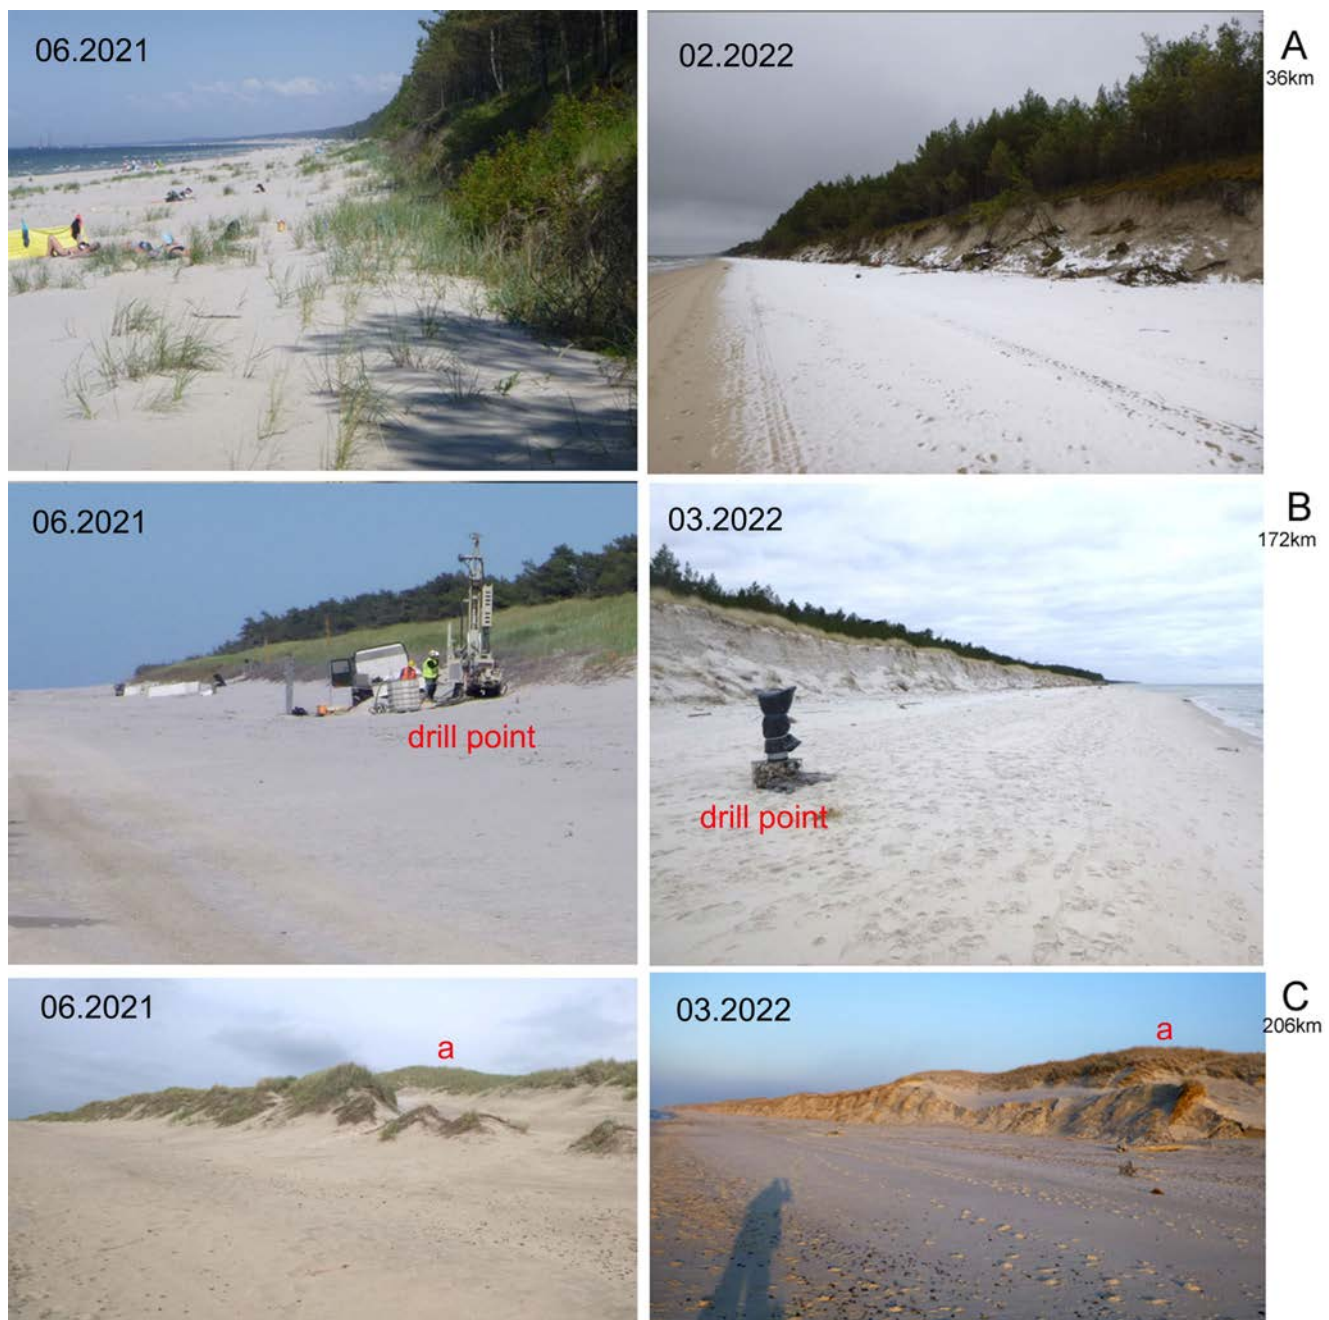
**Fig. 14.** Examples of average dune retreat after Nadine surge in January 2022 on the East coast. A – the erosion of embryo dune, small foredune and 3–6 m retreat of a high dune, Vistula Sandbar, km 30. B – 6 m retreat of foredune on the Kashubian Sandbar, km 172, visible retreat in place of geological drilling for the future location of the nuclear power plant. C – washed out foredune of 8–10 m width on the Lebsko Lake Sandbar, km 206, a – the same dune peak.
