## Research paper

# Effectiveness of preventive structural protection against mining impacts and Maintenance Management on technical state of masonry buildings

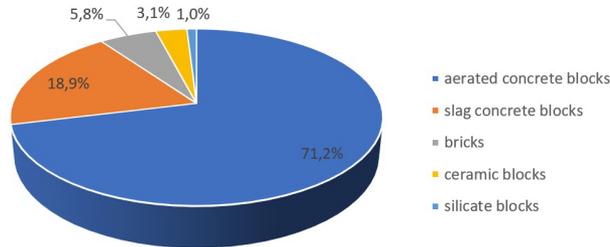
The examined buildings had a masonry load-bearing structure. 72.6% of them were built on a constant level. A little more than half of them (231 structures) had cellars under the whole building or under part of it. The foundations, in most cases, were made of concrete (58.8%), and less frequently of reinforced concrete (40.9%). In most cases (74.3%), the cellar (or foundation) walls were concrete monolithic or made of concrete blocks. In 24.0% of the cases, cellar walls were built of ceramic bricks, especially in older buildings. The load-bearing walls of the ground floor and the upper floors were made mostly of aerated concrete blocks (71.2%), and a significant part of slag concrete blocks (18.9%). In the remaining buildings, walls were made of ceramic bricks (5.8%), ceramic hollow bricks (3.1%) or silicate blocks (1.0%) (Fig. 1).

Fig. 1. Division of load-bearing walls according to the materials used

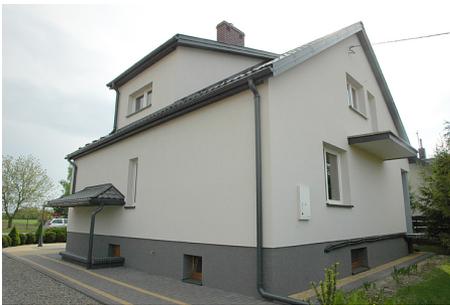
The database included 57 buildings (13.8%) that had been protected against mining impacts at the design and construction stages (e.g. Fig. 2 and Fig. 3). The foundations of 51 protected buildings were made as reinforced concrete continuous footing with additional longitudinal reinforcement. The diagonal braces of continuous footing were used in 68.4% of cases. Three buildings were founded on a reinforced concrete foundation slab and in other three cases anchor diaphragms were used. In addition, as part of preventive measures taken, 21 buildings had walls reinforced with concrete studs, and all protected buildings had continuous perimeter reinforced concrete beams in the ceilings.

Fig. 2. Example of a renovated building without preventive structural protection

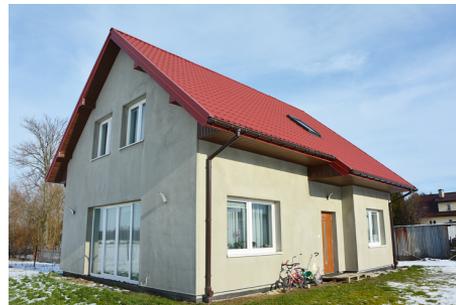
Fig. 3. Example of an unrenovated building with preventive structural protection

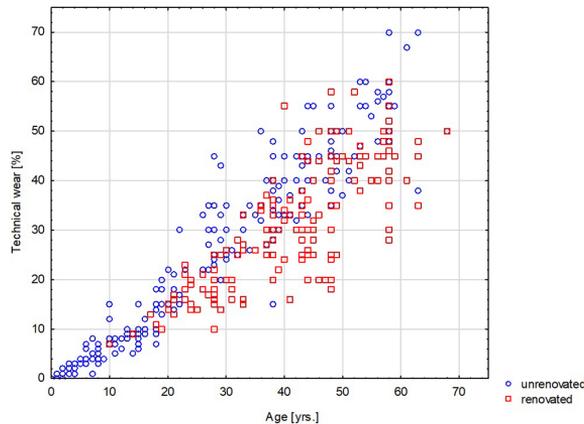
The distribution of the obtained values of the degree of technical wear  $s_z$  of the analysed building structures depending on their age and accounting for their division into *renovated* and *unrenovated* ones is presented graphically (Fig. 4).

Fig. 4. Scatter plots of  $s_z(t)$  buildings in the database, accounting for renovation works performed

First, the parameters of the linear model of the course of technical wear were determined for all 413 buildings (c.f. Fig. 1), in which the value of the slope coefficient  $b$  was 0.8353, which gave the value of the degree of technical wear of 20.9% after 25 years (Table 2). Then, the course of technical wear was determined with the division of the analysed building structures accounting for their renovation. In the *renovated* group, the average value of technical wear after 25 and 50 years of use was 18.8% and 37.5%, respectively. This value was lower than in the *unrenovated* group by 4.9% and 9.9%, respectively. The obtained results made it possible to estimate the durability of the studied building structures, which for renovated facilities is 133.2 years, i.e. 20.7% higher than for unrenovated facilities. This confirms the positive effect of renovations on the technical condition and durability of building structures.

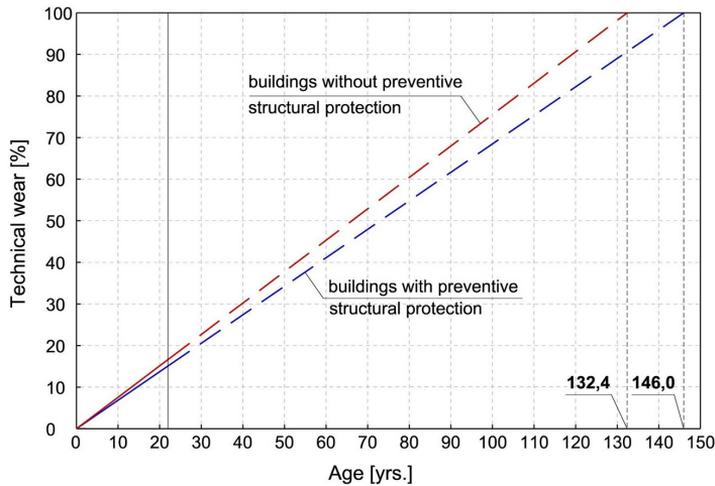
For the analysed groups of buildings, the obtained models of technical wear also allow for the assessment and comparison of their durability (Fig. 5).

Fig. 5. Course of technical wear summarised in Table 4 of unrenovated buildings with and without preventive structural protection, located in the LCB

Based on the analysis of the obtained models (Table 4) illustrated in Figure 5, it can be concluded that for the analyzed development the use of preventive structural protection results in extended durability of detached masonry houses by 13.6 years on average.
