Research paper

Conservation works in Tanais archaeological site in years 2016–2019

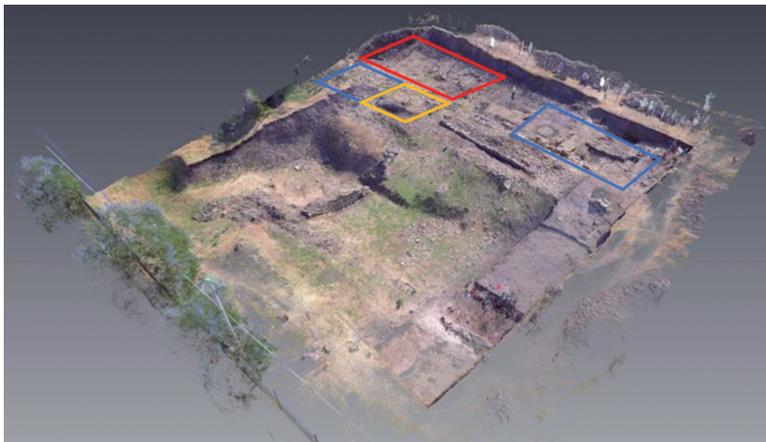
the excavation, which allows precise measurements of structures located inside (Fig. 1). An important advantage of using 3D scanning in archaeological research is measurement range. The technology allows the device to operate from 50 cm to 330 m (Faro Focus X300). The measurement data obtained by the laser scanner is of high accuracy. The 3d scanner uses a single point accuracy of ± 2 mm at a distance of 50 meters from the scanner at a measurement speed of up to ~ 1 mln per second. Mass measurement of the geometric characteristics of the excavation site allows for a detailed investigation of the residue of the structure of the site. 3d scans of the site were done in colour. Thanks to the built-in camera, it is possible to colour point cloud obtained in the first stage with images. Images taken by the scanner, once assembled, create a 360 panorama. Such imagery can be used to visualize the state of objects in the excavation site [13].

Fig. 1. Three-dimensional model of archaeological excavation in Tanais. A red box indicates an area of conservation work performed in 2017, a yellow area of conservation works completed in 2018 and a blue one in 2019 [17]

Conservation work carried out in the 2017 season was focused on the chamber located in the northeast corner of the excavation (Fig. 1). A partial reconstruction was performed with the semianastylosis method using an earth-based mortar stabilized with lime and cement. The bottom part of the reconstructed walls (foundation) was originally preserved in these walls. The upper parts were reconstructed using stones located close to these structures and between the original and reconstructed parts small ceramic remains were used. Due to the trial stage of conservation work, the pointing with earth-based mortar, a step of the conservation procedure described in the previous parts, was not applied. The results of the conservation work are presented in Fig. 2.

After a year, minor superficial scratches were observed, and about ten masonry elements (stones) were detached, so some works in 2018 were oriented on the reconstruction of these elements. This year, the conservation of further parts of the uncovered structures (yellow box in Fig. 1) was also started. This masonry structures showed a very far-reaching disintegration of its internal structure. They were preserved only in the near-surface areas

the reconstruction of a further part of the stone structures (the area marked in blue in Fig. 1) was started.

The work's second part was the protection and strengthening of stone structures. It was necessary to temporarily secure the detached masonry elements in the corner of the room (left blue area in Fig. 1). Anastylosis (re-alignment) of the masonry elements that needed preservation was performed. Original masonry elements were used, which had become detached from the overall wall due to weather conditions.

As the last part of the conservation work, the protection and stabilization of a section of the eastern side of the excavation were carried out (right blue area in Fig. 1). A retaining wall was constructed from stone elements in the trench (lying loosely and not connected with the existing masonry relics) and outside the excavation. The construction of the masonry is layered, in the lower part made from 2–3 rows of elements, in the upper part from one row of stone. The state of the wall before and after the conservation work can be seen in Fig. 4.

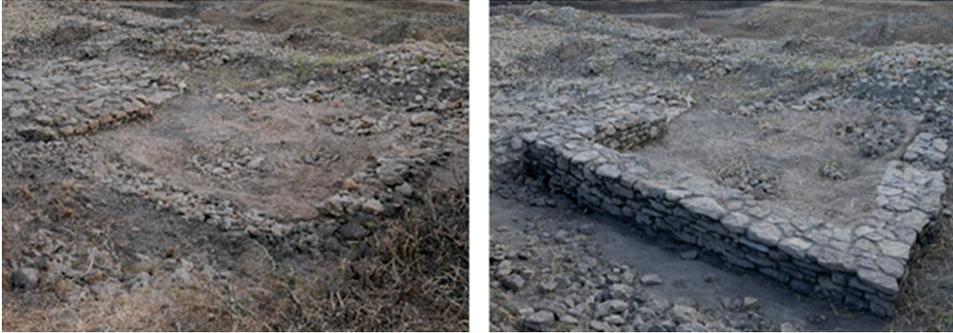
Fig. 2. Walls of the chamber located in the Tanais archaeological excavation before (on the left) and after (on the right) conservation work in 2017

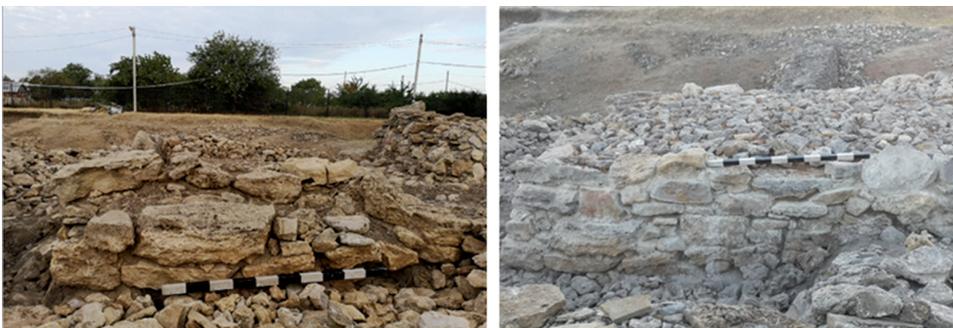
and were in poor technical condition. The wall was an irregular, three-layered wall - the faces of the wall were made of massive stones and the infill of finer stones and earth-based mortar. Visible faces of the masonry were not preserved along the entire length, and an original binder was washed out, so the rescue reprofiling of the masonry was necessary.

Fig. 3. Wall located in the Tanais archaeological excavation before (on the left) and after (on the right) conservation work in 2018

The work carried out this year consisted of 3 parts:

- 1) preparation of the masonry for conservation work (removal of the layer of stones protecting the excavation, removal of plants);
- 2) the conservation work;
- 3) protection of the trench wall (covering with a layer of stones).

The state of the structure before and after the conservation work can be seen in Fig. 3.

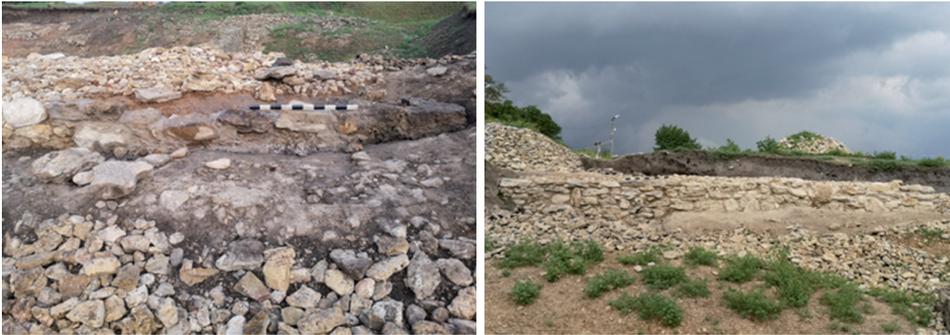
Fig. 4. Wall located in the Tanais archaeological excavation before (on the left) and after (on the right) conservation work in 2019

A part of the structure required the reprofiling of the outer layers, which was carried out using existing elements and elements near the wall, being its probable part of it (semianastylosis). Following the original technology, the substructure (foundation) of the wall was made of large stone elements. The infill of the wall was made of rubbles stabilized with mortar.

The final stage was the mechanical protection of the excavation and masonry structures located in the excavation. A layer of loose stones was used as a protection layer.
