Roman Cement – material with a history and future

ROMAN KOZŁOWSKI

Institute of Catalysis and Surface Chemistry, Krakow
Polish Academy of Sciences
nckozlow@cyf-kr.edu.pl

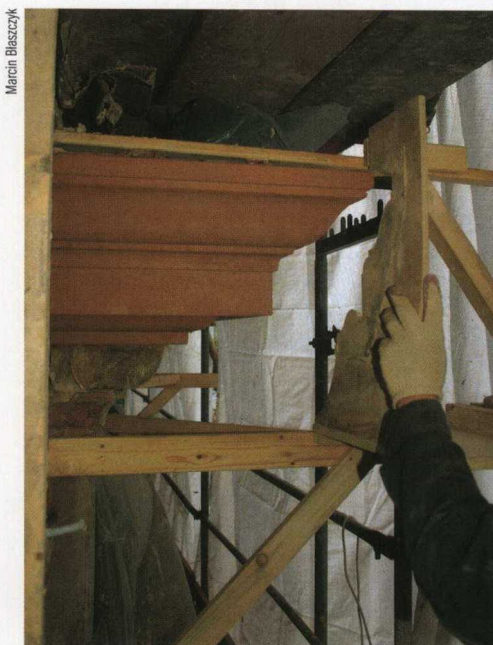
The missing part of this cornice is reconstructed by applying Roman cement mortar and repeatedly passing over a wooden profile

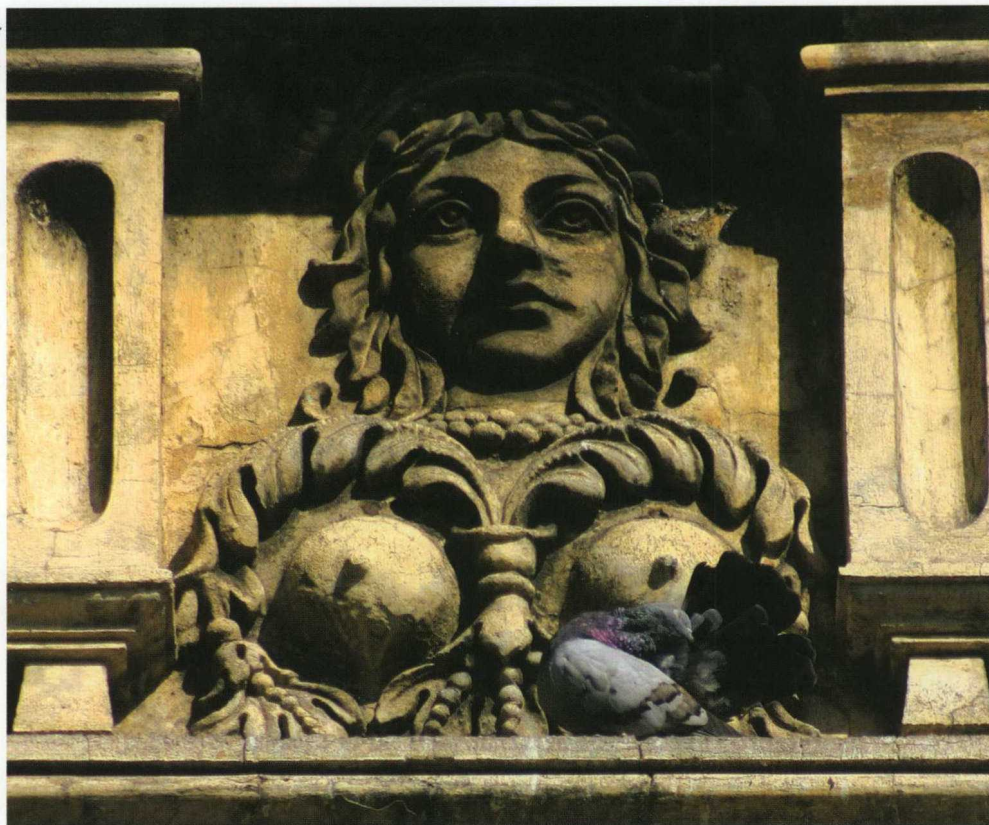
Warm colour, an irregular network of thin shrinkage cracks, and a good state of preservation are characteristic features of Roman cement decorations

The project's investigations discovered unique properties of the Roman cement renders and many secrets of their resistance to weathering. They combine high strength with very high porosity, which ensures their resistance to the impact of rain water and entails good drying of the building. Because of their low shrinkage, they can be applied as thick single coats (up to 50 mm). Roman cements are universal binders, ideally suited both for casting of decorative architectural details in moulds and for run work or rendering. They can be used to produce interior cores of decoration but also for sur-

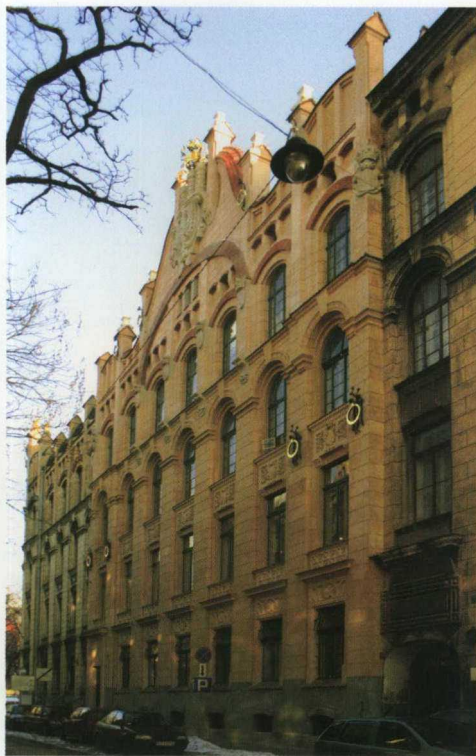
Jan Zawiejski's former Trade Academy in Krakow, built in 1904–1906. A monumental municipal school building decorated with Roman cement renders, here after conservation with the use of authentic stucco materials and techniques

The materials and techniques reestablished as a consequence of the project's efforts were used in restoring the façade of Jan Zawiejski's former Trade Academy in Krakow, built in 1904–1906. Supported financially by the Citizen's Committee for the Renovation of Krakow, restoration of the Academy's façade was finished in 2007. This was the first renovation of Roman cement stuccoes in Europe carried out with the use of materials compatible with the historic substance of the original decoration. With the ready availability of Roman cements, the family of historic hydraulic binders necessary for the appropriate conservation of the built heritage of the 19th and 20th centuries is now complete; we no longer need to turn to substitutes for help. However, further conservation and information activities are needed to encourage growing acceptance of the use of Roman cements in the restoration of historic buildings of the period. ■
