THE WEAR MECHANISMS DESCRIPTION OF MULTILAYER COATINGS, PERFORMED BY TRANSMISSION ELECTRON MICROSCOPY – AN OVERVIEW OF THE OWN RESEARCH WORK**OPIS MECHANIZMU ZUŻYCIA WIELOWARSTWOWYCH POWŁOK W OPARCIU O TRANSMISYJNĄ MIKROSKOPIĘ ELEKTRONOWĄ – PRZEGLĄD WŁASNYCH BADAŃ DOŚWIADCZALNYCH**

Keywords: multilayer coatings, TEM characterization, wear mechanisms

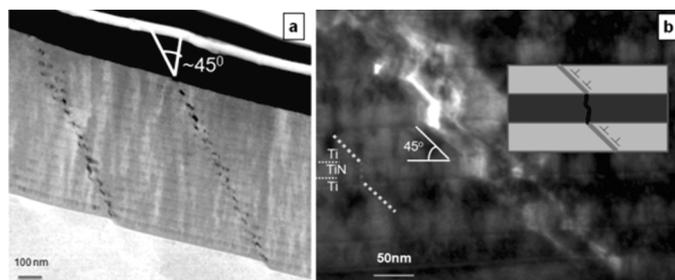
Deformation of the Ti / TiN multilayer with modulation ratio TiN:Ti = 1:1 coating, was done by indentation mechanical test. It caused the intergranular shear sliding and plastic flow of soft titanium layers, while ceramic layers (TiN) revealed the brittle cracking [7]. So called deformation lines were propagating across the total coating at an angle of 45° to the surface, which is a typical angle for plastic deformation of poly-crystalline metallic materials (Fig. 1) [7]. It informed, that plastic deformation dominated over the whole coating.

Fig. 1. Cross section TEM image of a 16 bilayer multilayer coating with modulation ratio TiN:T = 1:1; a). overview (STEM image) and b). detail of deformation mechanisms (schematics of deformation and cracking) (TEM BF image) [7]

Energy of brittle cracking in ceramic layers was converted into plastic deformation in metallic ones. Similar behavior was found for Cr / Cr₂N multilayer coating (Fig. 2) [8,9].

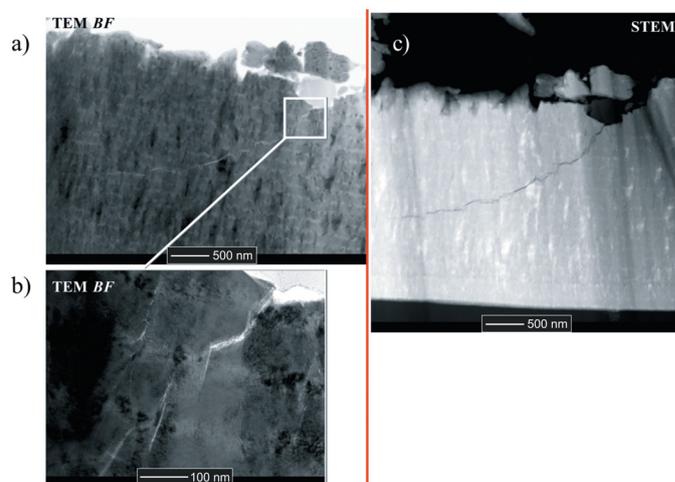
Fig. 2. Microstructure characterization of the Cr / Cr₂N part of the coating (first part from the substrate) after the 5 N and 20000 cycles wear test; a). TEM BF image; b). TEM BF image-higher magnification; c). STEM image [8]

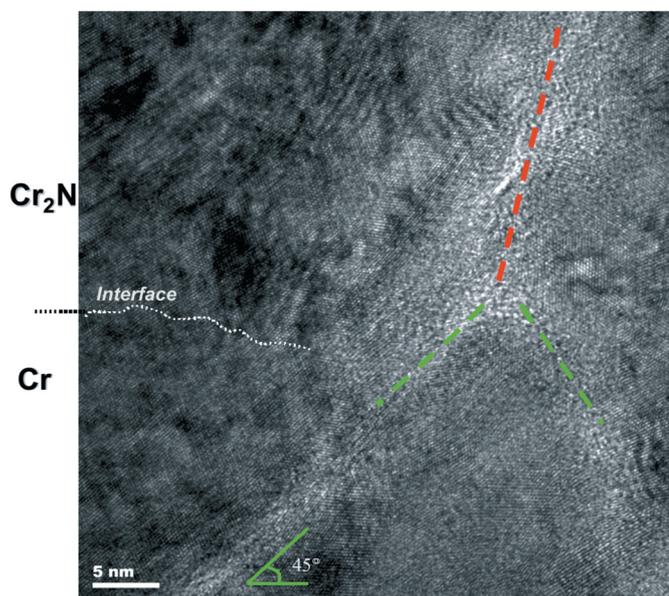
Coatings were subjected to mechanical ball-on-disc wear test with 5N of the applied load. This is another type of deformation process, however, the operating mechanism in microstructure was very similar. Conversion of brittle cracking to plastic deformation at the ceramic / metallic interface was confirmed by HRTEM image (Fig. 3).

Fig. 3. HRTEM image of the Cr / Cr₂N interface [8]

Cr₂N ceramic layers brittle cracked, while metallic Cr deformed plastically, reducing the cracking energy. Plastic deformation in metallic Cr layers was realized at 45°, which is a typical angle for plastic deformation of polycrystalline, metallic materials.

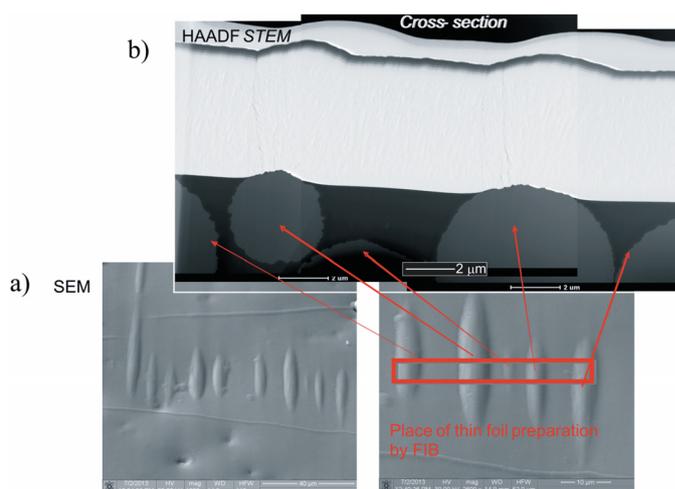
Requirements for modern coatings are constantly increasing. They should combine various properties. One of the innovative solution in coatings designing is additional deposition of the other material at the top of the typical multilayer structure. Although, this type of coating contains an inner (first from the substrate) and the outer part. Our latest research activity was connected with such type of coatings development. Cr / Cr₂N multilayers were deposited as an inner part. Its role was to compensate residual stresses in the coating. The outer part formed the amorphous carbon layer. The outer part of the coating plays the important role as a diffusion barrier during the wear process in aggressive, corrosive atmosphere or at elevated temperature. This type of coatings was deposited at the carbon-fiber-composite substrates [8] (Fig. 4).

Fig. 4. Microstructure characterization of an as deposited coating; a). image obtained using SEM technique; b). image obtained by TEM technique in STEM mode [8]

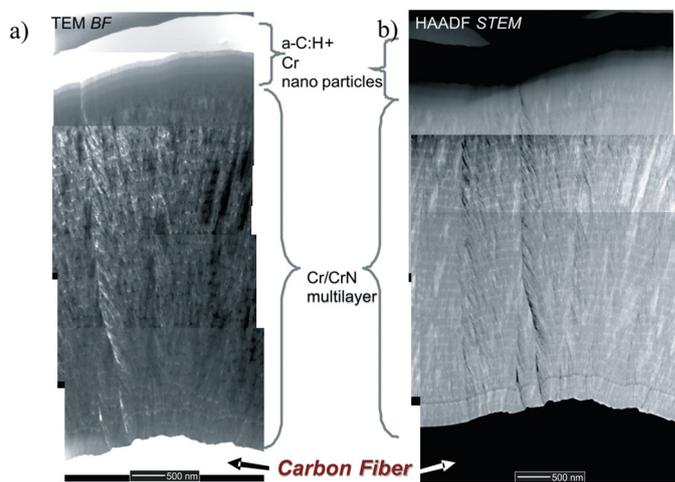
Details of the coating architecture were better visible by the application of the higher magnification in TEM bright field mode as well as in STEM (Fig. 5) [8].

Fig. 5. Microstructure characterization of the coating at the cross-section, performed by TEM technique; a). TEM BF image; b). STEM image [8]

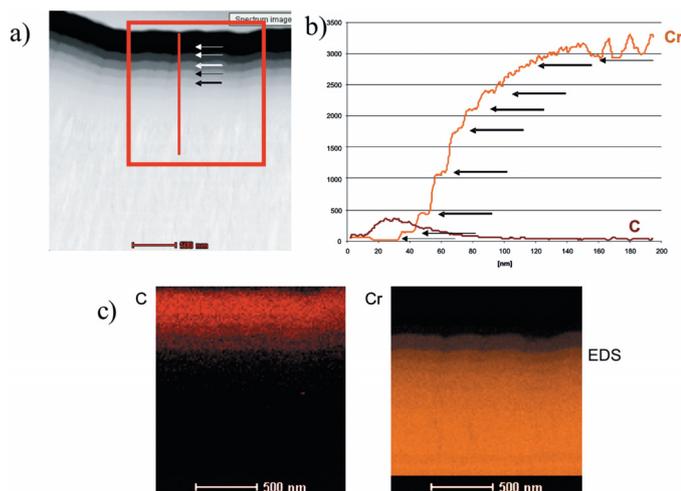
It is well-known that *a*-C:H coatings have low friction coefficients and low wear rates [10, 11]. Thus, the amorphous carbon coatings are very promising tribo-materials. However, the poor adhesion strength to substrate, high residual stress and weak thermal stability would limit their application. Currently, many metallic elements (Ti, W, Ag, Cr etc.) have been utilized to modify their structure, and it has been proved that the metal doping is an effective method to reduce the residual stress and enhance the adhesion strength of the film. In case of coatings developed by our group, *a*-C:H was gradually implanted by Cr [8] (Fig. 6).

Fig. 6. Qualitative EDS chemical analysis; a). STEM image; b). diagram of selected elements distribution along the line marked at the STEM image; c). maps of selected elements [8]

The higher the distance from the interface with the inner part of the coating (Cr / Cr₂N), the lower amount of Cr nano-crystals. Almost at the top part of the coating, the stage of implantation was practically negligible. Looking at the diagram which presents the chromium distribution in the a-C:H part of the coating, along the line perpendicular to the substrate, one may indicate formation of steps (Fig. 6b). Each step corresponded to the individual a-C:H layer with different amount of Cr nano-crystals concentration. The gradient concentration of chromium nano-particle in a-C:H structure was confirmed by selected area electron diffraction pattern (Fig. 7).

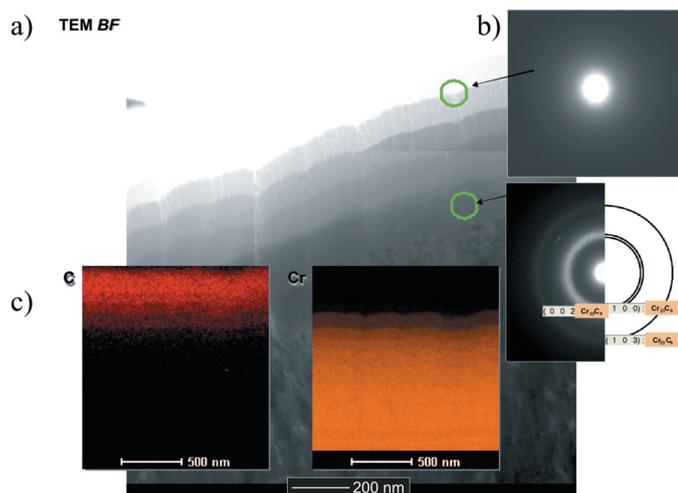
Fig. 7. Microstructure characterization of the amorphous carbon part of the coating (outer part) using TEM technique; a). TEM BF image; b). selected electron diffraction patterns (phase analysis); c). maps of selected elements obtained by EDS technique [8]

The character of the diffraction pattern changed with the distance from the interface with the inner part of the coating to the coating surface. Close to the interface, it had a nano-crystalline character (fine ring pattern). Close to the coating surface it had

almost amorphous character (two blurred rings round the main spot). The diffraction pattern not only confirm the gradient concentration of nano-particles implantation, but also indicated, that chromium which was inserted into a-C:H structure reacted with carbon during deposition (in plasma), forming chromium carbides (Cr₂₃C₆).

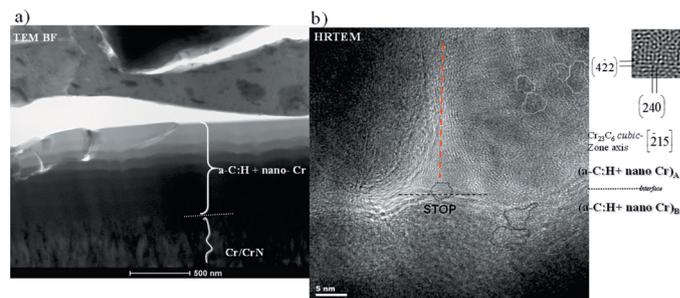
A role of chromium carbide nano-particles in wear resistant properties of coating was significant. Some cracks propagating through a-C:H layers with relatively low amount of Cr₂₃C₆ nano-particles, were stopped at interfaces with a-C:H layers with higher amount of Cr₂₃C₆ nano-crystals (Fig. 8) [8].

Fig. 8. Microstructure characterization of the amorphous carbon part of the coating after ball-on-disc wear test; a). TEM BF image; b). HRTEM image [8]

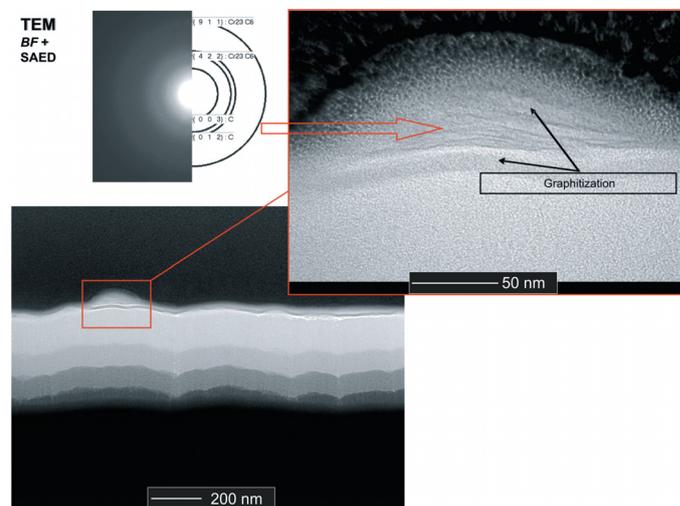
Focusing on the surface topography, it has been noticed that at the top of the coating graphite was formed during the wear process (Fig. 9).

Fig. 9. Microstructure characterization of the tribo-film formed after ball-on-disc wear test, performed by TEM technique [8,12]

The phase analysis performed by the diffraction pattern, showed the presence of graphite and chromium carbides in the tribo-film [8,12]. Tribo-film is a material which is usually formed during wear process from the removed fragments of material. A well designed outer part of the coating is a very important factor in its wear resistant properties.

As it was presented before, on one of the previous images (Fig. 9), formation of the tribo-film during a wear process may have a positive aspect. It may contain high amount of graphite, which is a good lubricant. In the presented case agglomerated Cr₂₃C₆ nano-particles in the wear process, which were initially as nano-multilayers in a-C:H layers, accelerated layers removal (Fig. 12).

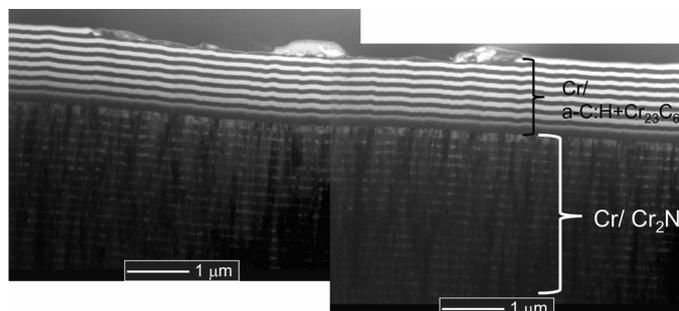
up the wear process of total coating. The coating was deposited on metallic substrate (tool steel-316L) consisting of two parts. The inner part (the first from the substrate) was formed by conventional Cr / Cr₂N multilayer system, while the outer part by a-C:H / Cr multilayer (Fig. 10).

Fig. 10. Microstructure characterization of the Cr / Cr₂N+a-C:H / Cr multilayer coating, performed at the cross-section, by transmission electron microscopy technique (bright field)

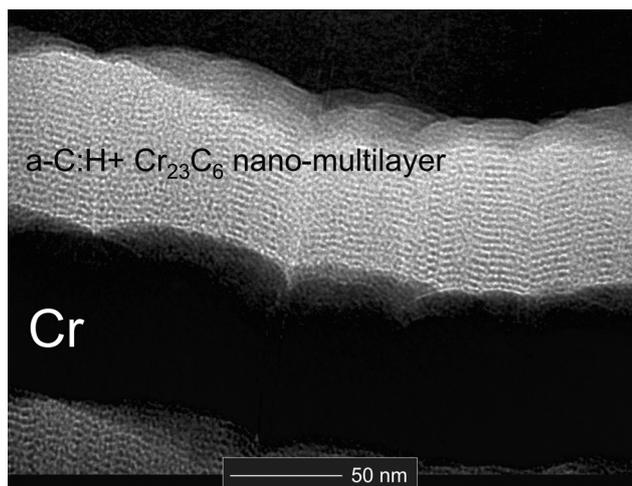
Additionally a-C:H was implanted by Cr₂₃C₆ nano-multilayers (Fig. 11).

Fig. 11. Microstructure characterization of the outer part of the coating (a-C:H / Cr), particularly a-C:H implanted by Cr₂₃C₆ nano-particles, performed at the cross-section, by transmission electron microscopy technique (bright field)

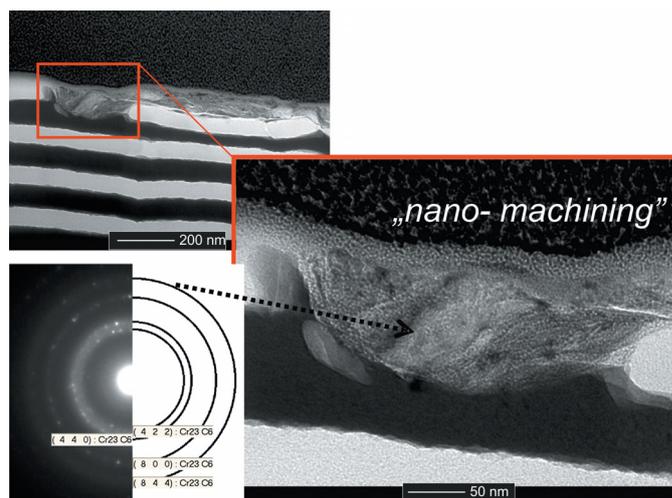
Fig. 12. Microstructure characterization of the outer part of the coating (a-C:H / Cr), after mechanical wear test, performed by transmission electron microscopy technique (bright field)

- A positive influence on wear process was found for α -C:H which was gradiently implanted by Cr_{23}C_6 nano-particles, while other example of the outer part of the coating (Cr / α -C:H+ Cr_{23}C_6 nano-multilayers) speeded up the wear process. The carbides agglomerated during wear causing so-called “nano-machining” process of the coating.

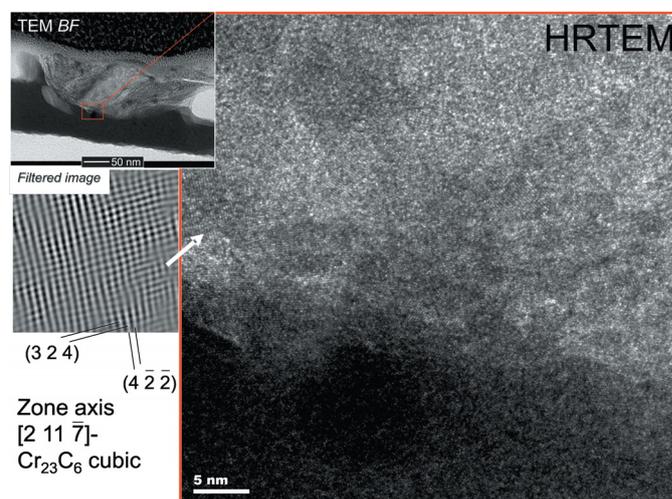
The phase composition was confirmed by HRTEM analysis (Fig. 13).

Fig. 13. HRTEM characterization of the tribofilm

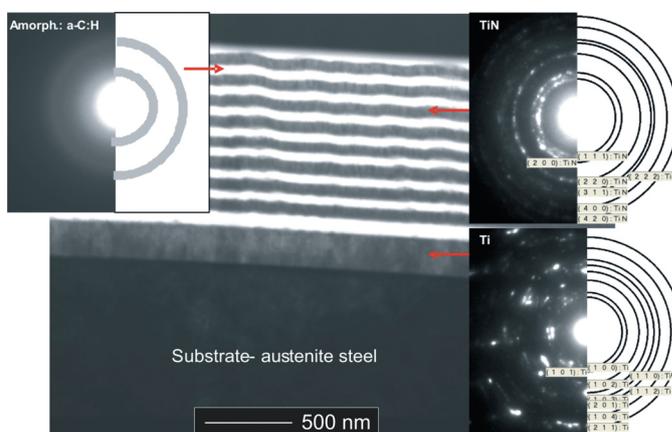
Another innovative solution in coating designing was application of very thin metallic interlayers at the ceramic / ceramic multilayer structure TiN / Ti / a-C:H (Fig. 14) [13].

Fig. 14. TEM bright field image of an as-deposited 8 TiN / Ti/a-C:H multilayer coating, together with selected area electron diffraction patterns from selected parts of the coating [13]

The first layer from the substrate, it was a pure, metallic titanium buffer layer. Its role was to increase adhesion of the coating to the metallic substrate. Then, the multilayer structure was deposited. The titanium nitride layers were sequentially placed with amorphous carbon layers. Additionally at each TiN / a-C:H interface, very thin (~7 nm) metallic, titanium layers were produced. Their presence was visible at higher magnification in the bright field mode (Fig. 15) [13].

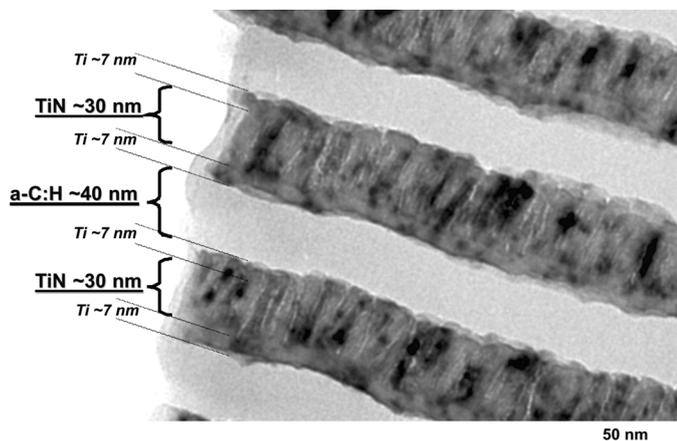
Fig. 15. TEM bright field image of an as-deposited 8TiN / Ti / a-C : H multilayer coating (higher magnification than (Fig. 12), revealing thin Ti layers presented at each interface) [13]

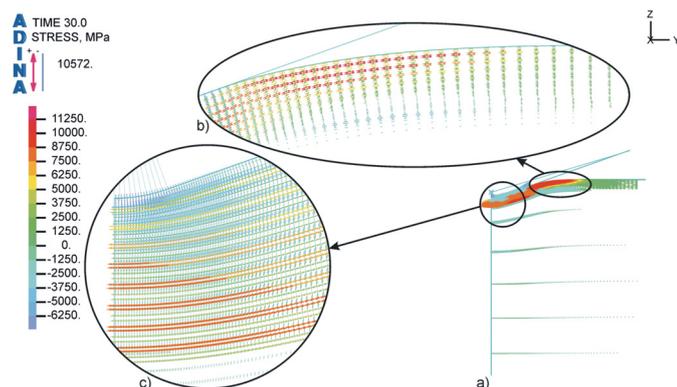
One of the main advantages of the described coatings was that cracking had not been performed suddenly. It occurred layer-by-layer. The highest, localized stress concentration was moved during the coating deformation from the bottom to the top part of the coating, which was modelled by the finite elements method [13] (Fig. 16).

Fig. 16. Finite elements modelling of residual stress distribution during the mechanical test; a). residual stress distribution in the total coating; b). magnification of the top part of the coating; c). magnification of the bottom part of the coating [13]

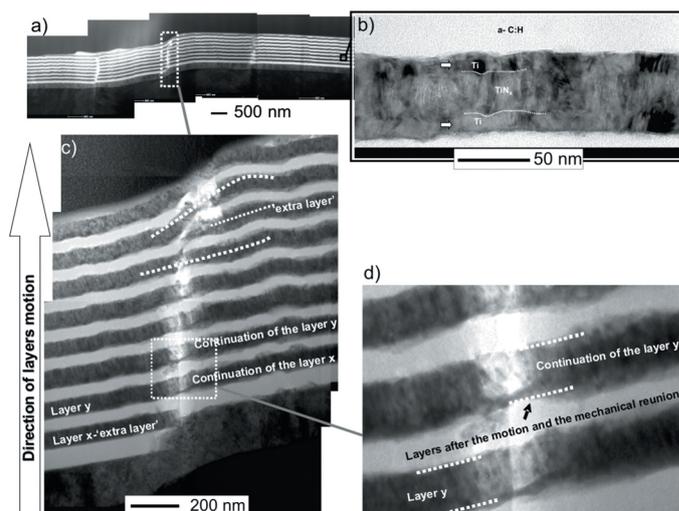
The numerical modelling was confirmed by TEM characterization of the wear mechanism in the real material (Fig. 17).

Fig. 17. TEM bright field image of the cracking place in an 8TiN / Ti / a-C : H coating (cross section): a). TEM bright field image of the cracked place; b). image revealing presence of thin Ti metallic layers at each TiN / a-C : H interface; c). the magnified area of one crack presenting the 'layers motion mechanism'; d). place of layers reunion after 'layers motion' [13]

The highest, localized stress concentration was moved during the coating deformation from the bottom to the top part of the coating. The layers reunion after movement of individual layers to the closest layer of the same phase was possible by the presence of metallic thin layers at each interface.

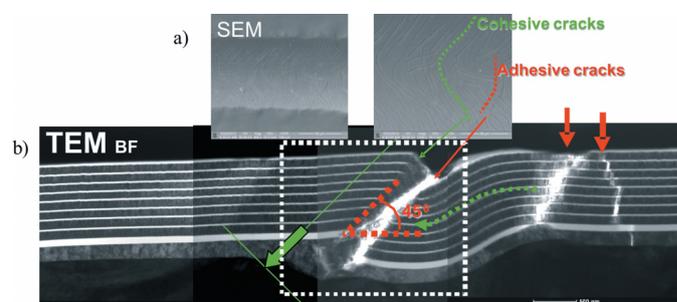
These type of coating exhibited also a good mechanical adhesion which was confirmed by the scratch test analysis. Detailed TEM microstructure analysis allowed to present stages of coating delamination during mechanical uploading (in the scratch test). During the scratch adhesion test, first cracks which are usually formed on the scratch track are called cohesive cracks. They are formed in the opposite way to the penetrator movement. Final cracking is called adhesive which is connected with coating delamination from the substrate. The TEM microstructure investigation allowed to describe, from the microstructure point of view, these two types of cracks (Fig. 18) [14].

Fig. 18. Microstructure analysis of 8xTiN / Ti / a-C:H multilayer coating with 4:1 (TiN:a-C:H) phases ratio, after scratch adhesion test; a). topography analysis by SEM technique, b). microstructure analysis on the cross- section by TEM technique (bright field mode) [14]

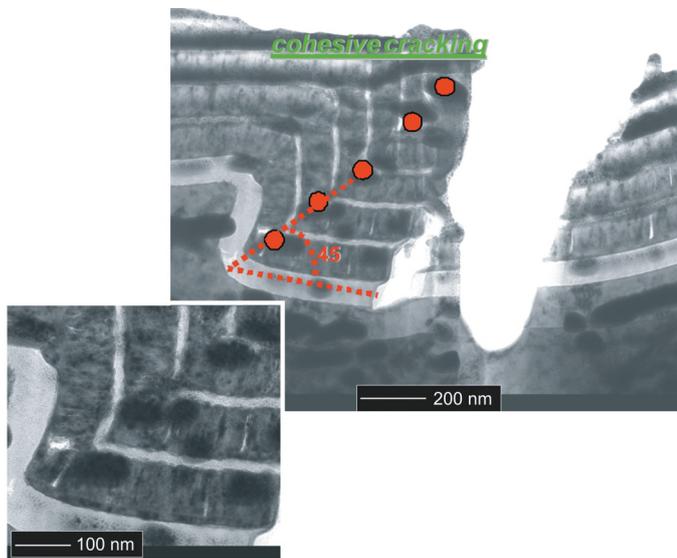
The another thin foil prepared for TEM observation allowed to study the earlier deformation stage in the cohesive cracking (Fig. 19) [14].

Fig. 19. Microstructure analysis of $8\times\text{TiN}/\text{Ti}/\text{a-C:H}$ multilayer coating with 4:1 (TiN:a-C:H) phases ratio, after scratch adhesion test-earlier stage of cohesive cracking than presented in Fig. 18 [14]

In cohesive cracking, ceramic TiN and a-C:H layers brittle cracked, while the crack propagation was fixed by very thin Ti layers at each TiN / a-C:H interfaces. The dots were placed on points where individual layers were bended.

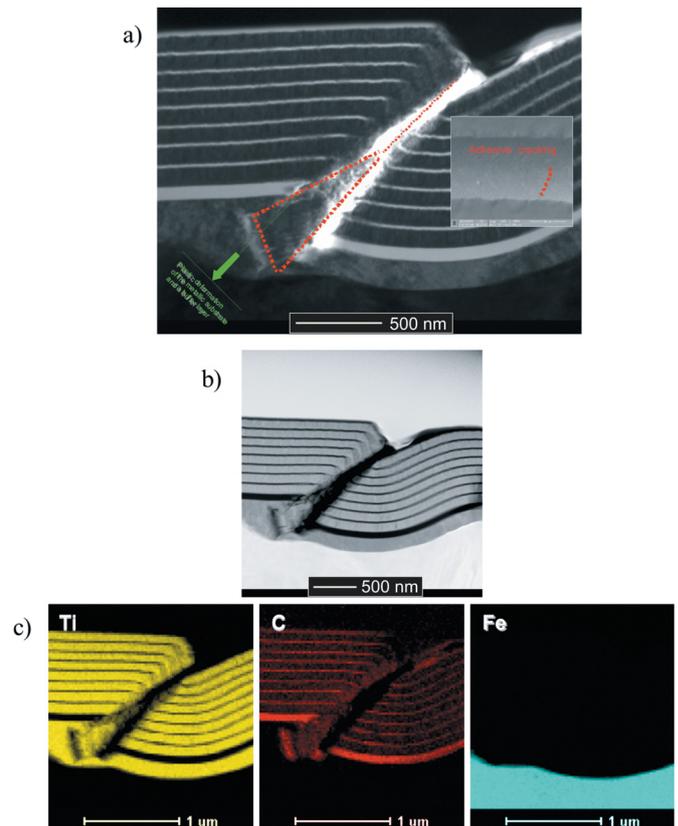
In the subsequent stage, with higher uploading (when adhesive cracking started to dominate), the crack was formed along line at 45° , however, the coating adhesion to the substrate was so strong that the plastic deformation of the metallic substrate pulled down the coating fragment (Fig. 20) [14].

Such behavior is a proof of a very good coating adhesion to the substrate.

Fig. 20. Microstructure analysis of $8\times\text{TiN}/\text{Ti}/\text{a-C:H}$ multilayer coating with 4:1 (TiN:a-C:H) phases ratio, after scratch adhesion test-adhesive cracking; a). TEM bright field image, b). image in the Z-contrast (contrast dependent on atomic number Z), c). maps of selected elements obtained in qualitative chemical analysis EDS [14]
