Short communication

Prosthetic reconstruction of broken canine teeth in dogs with use of cast metal posts

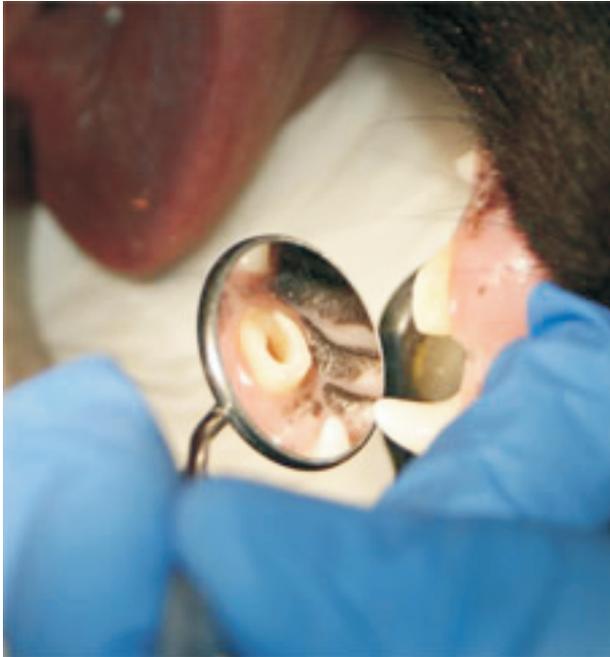
Fig. 1. Fractured right upper canine (during preparation for restoration).

to pulp exposures qualified for standard RCT and subsequent prosthetic restorations. As the crowns were severely damaged (Fig. 1) and the roots intact with completed apexification (Fig. 2), it was decided that a root post with a prosthetic crown would be necessary. For the root canal filling (Fig. 3) The Obtura System-injection of heated gutta-percha technique was used (Lipski et al. 2011). The canals were then prepared for the prosthetic procedures, silicone impressions were taken and referred to the laboratory (Coffman et al. 2007). The restorations were fitted (Fig. 4) and then cemented during a second anesthesia session, using Ketac Cem (3M ESPE)

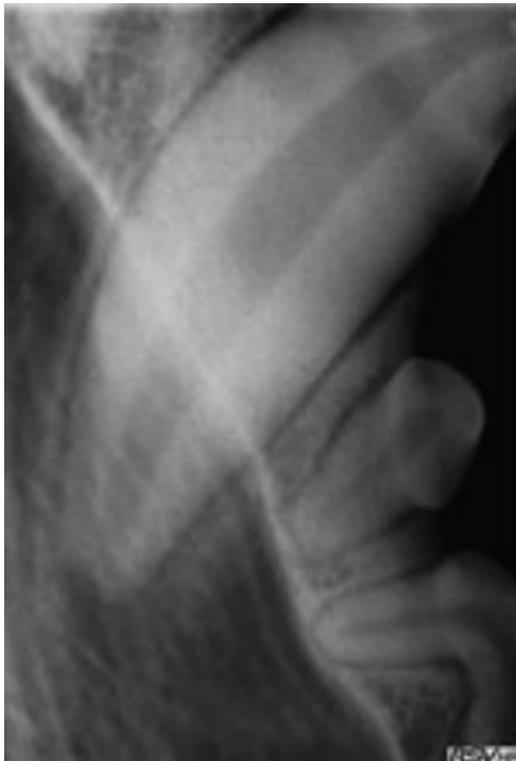
Fig. 2. X-ray image of the tooth root before RCT.

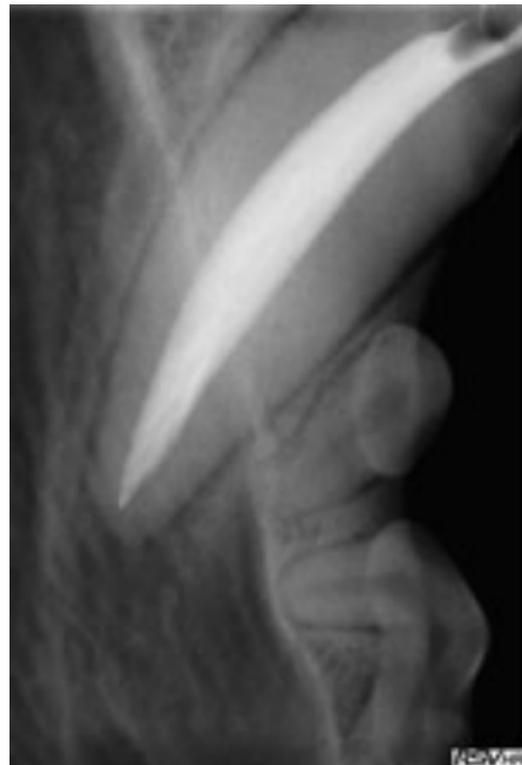
Fig. 3. X-ray after RCT before further preparation.

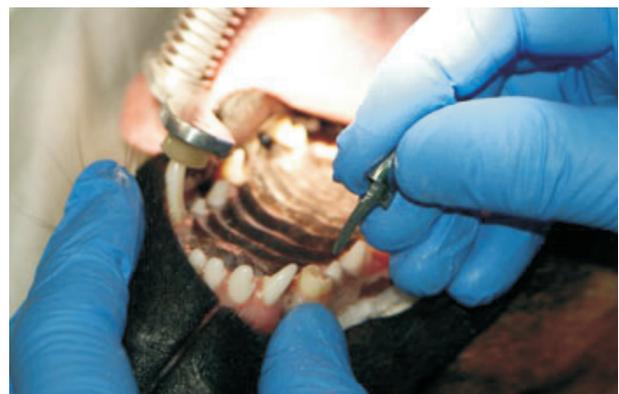
Fig. 4. Fitting of post.

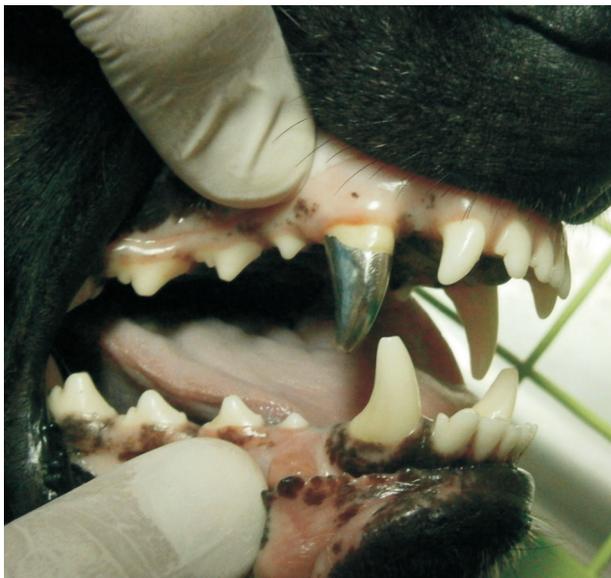
Fig. 5. Post in place – five weeks later.

glass-ionomer luting cement. The owners were asked to bring the dogs to the first clinical check-ups after four to six weeks (Fig. 5).

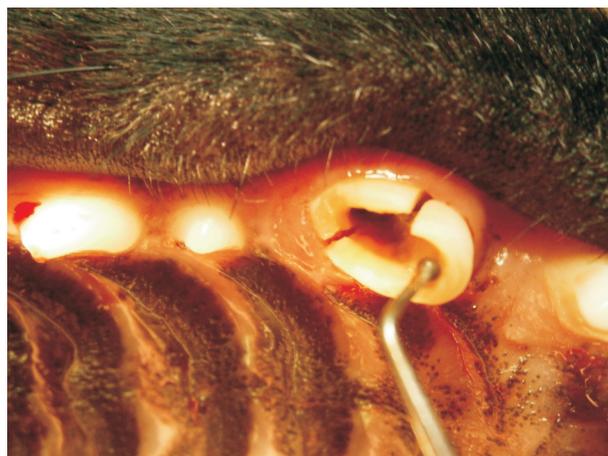
Despite great care taken to provide the best results, all the restored teeth were lost. The dog owners reported all restorations to be failures after a period of three weeks to six months. All roots suffered vertical fractures (Fig. 6), which classified them for extraction. The damage was due to application of forces much greater than biting whilst feeding (defence training, blunt force trauma, aggression). The authors therefore conclude that if the initial tooth fracture leads to a complete crown loss, it is not advisable to restore the crown. The root should be treated endodontically and protected by the use of a glass ionomer cement (GIC), to assure the tightness for the root filler in order to prevent periapical pathology and further deterioration of the tooth, as caries and gingival inflammation have never, or only seldom, been observed in association with GIC fillings (Forsten 1998). In this way the pathological migration of the neighbouring teeth and the atrophy of the alveolar process, can be prevented; this should ensure no further occlusion problems, and help to avoid further complications such as mandible fractures caused by weakened bone. The authors are also considering further research into reconstructing canines with the use of a post with a crown part which will cover up the top of the root to ensure the ferrule effect and possibly prevent root breakage.

Fig. 6. Vertical root fracture (post missing).
