Research paper

The landslide in the slope and side of the Warta River valley in the village of Wronki – process analysis, exploratory research, preventive measures, monitoring

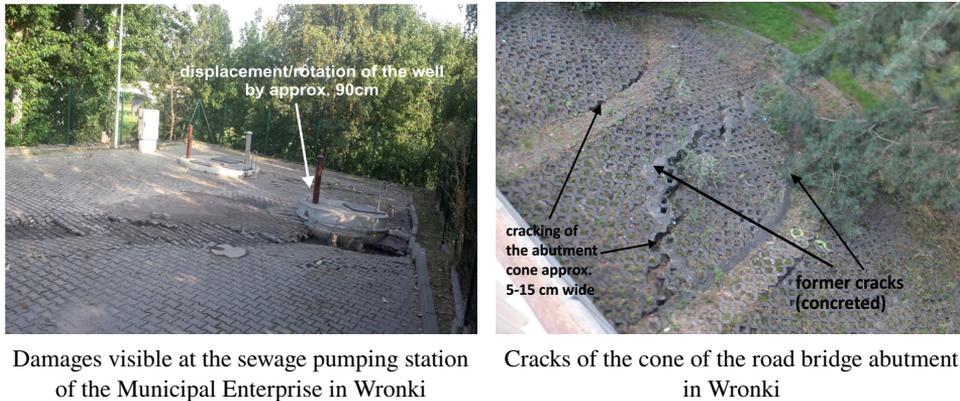
Fig. 3. The discussed area in Wronki [9]

During the field inventurization, numerous photographic documentation of the damages and deformations of the ground was also made. Selected damages that occurred in the discussed area in August 2018 are shown in the photos below (Fig. 3).

Cracks in the ground, approx. 50 cm wide, in the allotment gardens in Wronki

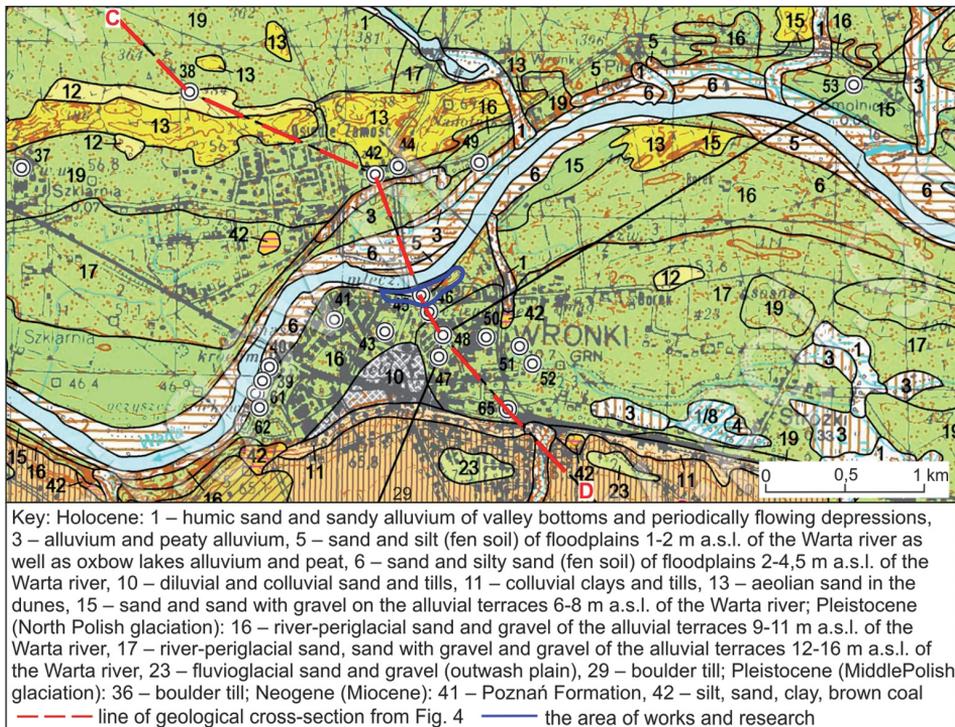
Fig. 4. Location of the research area against the background of a fragment of the detailed geological map of Poland, sheet 392 – Wronki, scale 1:50 000 [5]

In order to determine the causes of the landslide, the geological structure of the study area was analyzed in detail. The detailed geological map of Poland (Wronki sheet) shows the presence of mainly non-cohesive soils in the subsurface zone, i.e. river-periglacial sand and gravel of the alluvial terraces of the Warta river and sand and silty sand of floodplains of the Warta river (Fig. 4) [5].

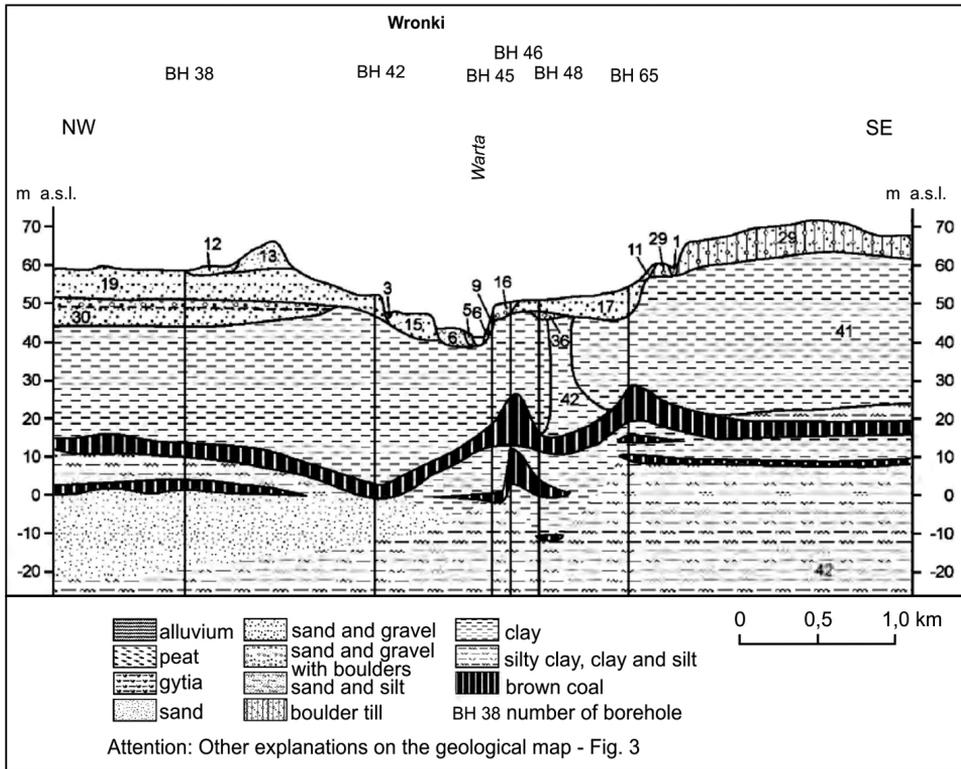
Fig. 5. The fragment of the C–D geological cross-section [6]

In turn, the sediments that appear below are illustrated by the geological cross-section included in the explanations to the above-mentioned map [6]. The mentioned sands (marked with number 6 and 17) lie on cohesive soils formed as Neogene clays of the Poznań series (marked with number 41), and locally on the boulder tills of the Middle Polish glaciations (marked with number 36). The Warta river bed is eroded in Neogene sediments, on which a layer of sand with a small thickness lie (Fig. 5).

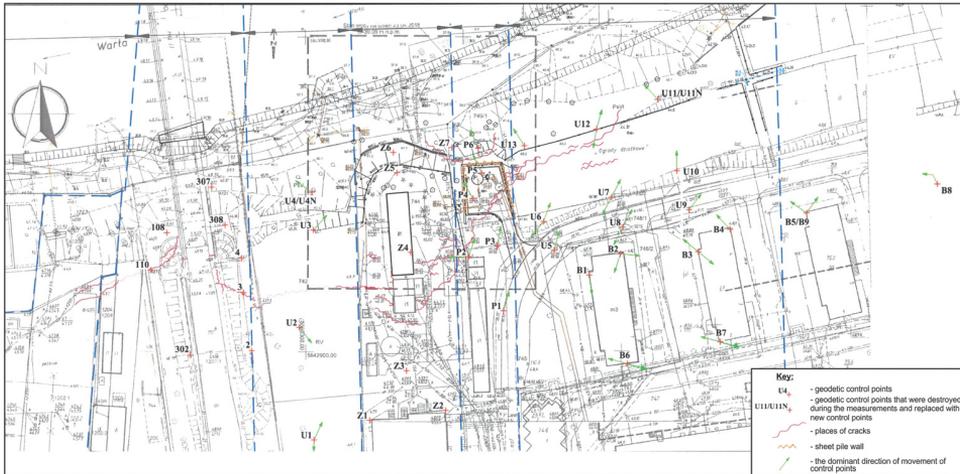
Fig. 7. Distribution of geodetic control points [13–15]

The measurement network is arranged so that it is possible to analyze all the critical points of interest, thus it covers the area of active landslide and allows to determine the displacement of surface points in the X, Y, Z direction. The presented map shows the distribution of geodetic control points in the zone where the greatest landslide movements occurred in 2018 (Fig. 7). Measurements are carried out from December 4, 2018. 13 control points marked with the letter U are located in the area belonging to the Wronki City Hall (currently measurements are carried out for points U1–U9) and 6 control points marked with the letter P are located on the premises belonging to the Company Municipal in Wronki. Points marked with the letter Z are located on the premises of the Correctional Facility in Wronki, where currently measurements are no longer carried out (completed in December 2018) [13–15].

In the Documentation of the subsoil research in March 2019, it was recommended to extend the monitoring by additional checkpoints in the area at Mickiewicz Street and a housing estate [10]. From October 28, 2019, measurements are carried out in the area belonging to Słowacki housing estate in Wronki using 8 control points marked with the letter B (Fig. 7).
