Research paper

Reinforcement solution of damaged load-bearing frame structure in a coal power plant for additional loads

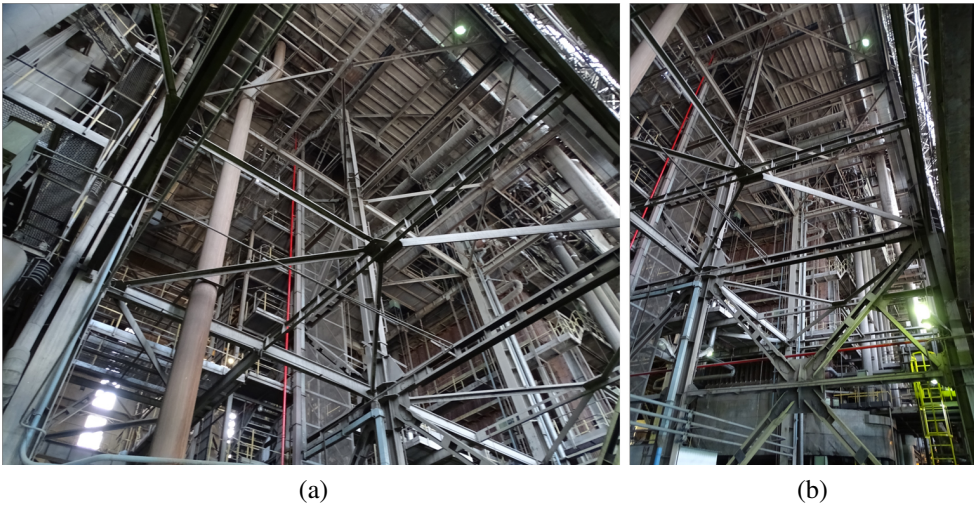
Fig. 3. Photos of steel structure at +25.5 m: a) Horizontal bracing on level 34.0, b) Vertical bracing in axes 12

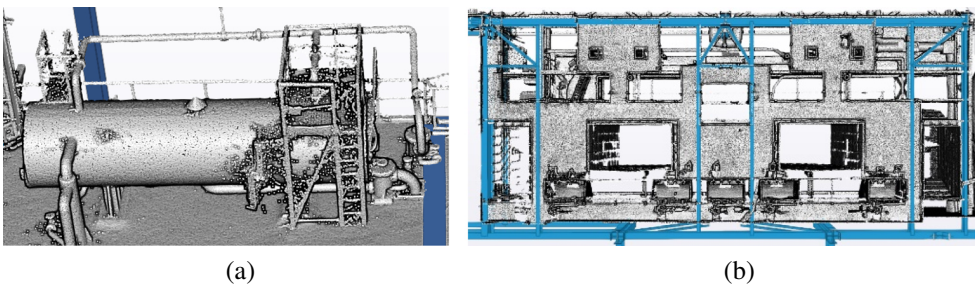
An additional complication was the uncertainty of archival data on process loads: the layout and magnitudes of loads have changed significantly over the 60 years of building operation. Based on the information obtained from the point cloud data (see Fig. 12), the layout of loads acting on the structure was verified and updated, which provided a basis for further analyses, including nonlinear analyses.

Fig. 12. Example of loads identification process based on the point cloud data: a) tank – assessment of load, b) floor at +34 m – lack of dead-loads

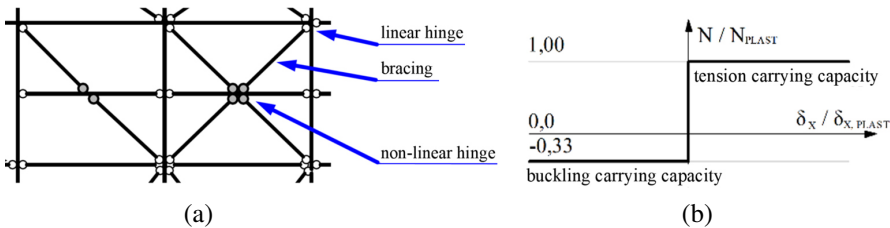
Due to the extent of the numerical calculations, the number of elements in which material nonlinearities were considered was limited to the vertical braces of the boiler room and included as nonlinear characteristics of the bracing hinges (Fig. 13). A rigid-plastic material model was used for the nonlinear joints, illustrating the tensile and compressive capacity of the members, including loss of stability (Fig. 13b). The buckling resistance model presented in Fig. 13b is a simplified model, however, due to the computational complexity, it was decided to adopt a simplification, which results in lower stiffness of the joints than in reality.

Fig. 13. Calculation model of bracing with nonlinearities at joint at one end: a) scheme with location of hinges, b) characteristics of non-linear hinge
