## DYNAMIC ANALYSIS OF DAMAGED MASONRY BUILDING REPAIRED WITH THE FLEXIBLE JOINT METHOD

A. KWIECIEN<sup>1</sup>, P. KUBOŃ<sup>1</sup>

The paper presents a dynamic analysis of the damaged masonry building repaired with the *Flexible Joint Method*. Numerical analysis helped to determine the effect of the applied repairing method on natural frequencies as well as values of stresses and accelerations in the analyzed variants of numerical model. They confirmed efficiency of the proposed repair method.

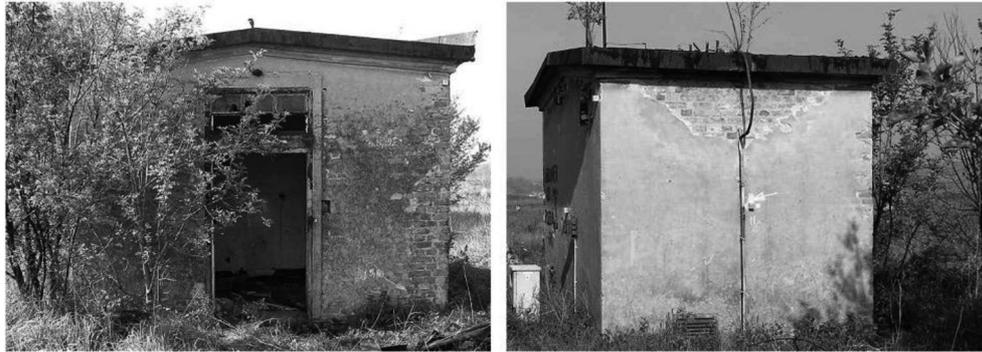
A subject of conducted analysis was the storied, masonry building of the transformer station (Fig. 1). The building was constructed on a rectangular plan with the external walls dimensions of 4.42[m]×3.07[m] and the height of 2.90[m] in the roof base and of 3.44[m] in the roof ridge. Walls of the building were constructed in the traditional technology, made of brick on cement-lime mortar with thickness of 25[cm], covered with a thin layer of plaster and based on a concrete floor plate with a thickness of 30[cm], which was constructed on the brick benches buried in the ground at 1.6[m].

Fig. 1. View of the analyzed building – undamaged stage.

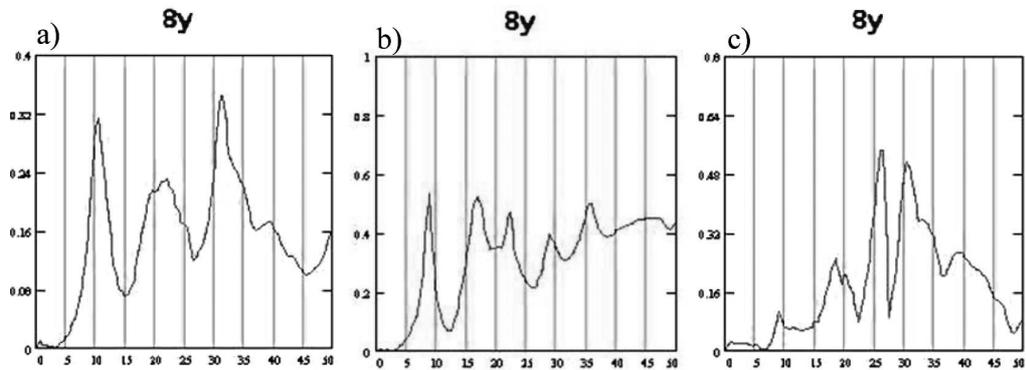
After the damage, the frequency response of the building has noticeably shifted towards lower frequencies, whereas repairing with polymer of the damaged structure has moved the mentioned response towards higher frequencies. Shifts scale for higher frequencies is greater than for lower ones. This trend can be observed both in the FFT as well as in the inertance module charts (Fig. 6, Fig. 8.).

Fig. 6. Exemplary FFT plots for the building (in different scale): a) undamaged, b) damaged, c) repaired.  
Rys. 6. Przykładowe wykresy FFT dla budynku (różna skala): a) nieuszkodzonego, b) uszkodzonego, c) naprawionego

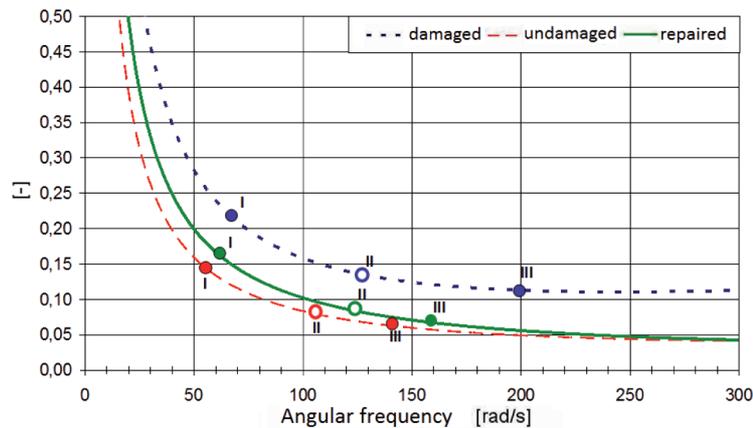
Damping coefficients  $\xi$  for the second dominant resonant frequency were calculated from the first and the third dominant resonant frequencies according to equation (3.5), using the equivalent Rayleigh damping method (Fig. 10). Comparison of estimated damping parameters shows that damage of the building reduces them by almost half, while repairing cracks with polymer causes growth of damping by about 10% in comparison to the undamaged building (Fig. 10).

Fig. 10. Function of critical damping fraction determined for three stages of the building.  
Rys. 10. Funkcja ułamka tłumienia krytycznego wyznaczone dla trzech faz pracy budynku
