DANIEL WAŁACH*, PIOTR DYBEL*, MAREK CAŁA*, JUSTYNA JASKOWSKA-LEMAŃSKA***EVALUATION OF LOAD CAPACITY OF SHAFT COLLAR SUBJECT TO UNINTENDED
EXCEPTIONAL LOADS****OCENA NOŚNOŚCI GŁOWICY SZYBOWEJ PODDANEJ NIEZAMIERZONYM
OBCIĄŻENIOM WYJĄTKOWYM**

The article presents an evaluation of the technical conditions of the shaft collar as well as its load capacity in which the consequences of uncontrolled displacement of part of the ventilation drift could have caused additional stress to occur. On the basis of comprehensive diagnostic examination undertaken by the authors, a comprehensive analysis of the static resistance of the shaft collar, which takes into consideration the exceptional unintended load. Examinations as well as calculations carried out have allowed for the evaluation of the practical degree of danger for shaft objects (constructions) as well as their infrastructure.

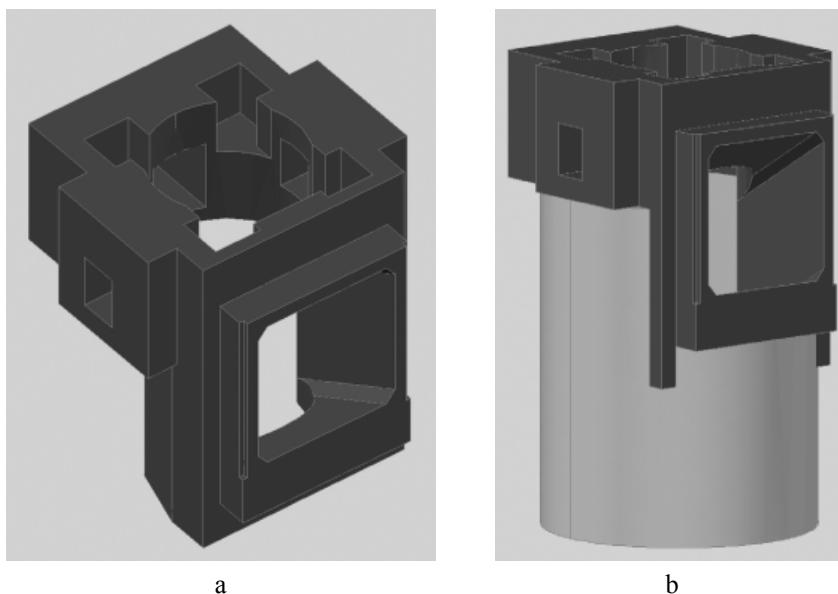
The original shape of the shaft collar was difficult to define due to the lack of appropriate documentation in this respect. Construction of the ventilation drift in its present form was carried out in the 1970s, which could have caused the necessity to ultimately upgrade the shaft collar with pipe-cable duct inlets. For this purpose, a partial demolition of the old collar was carried out, after which a new reinforced concrete construction was built, as presented in Fig. 2.2, the geometry of which is presented in Fig. 2a. The new construction of the shaft collar is based directly on the bricklaying of the shaft support structure, which in this place has a thickness of about 20 m. The method in which the collar is placed on the shaft support structure is presented in Fig. 2b.

Fig. 2. General view of the shaft collar
a) Geometry of the reinforced concrete construction of the shaft collar
b) Method of placing the shaft collar on the shaft support structure

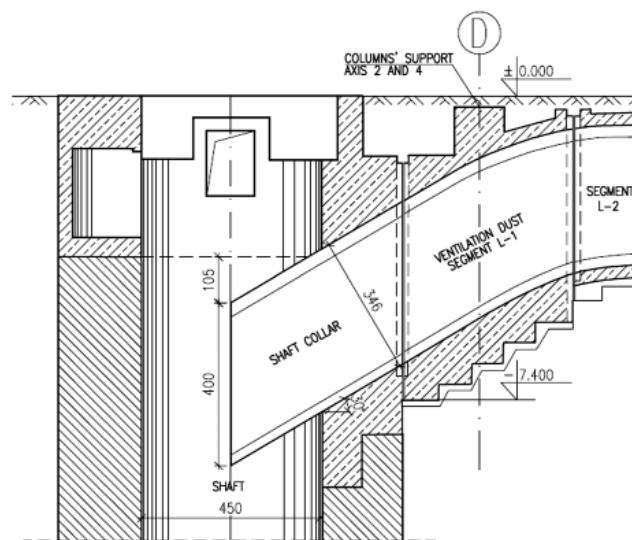
The analyzed construction consists of the shaft collar leaning directly on the shaft support structure. The shaft collar was made of a monolithic reinforced concrete element; however, the shaft has a brick structure support based on cement mortar. The ventilation duct, made of reinforced concrete segments, adjoins the shaft collar with a mutual dilatation from each other (Fig. 6). As a result of displacement of the first segment of the ventilation telescope relative to the shaft collar, it was stated that the possibility of transferring the additional load was not taken into consideration during the design stage. Due to the lack of accurate data in respect of the displacement of the ventilation drift segment and condition of the soil underneath the base plate, calculation of the most adverse case impact of the ventilation drift to the shaft collar had to be accepted. It was assumed that as a result of subsidence and rotation, the first segment of the ventilation drift would transfer horizontal loads to the shaft collar only via the face of the floor slab.

Fig. 6. Longitudinal section through the ventilation duct and shaft collar
