ARCHIVES  
 of  
 FOUNDRY ENGINEERING

# Study on Friction and Wear Characteristics of Aluminum Alloy Hydraulic Valve Body and Its Antiwear Mechanism

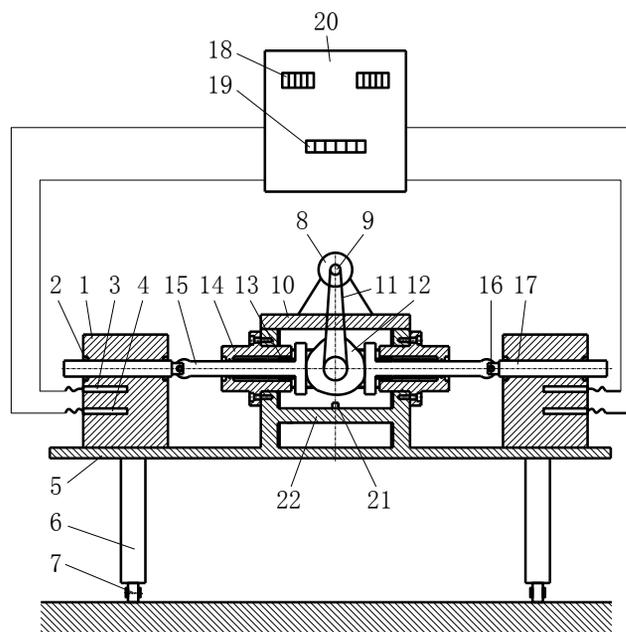
The experimental device is presented in Fig.1. This device can convert the motor rotating motion into a reciprocating linear motion of a valve stem through the cam. The actual working procedure is presented: the cam rotation is driven by a motor and following the top rod moves linearly. The cam seat is provided with a spring, constituting the push rod to be always adjacent to the cam. The push rod drives the valve rod to reciprocate within the hole of the valve body. In this procedure, the valve actual running simulation is demonstrated. A counting sensor is arranged on the bracket at the bottom of the cam and the counting sensor is connected to the counter in the electric control box. The reciprocating times of the valve rod during running can be recorded. Moreover, the valve body is provided with a thermocouple and a heating rod, therefore the valve body is heated by the heating rod. The valve body temperature can be measured by a thermocouple for the effects of temperature on friction and wear to be tested for the valve body. The valve body is connected to the hydraulic system, whereas both ends of the valve body are provided with a sealing ring and the valve body wear is determined by oil leakage observation through the sealing.

Fig.1 Experimental apparatus of valve body wearing

1-body, 2-sealing, 3- thermocouple, 4-heater, 5-plane, 6-leg, 7-wheel, 8-motor, 9-shaft, 10-frame, 11-belt, 12-cam, 13-spring, 14-cam seat, 15-push rod, 16-bolt, 17-valve rod, 18- monitor, 19- counting, 20- electric control box, 21- counting sensor, 22-frame

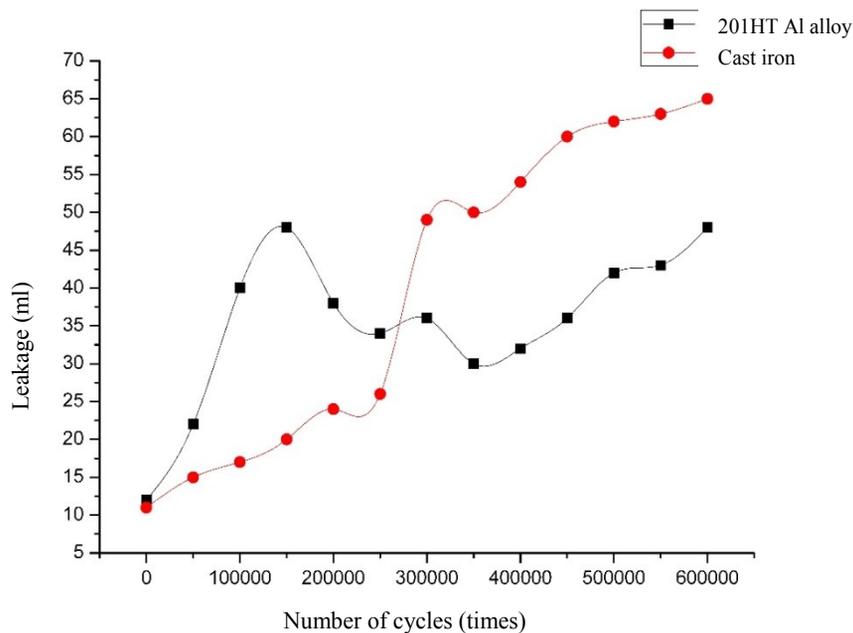
In Fig.2 the valve group leakage of various materials is presented. During various wearing cycles' times, the leakage was different. As presented in Fig.2, the cast iron leakage was significantly lower than the aluminum alloy valve leakage at the beginning of wear, whereas the leakage rate increased slowly as the number of times increased. Besides, a cast iron leakage

alteration following 300 thousand wear times was apparent, and therefore the leakage sustained a substantial increase. Consequently, the cast iron valve leakage increased slowly. The leakage of the aluminum alloy valve increased faster than the cast iron leakage. Whereas following 150 thousand wear times, the leakage decreased significantly and at 250 thousand times the first low leakage value was apparent. As the valve run continuously, the corresponding minimum leakage was apparent at 350 thousand wear times. Subsequently, the leakage gradually increased, whereas the leakage curve was parallel to the cast iron curve, even though aluminum alloy valve group leakage rate was lower than the rate of cast iron.

Fig. 2. Leakage curve of different material

Firstly, the inner surface of the valve body formed a number of plastic deformations and furrows: because the aluminum material was soft compared to cast iron. The CR valve rod presented hardness exceeding the 201HT and shoveling effects increased significantly. It resulted to a high deformation in plastic sliding and high sized furrow morphology. This morphology led to a valve group increased leakage, which was also explained in Fig. 2 where a high amount of leakage was apparent during early running.

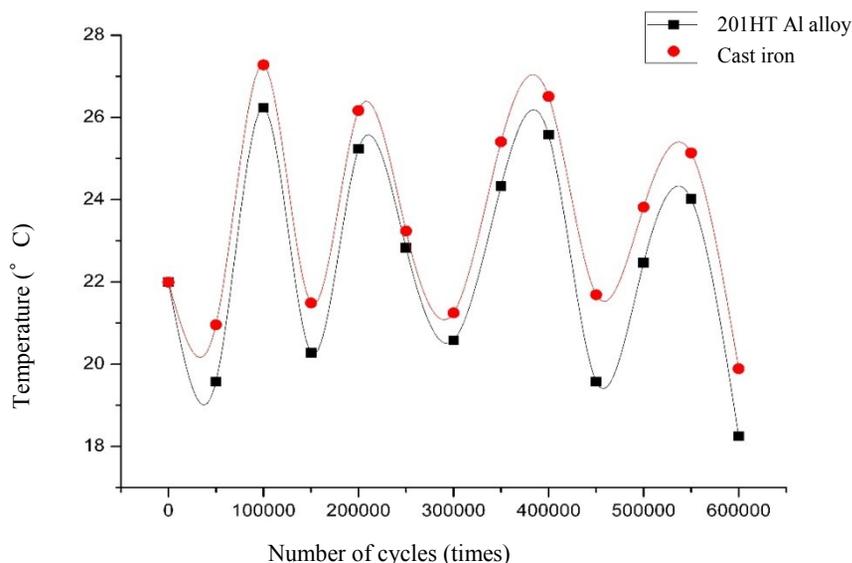
In Fig.3 the temperature curves of two types of materials are presented. It can be observed, that in addition to initial

temperature, the subsequent temperature of the aluminum alloy was lower than the corresponding cast iron temperature. The thermal conductivity of the aluminum alloy valve group was improved than the cast iron conductivity.

Fig. 3. Temperature curves of different materials

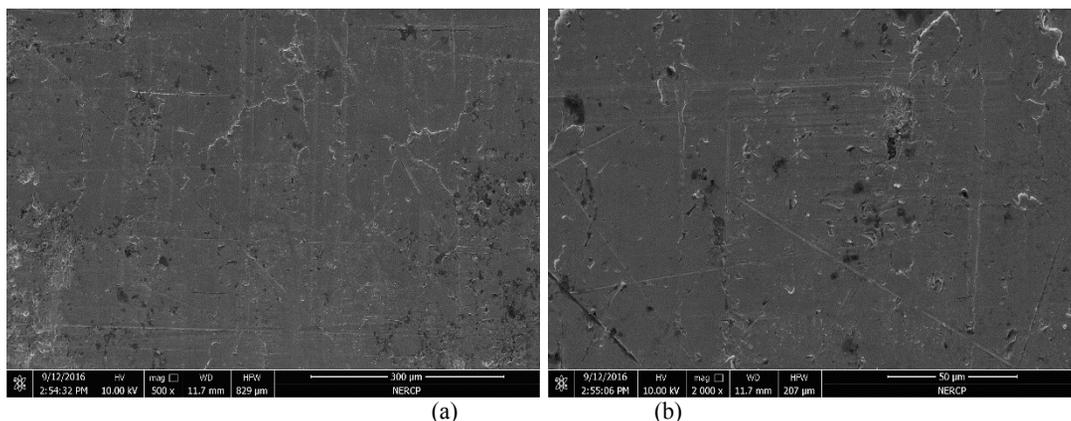
From the low magnification presented in Fig. 4, it can be observed that the cast iron valve body inner surface was quite smooth. Also, plastic deformation was the main friction result, along with the partial furrow. During magnification, the small pits could be observed being distributed on the surface and also the slip morphology of the materials following plastic deformation was apparent.

Fig. 4. Cast iron valve following a 300,000 cycles' times wear

Compared to the 300,000 cycles' times of cast iron and aluminum alloy body wear it can be observed, that the cast iron valve body surface damage was lower than the aluminum alloy body damage, being also significantly cleaner. The aluminum alloy valve body surface was consisted of a high number of furrows and plastic slips whereas in these furrows or slip bands a high amount of aluminum scrap was concentrated.

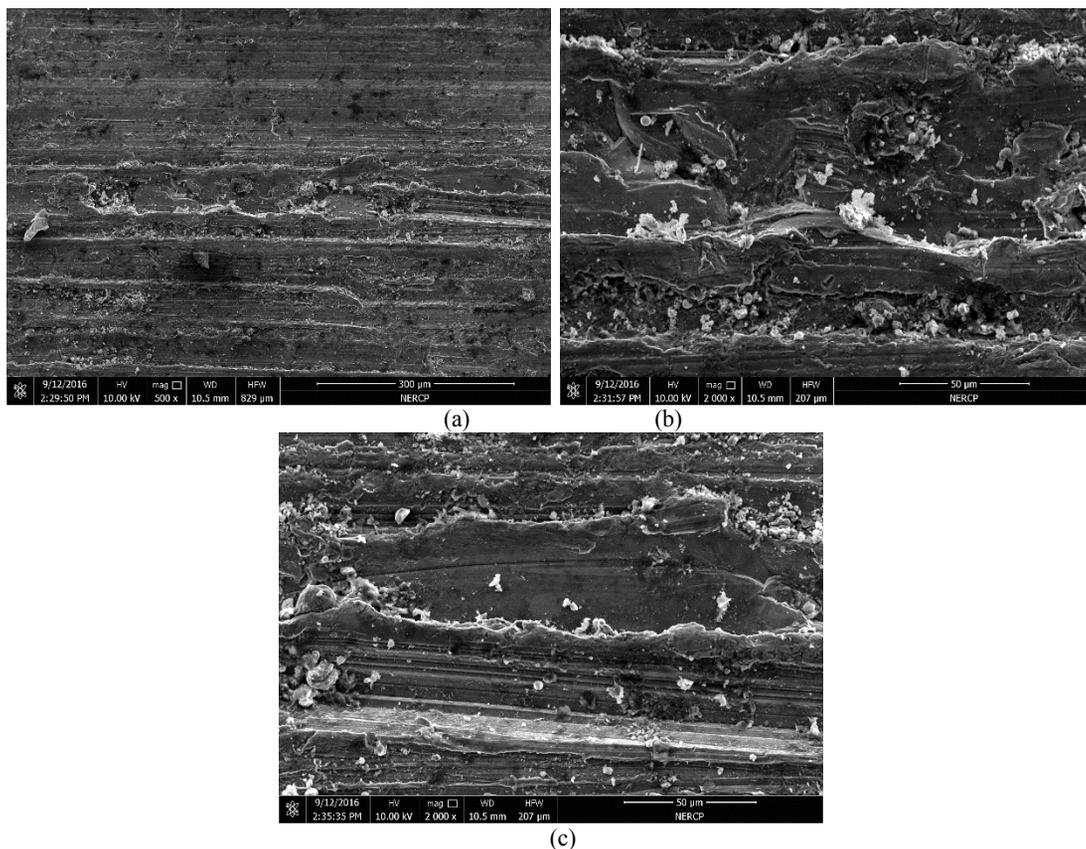
In Fig.5 the inner surface morphology of the 201HT valve body following a 300,000 cycles' times wear is presented. From Fig.5 (a) it can be observed that friction consisted of large furrows mainly and appeared with a significantly layered slip, also attributing a local melting point. During amplification, the local plastic deformation and micro lamellar slips could be observed. In addition, apparent material tear morphology existed, whereas in the micro pits a high amount of aluminum chips were concentrated, as presented in Fig.5 (b). Moreover, another slip band area demonstrated that broad furrows and slip band

morphology existed. Also, in these slip bands low sized furrows were apparent, possibly caused by the second cutting of aluminum scrap during running.

Fig. 5. 201HT valve body micrograph following 300,000 cycles' times of wear

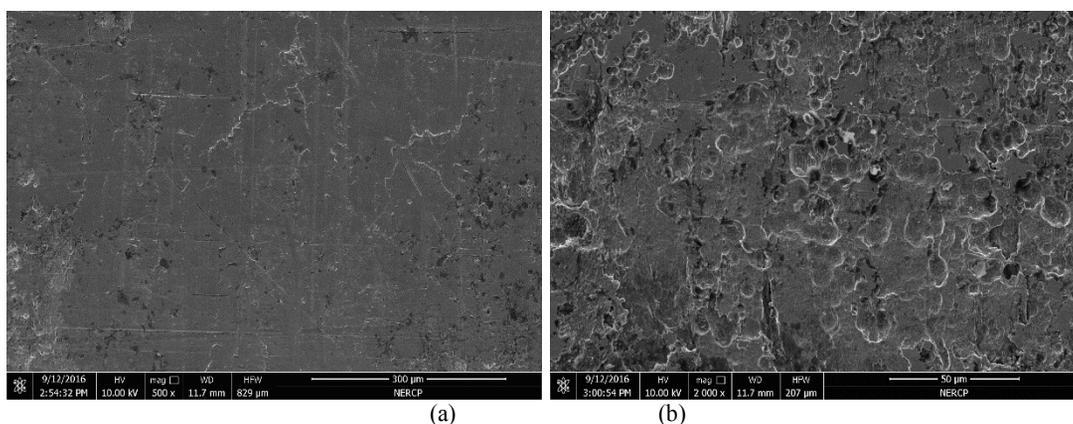
In Fig.6 the cast iron valve body surface morphology is presented, whereas in Fig.7 the aluminum alloy body morphology of following a 600,000 cycles' times running of wear is presented.

It can be observed from Fig.6 that the internal surface of the cast iron valve body displayed certain pits as wear times increased. The corresponding magnification is presented in Fig.6

(b). It can be observed that a high number of honeycomb pits were formed, whereas certain pits were polished. These pits would result in the valve group oil leakage during the hydraulic operation, whereas the subsequent result would be a system pressure loss.

Fig. 6. Cast iron valve after 600,000 cycles' times

Furthermore, due to cast iron's poor thermal conductivity, the temperature of the valve body surface gradually increased during continuous running. The graphite oxidized under high temperatures [8], exacerbating graphite peeling of the valve body inner surface. During this procedure a high amount of pits formed on the surface also as presented in Fig. 6.

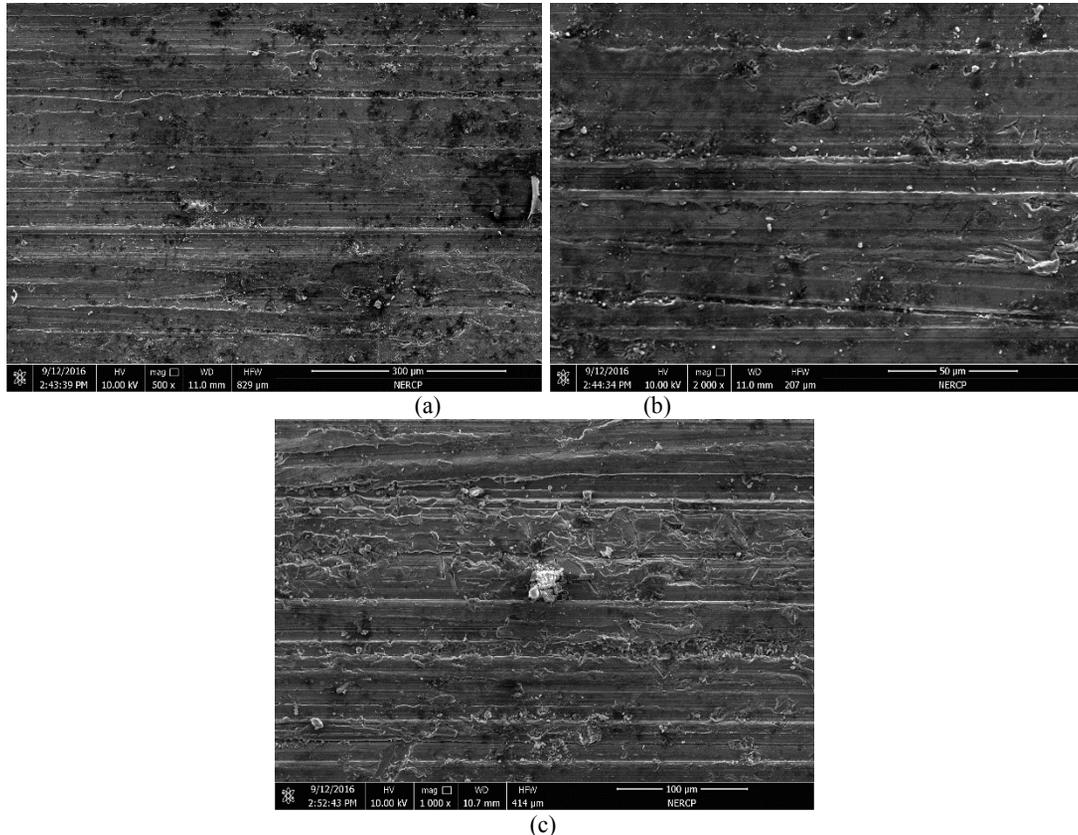
In Fig.7 the morphology of the aluminum alloyed body following 600,000 times of wear. It slips zone and furrow topography can be observed from Fig.7 (a) on the valve body

surface. Besides, following 600,000 cycles' wear times, the sliding zone tended to be flat and uniform, whereas a high amount of the original pits was filled and only a low sized furrow

remained, as presented in Fig.7 (b). In addition, due to continuously repeated rolling, a certain amount of surface material of the aluminum alloy valve body became thin and consequently formed a high number of fragments during the

600,000 cycles' times of wear, as presented in Figure 7 (c). The surface fatigue micro-cracks were formed by continuous rolling. These cracks were expanded due to stress alternation, continuing the valve body surface material exfoliation.

Fig. 7. 201HT valve body micrograph following 600,000 cycles' times of wear

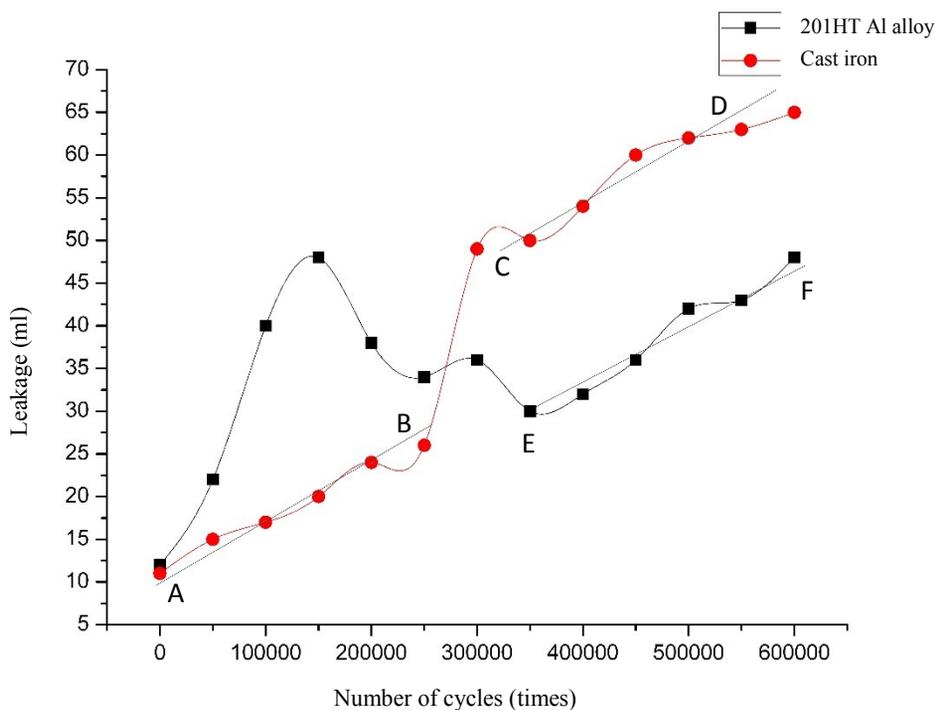
This relationship between the valve body leakage and wear times is significantly different in valve leakage between different materials. Besides, in Fig.8 the three parallel lines (AB, CD and EF) are presented, which describe different materials and different times demonstrating the same line slope. Therefore, a linear relationship existed between the number of wear times and the leakage amount of different materials.

The three-segment curves are presented in Fig. 8 and the slope of the straight line is:

$$K = \tan \alpha = \text{Leakage} / \text{time} = \tan 30^\circ = 0.577 \text{ (ml / time)}.$$

Fig. 8. Leakage and times linear fitting

Compared to the leakage curves of cast iron and aluminum alloys, various alterations existed in various stages on the leakage curves. At 300,000 cycles' times of wear, the curves of cast iron displayed a change: the curves slope of leakage presented an abrupt sudden increase, mainly due to the inner surface morphology alterations of iron (internal material surface peeling). It resulted in the valve group internal leakage and slopes increase. At this time, the system leakage performance for the wear process leakage. As running continued (exceeding 300,000 cycles' times), the valve body adapted to the new surface, therefore the valve leakage mechanism returned to the leakage value, composed by the foundation leakage value, friction and wear, resulting in a leakage value increase. Besides, due to internal morphology alterations, the foundation leakage amount increased, therefore the straight line moved upwards.

As running continued (exceeding 300,000 cycles' times), the friction surface gradually adapted to the valve rod and body gaps, whereas system was driven into a normal wear stage, as presented in the EF straight line area of Fig.8. Consequently, the aluminum alloy valve leakage became similar to the leakage mechanism: composed of foundation leakage values and friction and wear resulting in the leakage value increase.

Therefore, the leakage level of the aluminum alloy valve was lower than the cast iron leakage level, as presented from the EF line in Fig. 8.

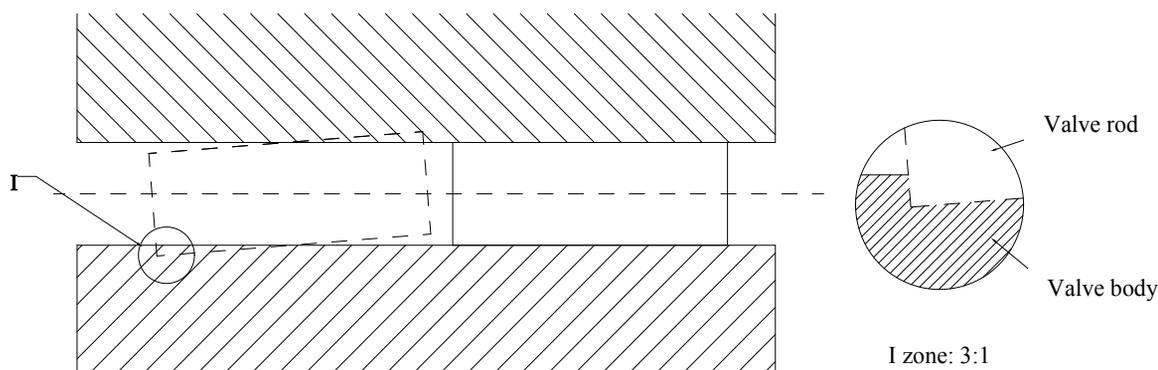
Due to the valve group being mainly a longitudinal sliding during actual running, unavoidable non-parallel or offsets appeared between the rod and valve body, as presented in Fig.9. It led the valve rod shovel the internal surface of the valve body, causing the formation of surface furrows and plastic slips on the material surfaces.

Fig. 9. Valve body and rod actual position
