High temperature resistance of silicide-coated niobium

Abstract. In this paper, thermal oxidation resistance of silicide-coated niobium substrates was tested in a temperature range of 1300–1450°C using an HVOF burner. Pure niobium specimens were coated using the pack cementation CVD method. Three different silicide thickness coatings were deposited. Thermal oxidation resistance of the coated niobium substrates was tested in a temperature range of 1300–1450°C using an HVOF burner. All samples that passed the test showed their ability to stabilize the temperature over a time of 30 s during the thermal test. The rise time of substrate temperature takes about 10 s, following which it keeps constant values. In order to assess the quality of the Nb-Si coatings before and after the thermal test, light microscopy, scanning electron microscopy (SEM) along with chemical analysis (EDS), X-ray diffraction XRD and Vickers hardness test investigation were performed. Results confirmed the presence of substrate Nb compounds as well as Si addition. The oxygen compounds are a result of high temperature intense oxidizing environment that causes the generation of SiO phase in the form of quartz and c

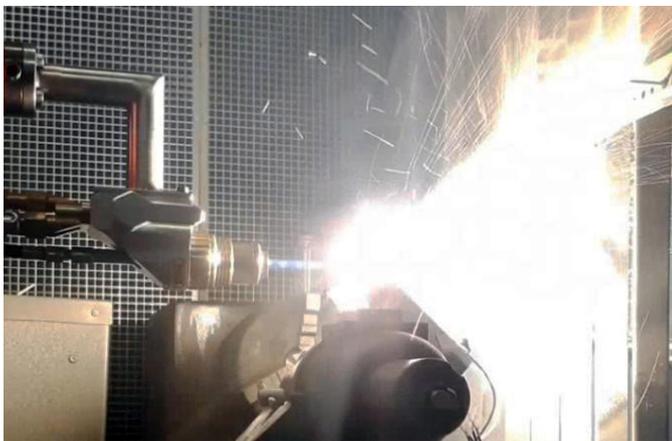
Fig. 1. Thermal test of Nb sample without coating

Pure and coated Nb samples were subjected to thermal testing using an HVOF flame in a fixed process parameter. The purpose of the test was to pre-determine the suitability of the produced coatings for use in high temperature applications. In addition, temperature was measured on the opposite side of the sample relative to the flame, in order to determine the thermal resistance of the coatings deposited on Nb substrates. The course of the thermal resistance test consisted of the following steps (Fig. 1):

1. Clamping a cylindrical sample with a diameter of 50 mm in the holder (tools steel) under 45° to the flame axis.
2. HVOF ignition and stabilization of combustion conditions away from the sample.
3. Rapid approach of the HVOF gun to the central position of the sample at the distance of 80 mm between the nozzle exit and the sample surface.
4. Holding for 30 s and simultaneous temperature measurement on the other side of the sample.

5. Quick nozzle departure, flame extinguishing and slow cooling of the sample in the air flow.

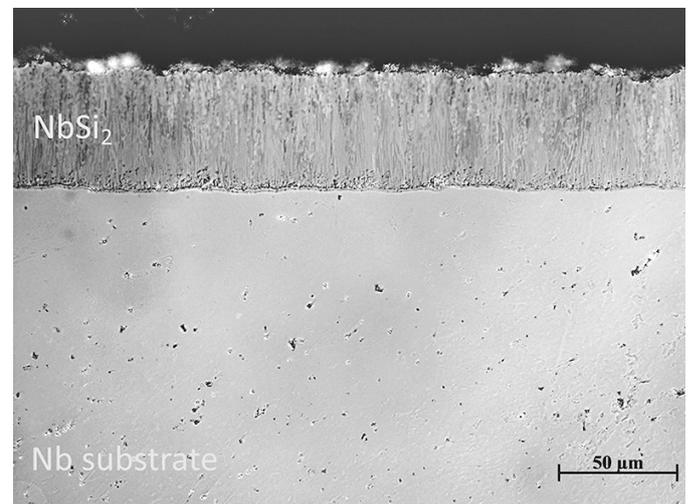
Fig. 2. Cross section of W1 sample. Columnar structure of NbSi coating can be observed on the top. Magnification $\times 500$

Analyzing the coating structure, as shown in Fig. 2–4, allowed for characteristic columnar shape to be observed. This shape is a result of crystal-growing during the CVD process. It seems that there is relation between NbSi crystals size and the coating thickness. The smallest crystals grew in the W1 speci-

men and the largest ones – in W3. The coating of sample W1 is the thinnest (50 μm) and the CVD process time is shorter than for W2 and W3 samples, which have better thermal conditions for crystals growing.

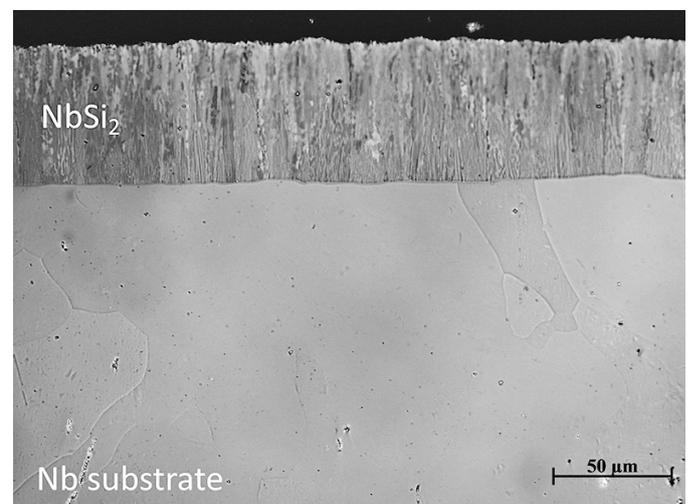
Fig. 3. Cross section of W2 sample. Columnar structure of NbSi coating can be observed on the top. Magnification $\times 500$

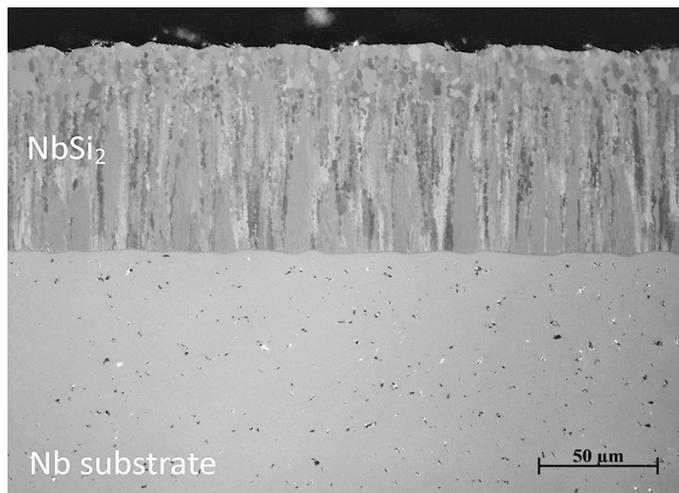
Fig. 4. Cross section of W3 sample. Columnar structure of NbSi₂ coating can be observed on the top. Magnification ×500

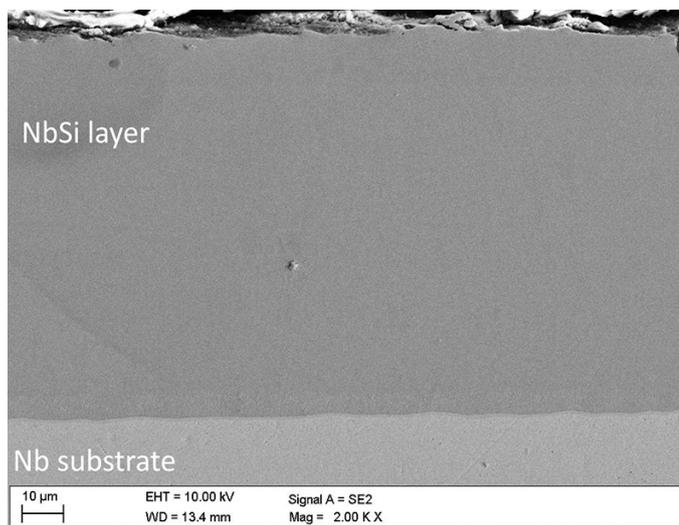
Fig. 5. SEM cross section of W3 sample. The NbSi layer visible as dark gray area

Scanning electron microscopy cross section of the W3 specimen is shown in Fig. 5 and topography of W1–W3 is presented in Fig. 6–11. The NbSi coating is homogenous and a thin bond coat layer on the substrate surface is observed. This layer also has a columnar structure and may influence the coating structure above.

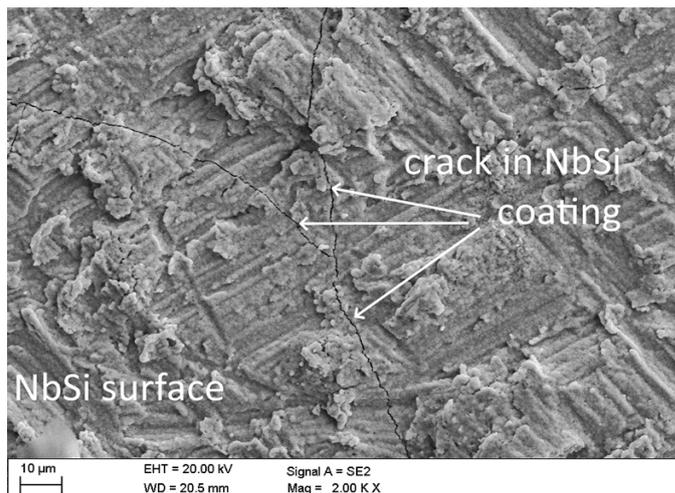
Fig. 6. SEM surface morphology of NbSi layer (W1 specimen). Cracks were observed on the NbSi surface

The coating surface topography it is not homogenous. Characteristic relief was observed as well as small cracks on the top. The cracks size relates to the specimen type. The smallest width of cracks occurred for sample W2.

The coating surface EDS chemical analysis confirmed similar composition for all coated specimens which are shown in Fig. 6, 8 and 10 (Table 1–3).

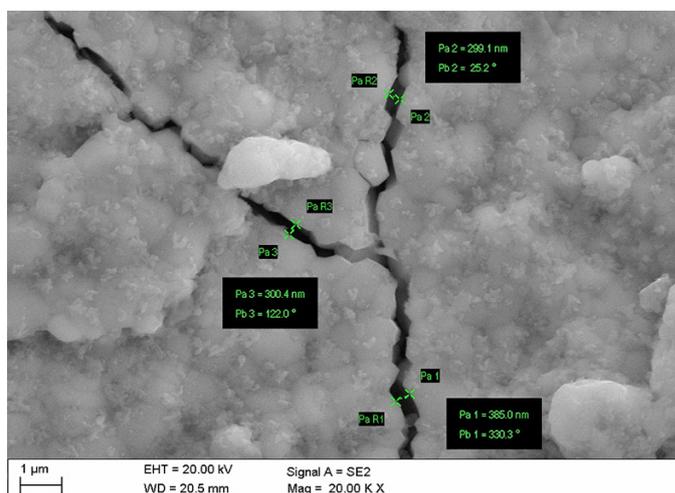
Fig. 7. Surface morphology of NbSi layer (W1 specimen). Cracks were observed on the NbSi surface

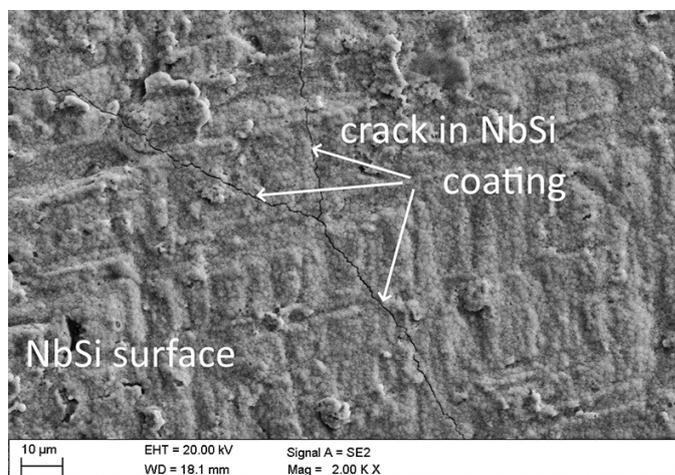
Fig. 8. Surface morphology of NbSi layer (W2 specimen). Cracks were observed on the NbSi surface

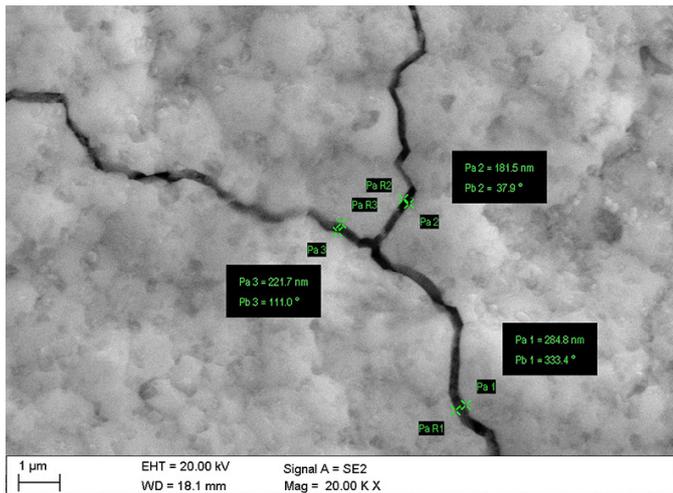
Fig. 9. Surface morphology of NbSi layer (W2 specimen). Cracks were observed on the NbSi surface

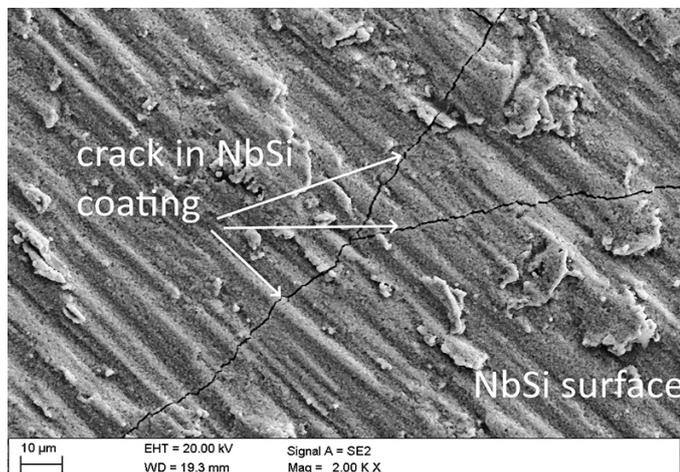
Fig. 10. Surface morphology of NbSi layer (W3 specimen). Cracks were observed on the NbSi surface

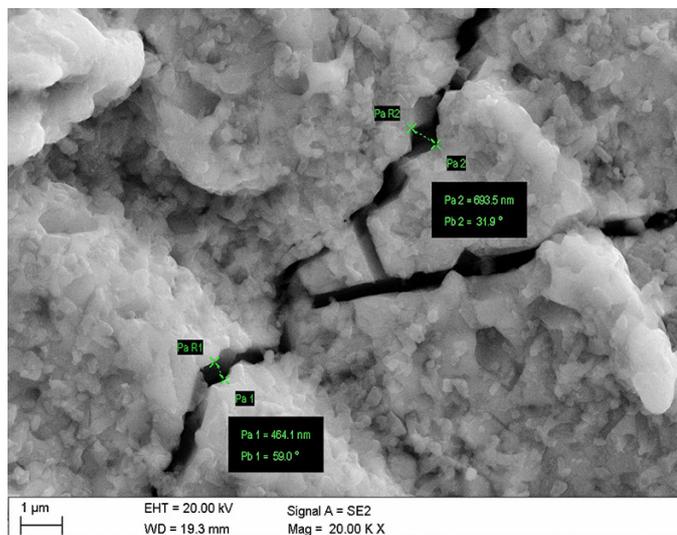
Fig. 11. Surface morphology of NbSi layer (W3 specimen). Cracks were observed on the NbSi surface

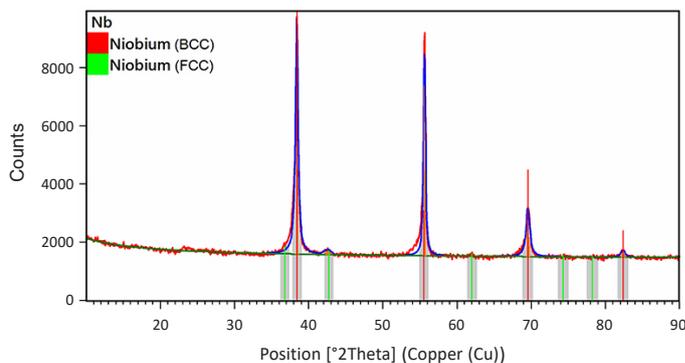
Fig. 12. X-ray diffraction pattern of Nb substrate

According to the assumptions, the phases occurring in the substrates are in the case of a niobium substrate the phase with a predominant volume share is the Nb phase of a body-centered cubic network, space group Im-3m (ICSD: 98–064–5060) and in a lower proportion the Nb phase of a face-centered cubic structure, space group Fm-3m (ICSD: 98–004–1512) (Fig. 12). All specimens (W1, W2 and W3) revealed the presence of NbSi₂ phases of hexagonal structure P 62 2 2 (ICSD: 90–060–1659) (Fig. 13–15).

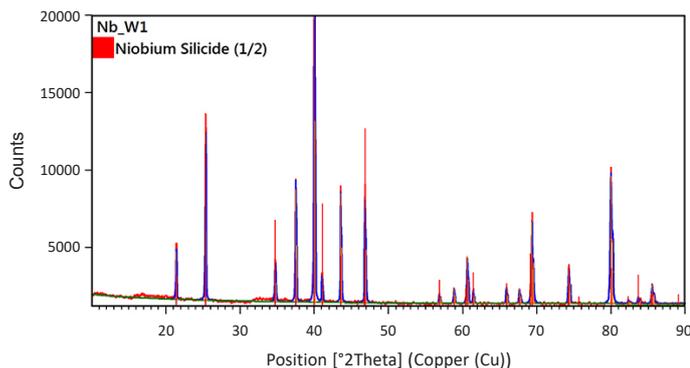
Fig. 13. X-ray diffraction pattern of silicon coatings on an Nb substrate, variant 1 (NbSi-W1)

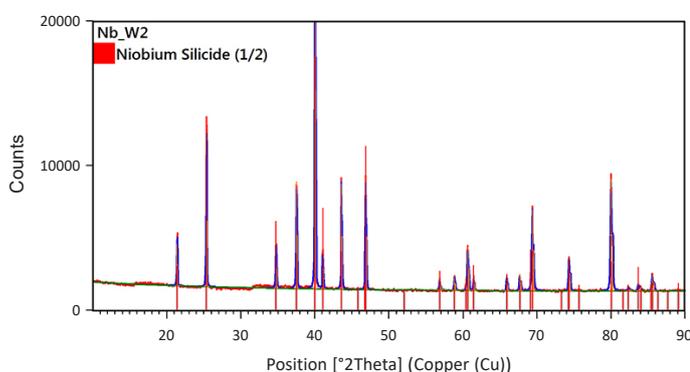
Fig. 14. X-ray diffraction pattern of silicon coatings on an Nb substrate, variant 2 (NbSi-W2)

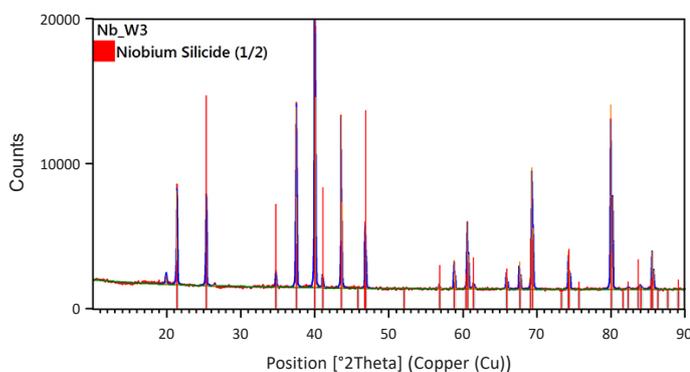
Fig. 15. X-ray diffraction pattern of silicon coatings on an Nb substrate, variant 3 (NbSi-W3)

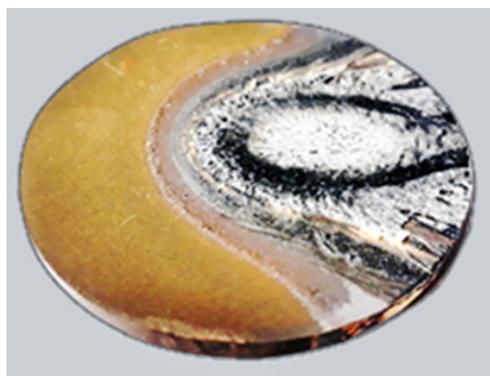
Fig. 16. Pure niobium substrate after thermal test (30 s). Magnification $\times 1$. Material sputtering effect occurred. Yellow oxides on the surface were observed

As a result of the HVOF heat test of samples not coated with TBC coating, a significant sparkle sputtering phenomenon was visible. The high velocity of gases as well as high temperature on the substrate surface causes materials sputtering. This thermal abrasive wear caused a form of a crater to occur and thinned the Nb sample (Fig. 16).

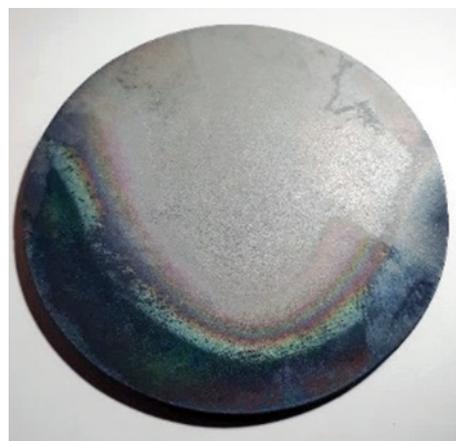
Fig. 17. W1 sample after high temperature oxidation thermal test. Magnification $\times 1$. No material sputtering effect occurred

As a result of the thermal test of Nb-NbSi TBC samples, the traces of wear were observed and rated. All of the samples, except for Nb-NbSi W2 (Fig. 18), passed the thermal test without significant destruction of the TBC layer or the metallic Nb substrate (Fig. 17, 19).

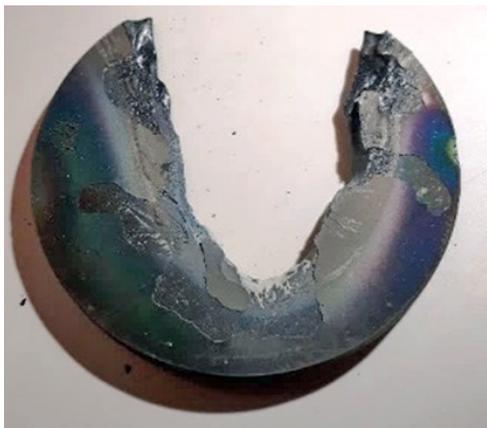
Fig. 18. W2 sample after high temperature oxidation thermal test (failed). Critical material sputtering process occurred. The specimen was destroyed. Magnification $\times 1$

The NbSi structure has a characteristic columnar shape. It may grow according to Thornton's rule [27]. Only the Nb-NbSi W2 sample exhibits total destruction as a result of damage to the TBC layer. It is thought that the NbSi coating on the sample showed some defects before the test. Probably the present cracks were formed during the coating process. This stands as clear evidence that even a small defect of the TBC layer may cause rapid destruction of whole composite material. In the case of sample W2, the depth of cracks could be higher than those of sample W1 and W3.

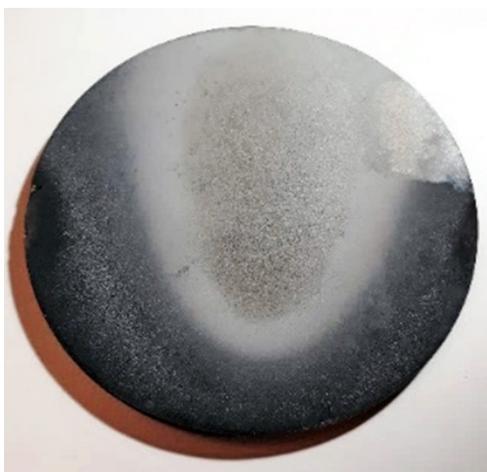
Fig. 19. W3 sample after high temperature oxidation thermal test. Magnification $\times 1$. No material sputtering effect occurred

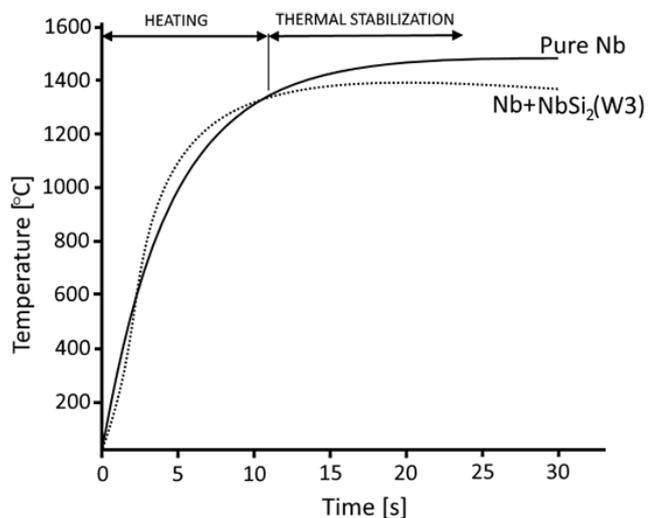
Fig. 20. Heating rate characteristic during thermal test of W3 sample (NbSi thickness – 90 μm) and pure niobium

All samples that passed the test showed their ability to stabilize the temperature over time of 30 s during the thermal test. The rise time of substrate temperature takes about 10 s, after which it keeps constant values (Fig. 20).

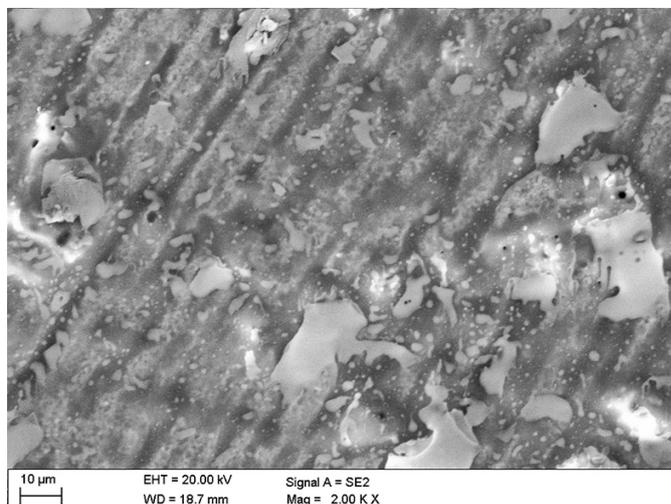
Fig. 21. NbSi topography after HVOF high temperature oxidation thermal test (W3 sample)

cal analysis (EDS) investigation were performed (Figs. 21–23, Table 5). Results confirmed the presence of substrate Nb compounds as well as Si addition. The oxygen compounds may be a result of the highly oxidizing environment that causes the generation of a SiO phase in the form of quartz and cristob-

alite during the thermal test. The SEM photography additionally shows some micro-cracks on NbSi TBC coating, which were also observed before thermal testing (Figs. 6–11). This may be a result of the influence of growing NbSi crystals at high temperature and thermal stress during the CVD process. Fortunately, the micro-cracks that were created did not cause the rapid delamination and destruction of the sample during the test performed. The crack size comparison is shown in Table 6.

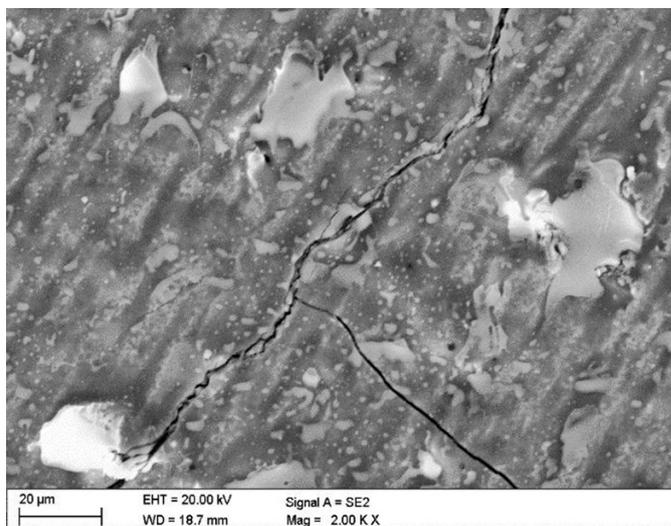
Fig. 22. NbSi topography after HVOF high temperature oxidation thermal test (W3 sample)

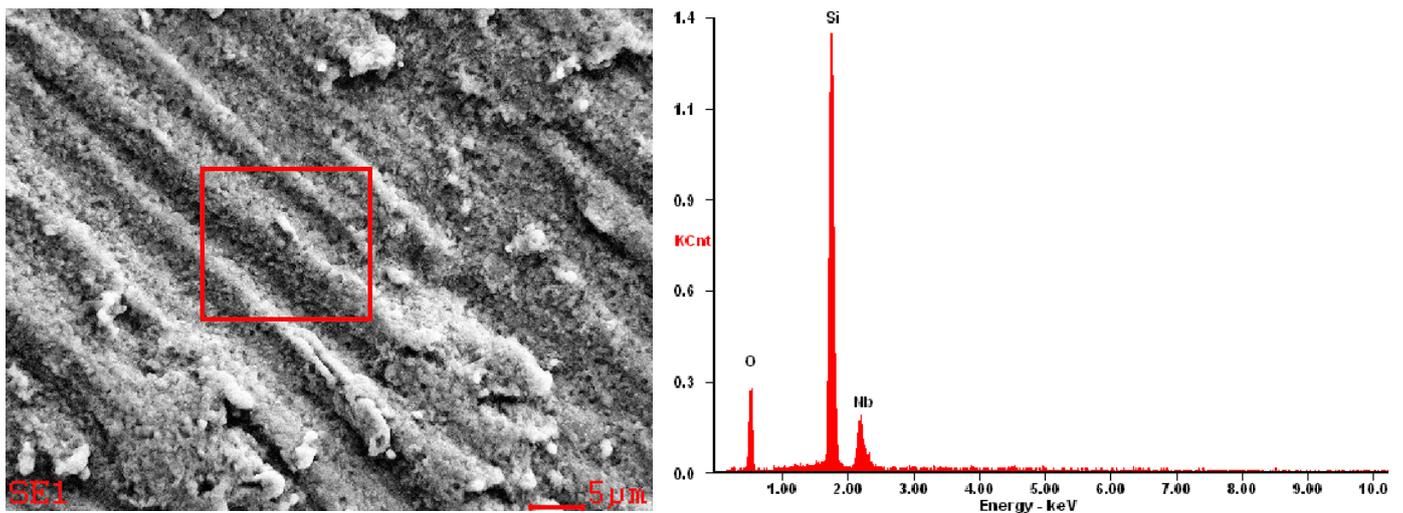
Fig. 23. Surface EDS chemical analysis in the defined area of NbSi coating (W3 sample) after HVOF high temperature oxidation thermal test
