Silane-Based Injection Methods for Moisture Protection in Ceramic Bricks

N. SZEMIOT-JANKOWSKA^{*1}, A. HOŁA¹

¹ Department of Materials Engineering and Construction Processes, Wrocław University of Science and Technology,
Wybrzeże Wyspiańskiego 27, Wrocław, Poland

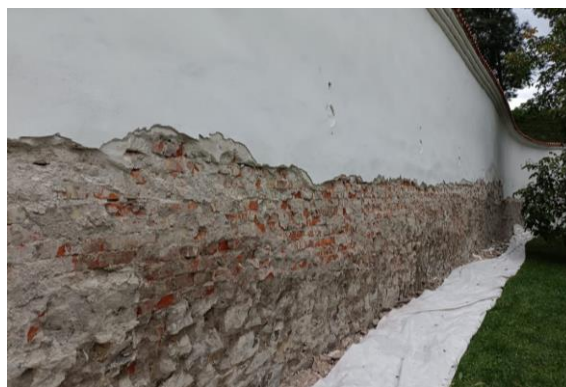
Fig. 1. Fragments of brick walls with visible traces of destruction caused by moisture and frost: a) the wall surrounding Pardubice Castle (Czech Republic); b) the external wall of a residential building in Kaunas (Lithuania); c) a residential building in Bergen (Norway); the building of Collegium Marianum in Pelplin (Poland)

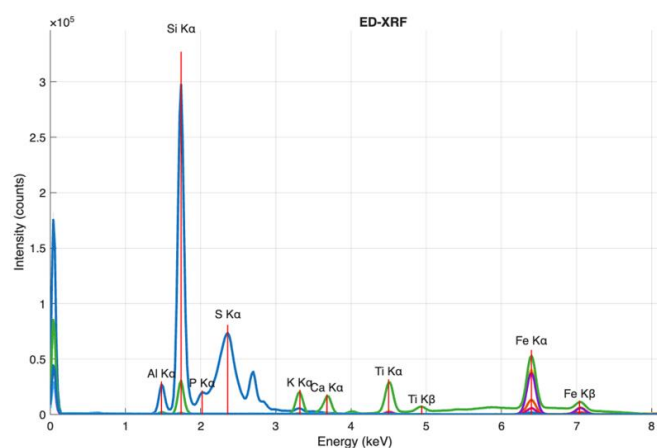
Fig. 2. ED-XRF spectrum showing elemental peaks in the brick sample

To determine the chemical composition of the examined brick, X-ray fluorescence (XRF) analysis was performed on a sample taken from a randomly selected reference brick. The obtained ED-XRF spectrum revealed distinct peaks corresponding to elements such as silicon (Si), aluminum (Al), iron (Fe), calcium (Ca), potassium (K), and titanium (Ti), which confirmed their presence in the material structure. The highest intensity was recorded for the Si K α line (~1.75 keV), indicating a dominant content of silica. (Fig. 2).

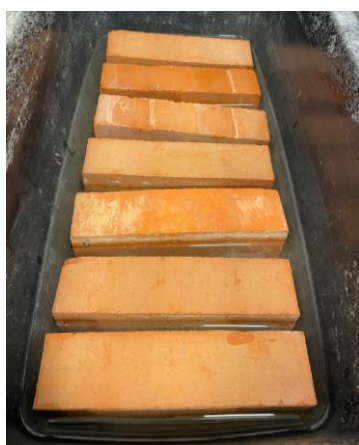
Fig. 3. A building caster containing bricks flooded with water to achieve adequate moisture content

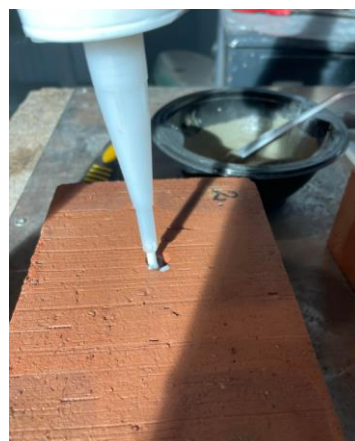
Fig. 4. Performing gravity injection in the brick with injection cream

In nine bricks, which were characterized by three different degrees of moisture content (three bricks each from groups I, II, and III), a pressure injection was performed. It involved the implementation of the injection cream (in a continuous manner) using a dispenser under a pressure of 2 atm. In the remaining nine bricks (also three bricks each from groups I, II, and III), a gravity injection was performed. It consisted of the introduction of the injection agent, as a result of the action of gravity, into the borehole (Fig. 4). After conducting the injections, the holes were sealed with cement mortar and the bricks were placed in plastic zip-lock bags to maintain their moisture content while the cream spread. In the reference bricks, no injections were performed.

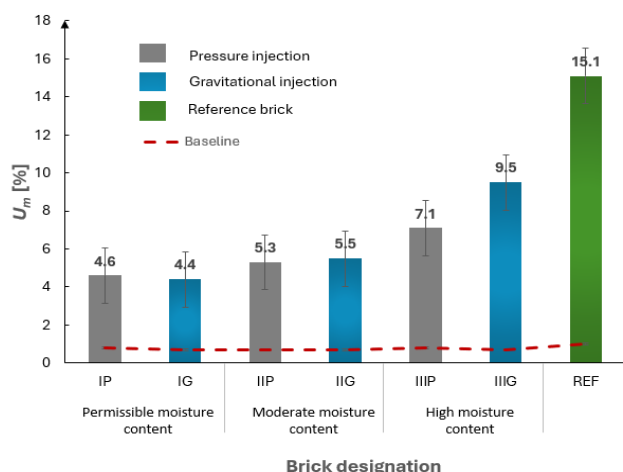
Fig. 8. Average mass moisture values (U_m) for re-moistened bricks from groups IP, IG, IIP, IIG, IIIP, IIIG and the reference group (REF)

The maximum values of the mass moisture content (U_m) of re-moistened bricks from groups IP, IG, IIP, IIG, IIIP, IIIG and REF are shown in Fig. 8.

When analysing the graph shown in Fig. 8, it can be seen that the average mass moisture content U_m for the bricks from the IG group (with an initial permissible moisture content, subjected to gravity injection) was characterized by having the lowest moisture content ($U_m = 4.4\%$). In contrast, the average mass moisture content (U_m) for the bricks from group IIIG (with a high moisture content at the time of injection, subjected to gravity injection) had the highest value ($U_m = 9.5\%$). The mass moisture content

values of all the brick groups in which injections were performed are two to three times lower than the average moisture content of the reference brick group, which amounted to 15.1%. This demonstrates a clear reduction in water absorption capacity as a result of the applied protection.

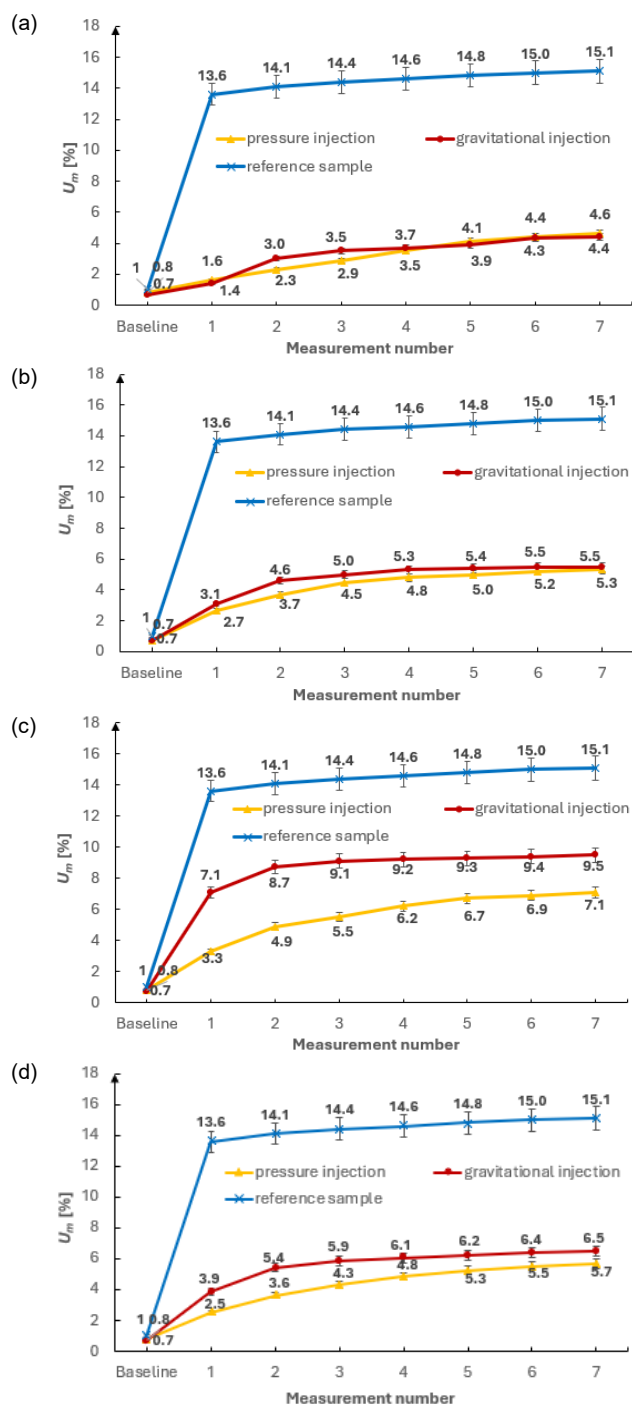
Fig. 10. Comparison of the effectiveness of the protection against moisture in the bricks subjected to pressure and gravity injection, taking into account different degrees of brick moisture content at the time of injection: a) permissible moisture content (IP vs. IG); b) moderate moisture content (IIP vs. IIG); c) high moisture content (IIIP vs. IIIG); d) average values

The effectiveness of damp-proofing the bricks was also compared according to the injection method used. Pairwise comparisons (pressure vs. gravity injection) were made for groups IP, IG, IIP, IIG, IIIP, IIIG and REF, as shown in Figures 10a-c. In addition, Fig. 10d shows the average moisture values obtained for the pressure and gravity methods, excluding the degree of brick moisture at the time of injection.

The conducted tests showed slight differences in the effectiveness of gravity and pressure injections in conditions of the permissible moisture (Fig. 10a) and moderate moisture content (Fig. 10b) at the time of injection. When analyzing subsequent measurements, in most cases gravity injection gives higher U_m values than pressure injection, but the differences are not significant. However, under high humidity conditions (Fig. 10c), the differences between the methods are clearly noticeable, reaching a maximum of approximately 3.8 pp in measurements no. 1 (7.1% vs. 3.3%) and no. 2 (8.7% vs. 4.9%). In subsequent measurements, this difference gradually decreased, stabilizing at around 2.4 pp in measurements no. 6 and 7. In relation to the average difference between the mass moisture values obtained for the pressure and gravity injection methods, its values were: 0.1% in group I, 0.4% in group II, and 2.7% in group III.

Taking into account the maximum achieved humidity values of the re-moistened bricks (measurement No. 7), the results suggest a potential advantage of the gravity injection method under conditions of acceptable material moisture content. Conversely, under medium to high moisture levels, the pressure injection method demonstrated greater effectiveness. However, given the relatively minor differences in performance between the two techniques, based on the results obtained to date, it is not possible to definitively determine which method is generally more optimal. For this reason, further research is necessary, including a larger number of samples and a broader range of variables, including comparisons of different injection creams.

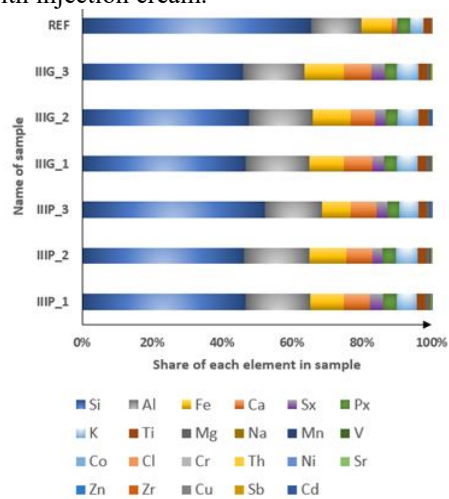
Fig. 15. Percentage share of individual elements in the samples from groups IIIP, IIIG and REF, determined by X-ray fluorescence analysis

Figure 15 shows, based on XRF analysis, a graph illustrating the percentage share of individual elements in the samples. The elemental distribution in the injected bricks shows high consistency—the values are similar regardless of the sample's location. It is worth noting that the silicon (Si) content in the reference brick is about 15% higher than in the samples injected with injection cream.
